Aviation Technical Bulletin

LYCOMING SERVICE INSTRUCTION #1442

Service Instruction No. 1442
Engineering Aspects are
FAA Approved

Improved Oil Filter Bypass Valve

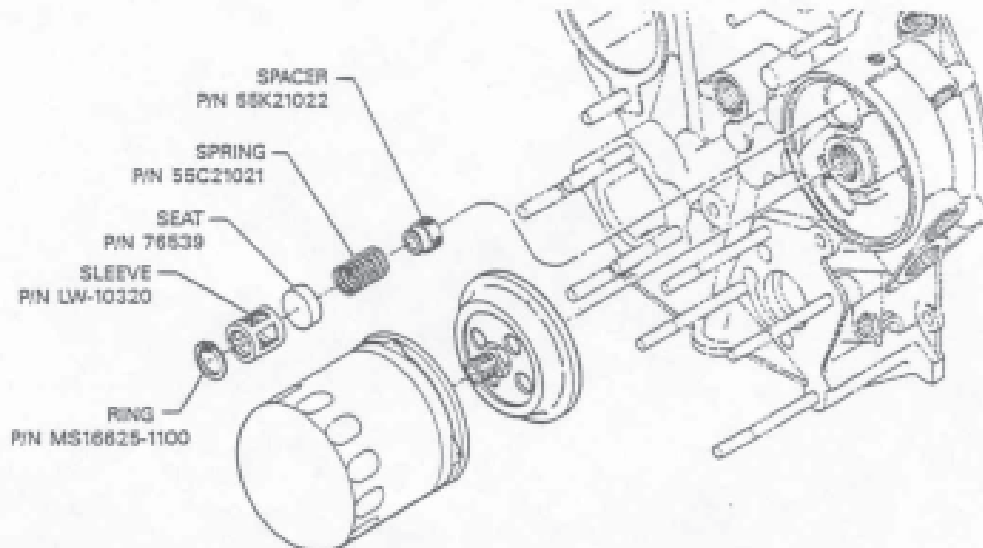
Figure 1. Oil Filter Bypass Valve Installation

Reports from the field have disclosed the possibility of oil filter elements collapsing, particularly on cold starts. As a product improvement, a new Spring, P/N 55C21021 and Spacer, P/N 55K21022 are to be used at time of overhaul. See Figure 1 for proper installation of all bypass valve parts.
