Aviation Technical Bulletin

95-15

NORMAL VS. ABNORMAL SEMI-CONDUCTOR WEAR

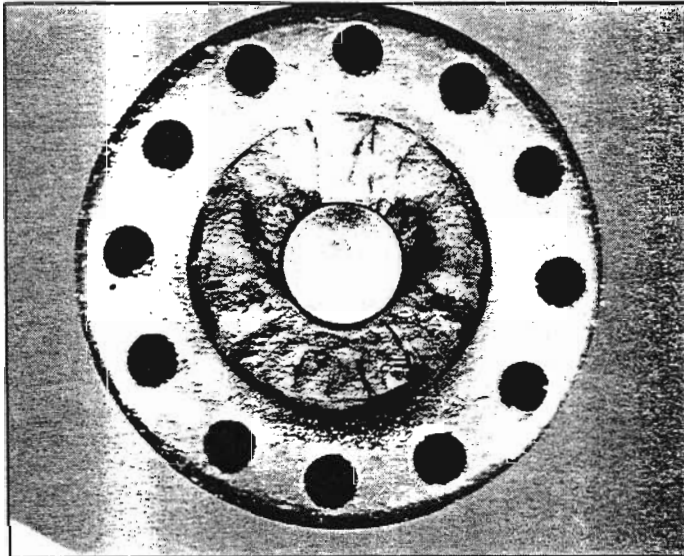
Photograph 1 – Firing End of Igniter
Note: Normal "channeling" wear of semiconductor

OK to "Return to Service" if other inspection criteria per manufacturer is met.

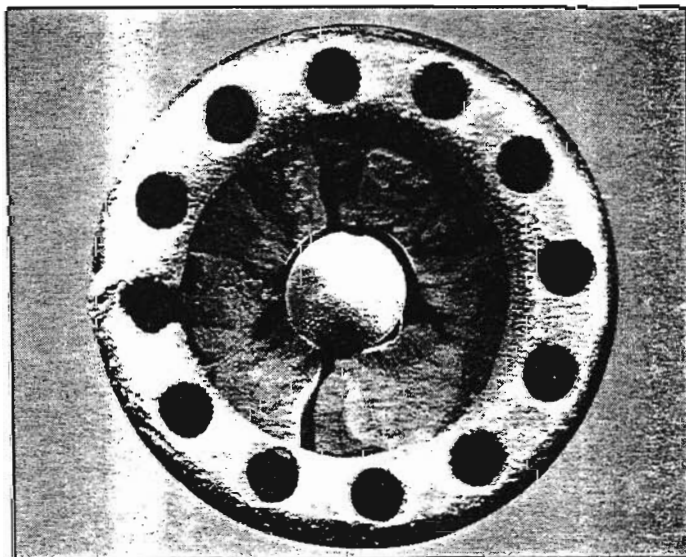
Photograph 2 – Firing End of Igniter
Note: Cracks in semiconductor

The main reason for this condition is: Igniters that have remained in service past useful life.

SCRAP!
