# TECHNICAL BULLETIN

**SUBJECT: Ignition - Distribution - Inspection/Check Instructions for Champion Igniter CH34682**

T.B. NUMBER: T.B.CH34682-74-20-02-003

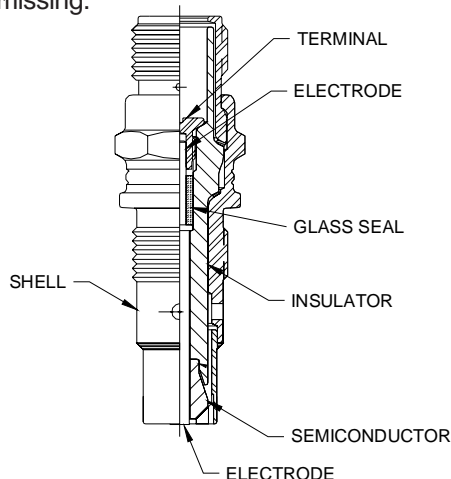
Figure 1. Igniter CH34682 construction  
October 10, 2002

Champion Aerospace is providing this technical bulletin to assist in the servicing of igniter CH34682 (Figure 1). This information is specific to igniter CH34682 and includes detailed inspection and checks instructions to determine the operational condition of the igniter.

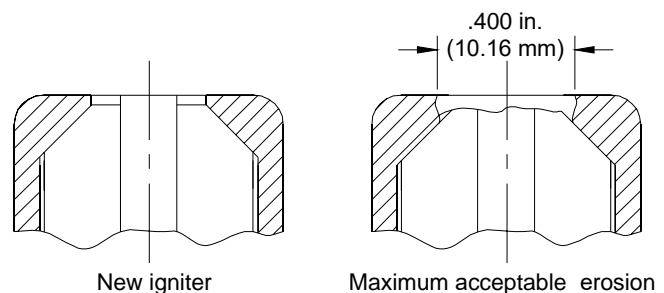
Figure 3. Igniter wear limits  
T.B.CH34682-74-20-02-003  
Page 1 of 2

- (2) Inspect firing tip for erosion to determine if gap is within serviceable limits (See Figure 3). Use calipers or gap gage to measure ground shell ID. If limits are exceeded, discard igniter. Limits are:

Ground Shell ID - .400 in. (10.16 mm)
