# TECHNICAL BULLETIN

NO. 60-1

## CENTER ELECTRODE COPPER EROSION

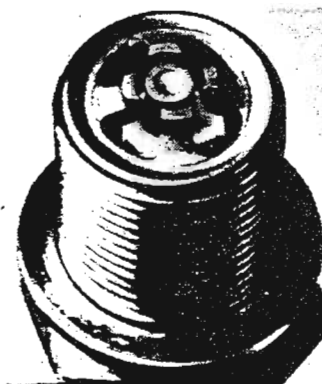
Figure 1 illustrates copper erosion (sometimes called cupping). This is a normal condition and as the spark plug gains service time, erosion decreases to a point whereby it stabilizes and practically ceases. From laboratory analysis and field experience throughout the years, it has been determined that erosion or cupping of the center electrode copper core is not detrimental nor will it effect the operational ability of the spark plug.

Normal Erosion

Such plugs can be serviced and reused provided the spark plugs are satisfactory in all other respects.

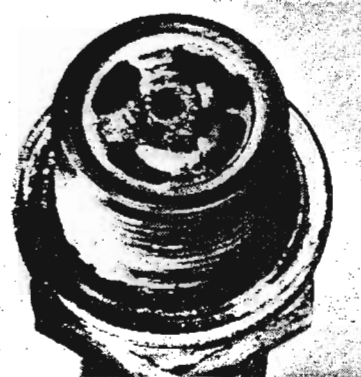
Figure 2 illustrates a typical example of copper run-out. When this type of spark plug condition occurs, it is usually the result of preignition; the causes of preignition are too many and varied to be discussed in this bulletin. Normally, the copper will flow and bridge the electrode gaps, shorting the plug out and reducing the chance of further engine damage. Plugs evidencing this condition should be scrapped. When the foregoing is encountered, other attendant combustion chamber difficulties are often noted. Engine manufacturers recommendations for inspection and service should then be followed.

Copper Run-out
