AVIATION TECHNICAL BULLETIN

Champion Spark Plug Company

NO. 68-17

SHORT PLUG LIFE??

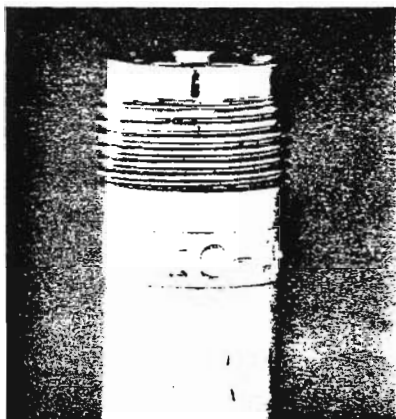
3/4-20 with damaged threads

Damage to the 3/4-20 Barrel threads prevent connecting the ignition harness to the plug. Use of an ordinary deep socket with insufficient internal clearance caused the damage pictured. In this case a \$13.00 spark plug was rendered useless on installation.

CT430 Socket

The recommended plug socket such as the CT-430 shown above is inexpensive insurance against this kind of plug damage. It not only has the correct internal dimensions, it has a built-in permanent magnet which prevents dropped plugs -- another cause of short plug life.
