AVIATION TECHNICAL BULLETIN

Champion Spark Plug Company

NO. 70-9
CONTROLLED
COPY

SWAP SPARK PLUG LOCATIONS TO EQUALIZE WEAR

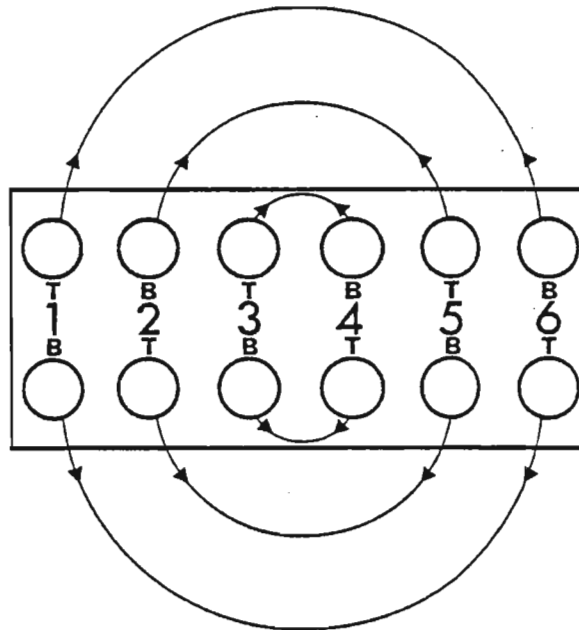
Technical Bulletins Nos. 70-4, 70-6, and 70-8 described different causes of uneven electrode wear patterns in an engine set of spark plugs.

To help equalize this wear, keep the spark plugs in engine sets by placing them in a spark plug tray identified the same as this illustration.

DO NOT CHANGE SPARK PLUG LOCATION DURING THE CLEANING OPERATION.
Before re-installing the spark plug, switch the spark plugs according to the diagram. (Example: #1 top spark plug with #6 bottom spark plug.)

This will not only switch plugs from top to bottom to keep lead accumulation down to a minimum (as described in Technical Bulletin No. 70-4), but will also equalize electrode wear caused by capacitance and constant polarity (as described in Technical Bulletins Nos. 70-8 and 70-6).
