# AVIATION TECHNICAL BULLETIN

Champion Spark Plug Company

NO. 71-9

## SHORT PLUG LIFE??

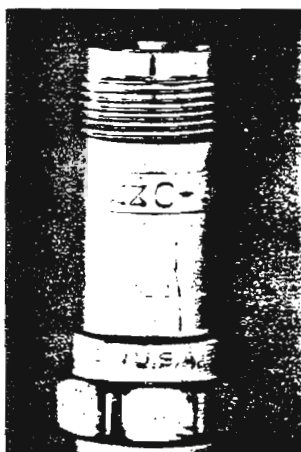
Can you imagine a plug with zero operating hours being rejected for further use? Such a plug is pictured below.

Damaged Terminal Threads

A badly worn spark plug socket or a 12 pt. socket may cause such damage. Terminal thread damage is a sure sign to suspect ceramic insulator cracks. The side pressures to the shielding barrel may be transmitted through to the barrel ceramic insulator. This side pressure may crack the insulator and cause the spark plug to short out.

A 6 pt. plug socket, as shown, is inexpensive insurance against this kind of plug damage. In fact, this socket (CT-430) has a built-in magnet that prevents dropped plugs -- another cause of short plug life.

Regular inspection of spark plug sockets will save you and your customer a lot of grief.
