AVIATION TECHNICAL BULLETIN

Champion Spark Plug Company

NO. 75-1

THE MODEL 2400 DRY ABRASIVE CLEANER

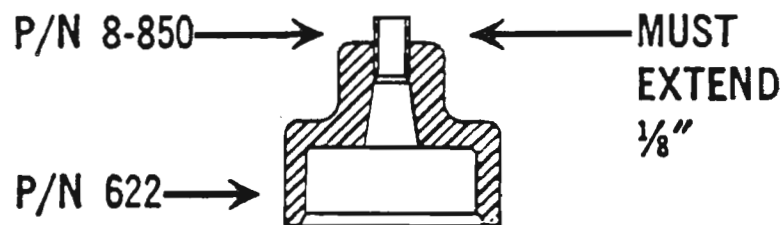
Investigation of this cleaner indicates the problem involves the positioning of the heavy duty nozzle tip, Part No. 8-850 in the rubber nozzle tip, Part No. 622. In most cases, the carbide tip is positioned too far into the rubber tip.

Repositioning of the carbide tip as illustrated above will correct the poor cleaning action problems.
