# Aviation Technical Bulletin

No. 87-1  
Supersedes 81-5

## REM37BY ELECTRODE WEAR

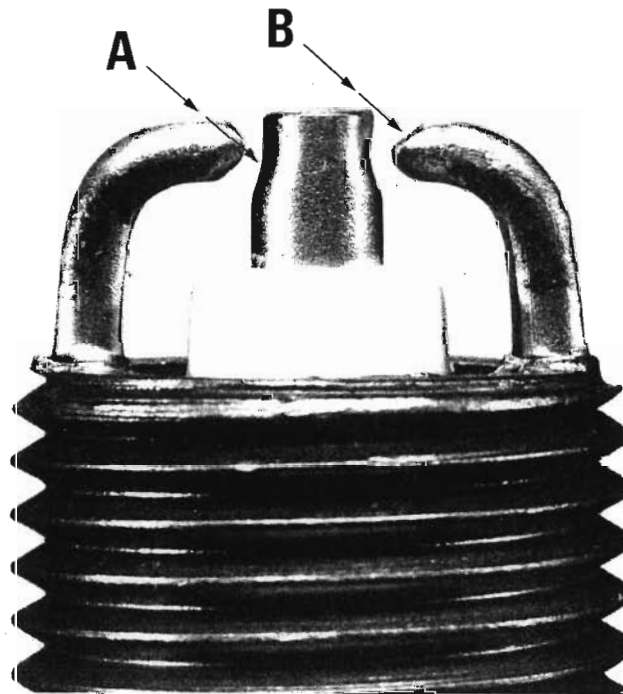
Illustration "A" of the above photograph depicts center electrode bottlenecking. The erosion adjacent to the ground electrode is a normal condition, which occurs as the result of electrical erosion and chemical corrosion. When the REM37BY reaches this condition it should be replaced, as the center electrode sheath has eroded more than two-thirds the original thickness. Service beyond this condition could expose the copper core which would cause rapid erosion, extremely wide gaps, and an increasing possibility of misfire.

Illustration "B" demonstrates ground electrodes eroded to a knife edge, or pointed condition, which is also a criteria for replacing the spark plug. The pointed condition reduces the sparking plate area, leading to rapid erosion and wide gaps.
