# Aviation Technical Bulletin

## LYCOMING SERVICE INSTRUCTION #1442

SUBJECT: Improved Oil Filter Bypass Valve

MODELS AFFECTED: All Textron Lycoming piston engines with dual magneto accessory housing.

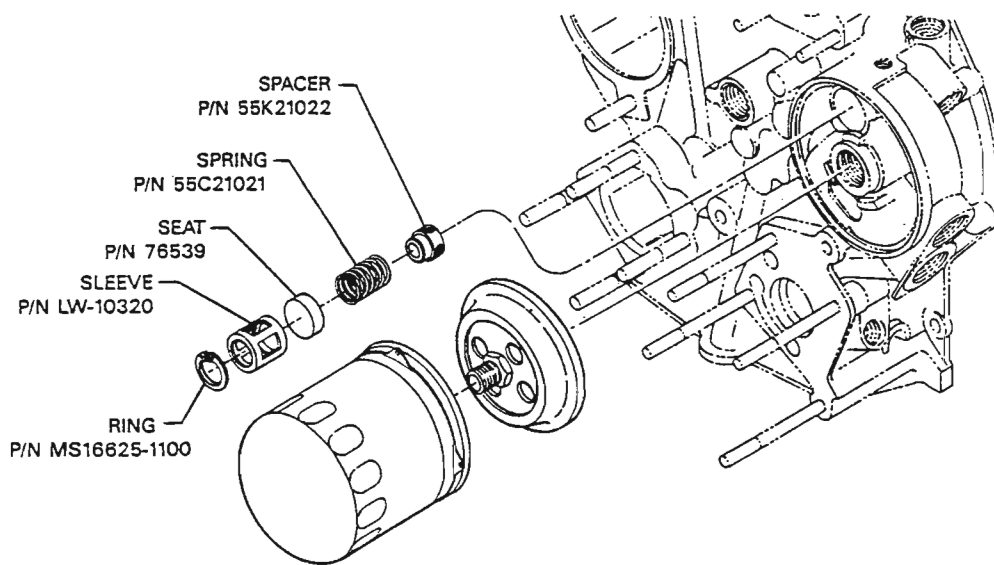
Figure 1. Oil Filter Bypass Valve Installation

Reports from the field have disclosed the possibility of oil filter elements collapsing, particularly on cold starts. As a product improvement, a new Spring, P/N 55C21021 and Spacer, P/N 55K21022 are to be used at time of overhaul. See Figure 1 for proper installation of all bypass valve parts.

TIME OF COMPLIANCE: At next overhaul or evidence of a filter element collapse.
