Service Bulletin

SUBJECT: Mandatory replacement of magnetos on certain 6-cylinder Teledyne Continental Motors engines, including like versions built under license by Rolls-Royce.

SLICK Service Bulletin SB1-00C

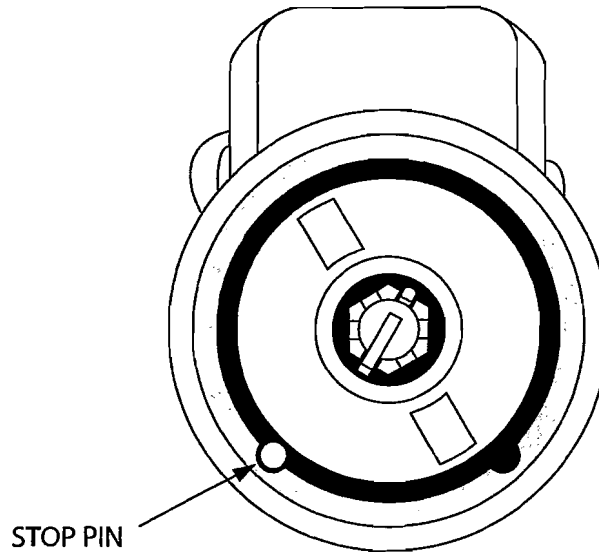
FIGURE 1

- A. Locate magneto serial number on magneto dataplate. If magneto serial number is determined to be within the range specified in this bulletin, remove the magneto from engine in accordance with the latest revision of the engine manufacturer's manuals.
- B. Inspect the magneto to confirm that the stop pin is present in the magneto frame. View the drive end of the magneto where the impulse coupling is attached and position the magneto as detailed in Figure 1. The magneto stop pin should be located at approximately the 8 o'clock position. Only one stop pin is installed in the magneto and the hole in the magneto frame located at the 4 o'clock position should be open.

- C. If the stop pin is present in the magneto frame, replace the magneto with a new or serviceable unit. If the magneto stop pin is not present in the magneto frame, proceed as detailed in step D or E.
- D. C-125, C-145, O-300, IO-360, and TSIO-360 engines:
