# SLICK

# Service Bulletin

**SB1-07**

**SUBJECT:** Inspection of magneto driver P/N K5265 and clarification of torque requirements.

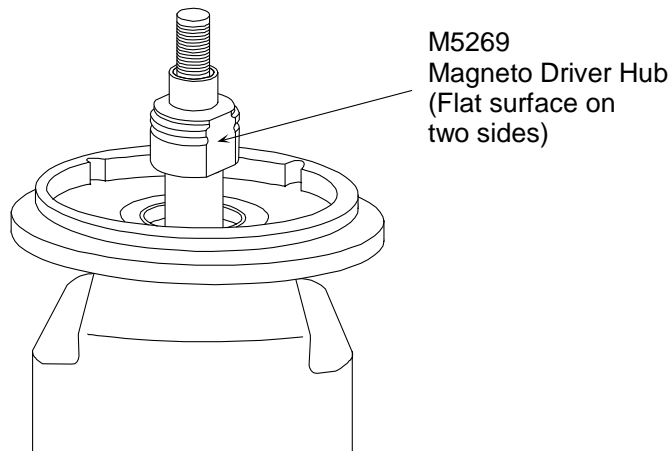
Figure Two

2. Visually inspect the M5269 magneto driver hub for any signs of cracking on the flat surfaces. See Figure Two.
