# SLICK SB1-88B

## Service Bulletin

**SUBJECT:** Periodic Inspection of Slick Models 6320, 6324, 6360, 6361, 6363, and 6365 Pressurized Magnetos

**MODELS AFFECTED:** These magnetos, when installed on Piper Dakota PA-28, Seneca PA-34, Saratoga PA-32, Cherokee 6 PA-32, Seminole PA-44, Navajo PA-31, and Malibu PA-46 aircraft.

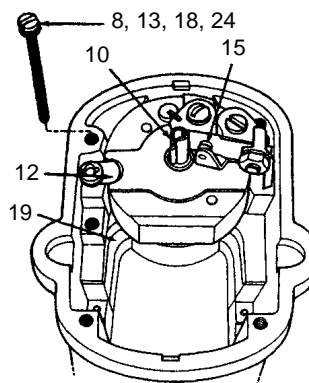
Figure 1

- (1) Check for rust and corrosion on screws (8, 13, 18, 24), bearing cap hold down clamps (12), rotor shaft (10), breaker point assembly (15), frame and coil laminations (19), etc. See Figure 1. Rust and corrosion are signs of contamination and require component cleaning or replacement (reference paragraphs 3.B and C of this bulletin and Slick Maintenance and Overhaul Manual L-1037).

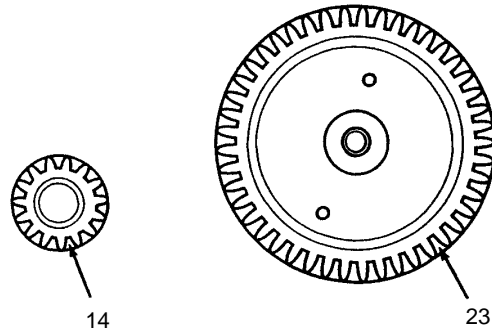
Figure 2

- (2) Soft or sticky distributor and rotor gears (14, 23) indicate moisture contamination and require component replacement (reference Slick Maintenance and Overhaul Manual L-1037). See Figure 2.

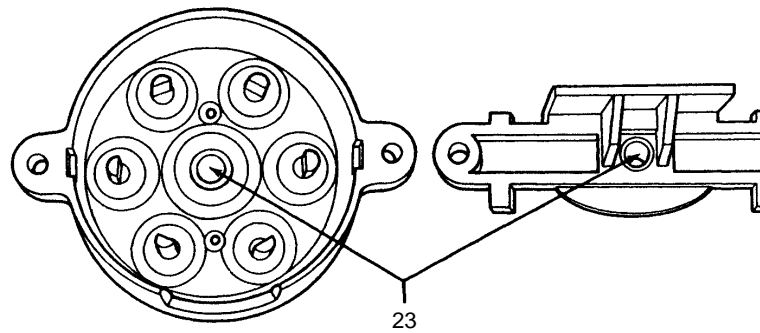
Figure 3

- (3) Gummy or sticky distributor gear oilite bearing (23) indicates contamination. Check distributor block assembly according to instructions in Slick Maintenance and Overhaul Manual L-1037. See Figure 3.

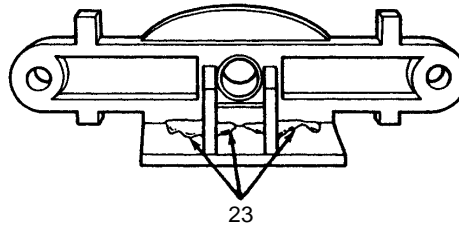
Figure 4

- (4) Traces of pooling water on the distributor bearing bar (23) in the vicinity of the carbon brush or other internal surfaces of the magneto indicates the presence of moisture. See Figure 4. Check distributor block assembly according to instructions in Slick Maintenance and Overhaul Manual L-1037.

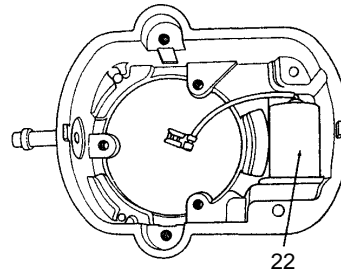
Figure 5

- (5) A yellow powder, yellow particles, oxides, or white chalky powder on the condenser housing (22) indicate moisture contamination. See Figure 5. Refer to paragraphs 3.B and C of this bulletin and Slick Maintenance and Overhaul Manual L-1037.

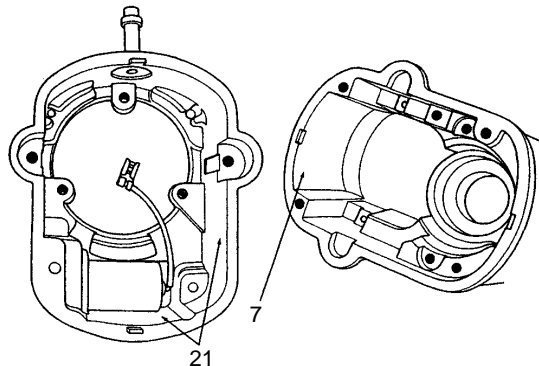
Figure 6

- (6) A yellow powder, yellow particles, oxides, or white chalky powder on the magneto frame (7) and housing (21) indicates moisture or corrosive contamination. See Figure 6. Clean or replace as necessary following procedures in paragraphs 3.B and C of this bulletin and Slick Maintenance and Overhaul Manual L-1037.

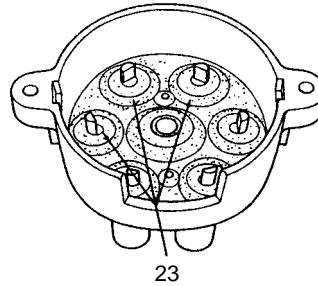
Figure 7

- (7) White or gray chalky deposits around the electrodes inside the distributor block (23) indicates lack of pressurization. See Figure 7. Refer to paragraphs 3.B and C of this bulletin for cleaning and pressurization system check. Check distributor block assembly according to instructions in Slick Maintenance and Overhaul Manual L-1037.

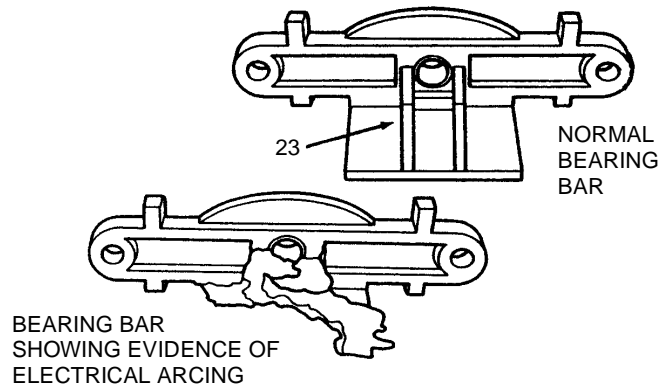
Figure 8

- (8) Electrical tracking or arcing in the distributor block and bearing bar (23) indicates contamination or lack of pressurization. See Figure 8. Check distributor block assembly according to instructions in paragraphs 3.B and C of this bulletin and Slick Maintenance and Overhaul Manual L-1037.

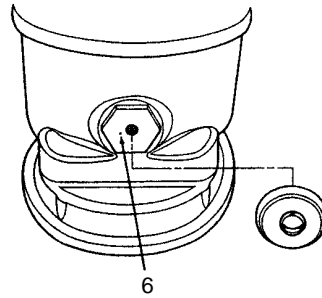
Figure 9

- (12) Harness Cap "O" Ring (not shown in Figure 2) - Check "O" ring M3184 for wear and replace as necessary.
- (13) Orifice Vent (6) - Check and clean orifice vent M3179 to insure it is clean and free of obstruction. Reference paragraph 3.B of this bulletin. Maximum orifice diameter is .025 inch. See Figure 9.

**NOTE:** Moisture contamination is more likely to occur on magnetos that have Piper PN 84652-002, Teledyne Controls PN 0402-102 tachometer sensor installed on the magneto in place of the factory orifice vent. Tachometer sensors identified as Mod 1 do not have this problem.

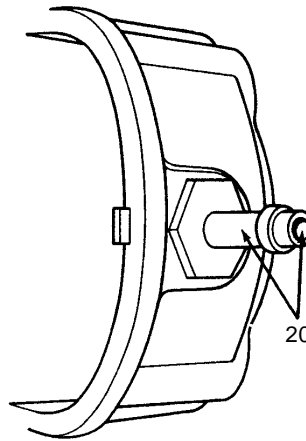
Figure 11

- (15) Inlet Nozzle (20) - Check and clean inlet nozzle M3180 to insure it is clean and free of obstruction. See Figure 11. Reference paragraphs 3.B and C of this bulletin. Yellow or white particles or an oily film in the inlet nozzle indicates moisture contamination and possible lack of pressurization. Reference the engine and/or airframe manufacturer's literature for pressurization system corrective action.
