SLICK SB3-08B

Service Bulletin

SUBJECT: Mandatory inspections on all Slick 4200/6200/4300/6300 series and LASAR™ 4700/6700 magnetos

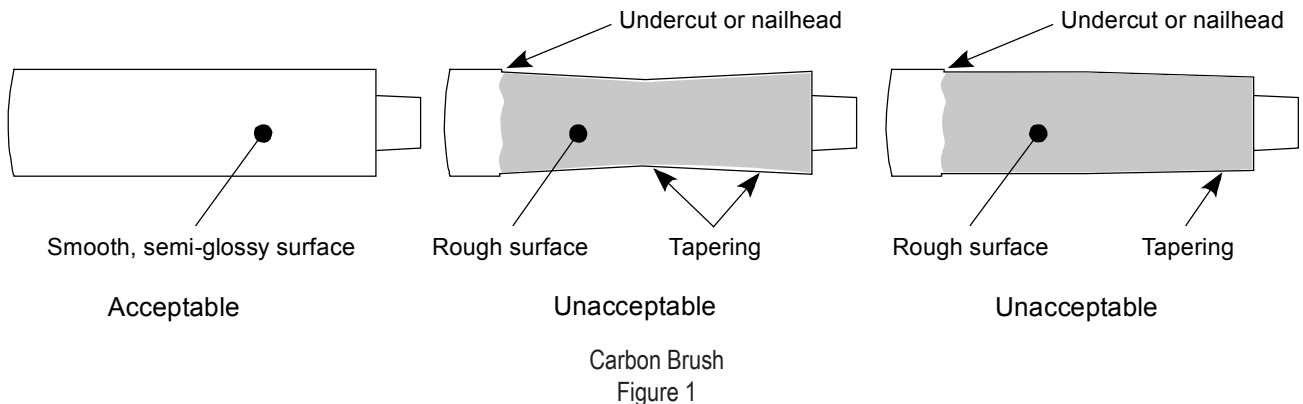
INFORMATION: Field reports indicate operators have experienced premature carbon brush wear. Premature brush wear can lead to failure of the magneto to provide consistent spark and possible loss of engine power. This bulletin describes an inspection schedule for specific serial number ranges and magneto and brush operating times due to observed variations in premature wear rates.

1. Use lighted magnification (4X minimum) to inspect carbon brush for rough surface and possible tapering. **REPLACE CARBON BRUSH THAT SHOWS ANY OF THE UNACCEPTABLE CONDITIONS SHOWN IN FIGURE 1 PER THE APPLICABLE MAINTENANCE AND OVERHAUL MANUAL.**

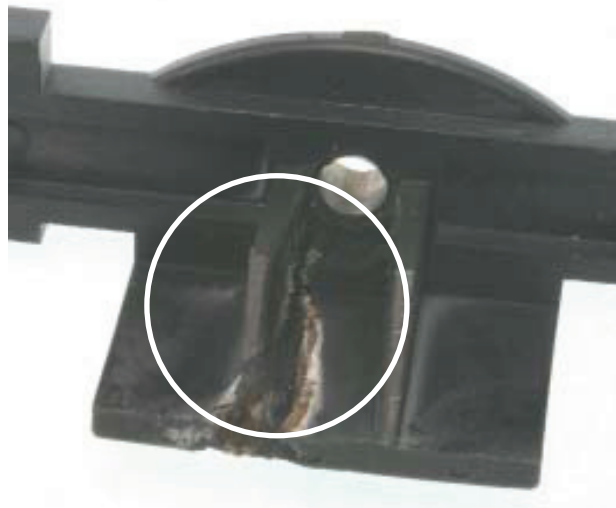
Bearing Bar
Figure 2

Unacceptable
(Developing bearing bar failure)

- Inspect bearing bar for evidence of brush residue contamination, burning, or arcing. See Figure 2. **REPLACE DISTRIBUTOR BLOCK ASSEMBLY PER THE APPLICABLE MAINTENANCE AND OVERHAUL MANUAL IF THERE IS ANY EVIDENCE OF ELECTRICAL ARCING OR BURNING.** The new bearing bar can be identified by either the manufacturer-dated packaging, or visually by noting the dams.

- If bearing bar does not show evidence of burning or arcing, clean and remove any normal residue per the applicable Maintenance and Overhaul Manual and reassemble into the magneto.

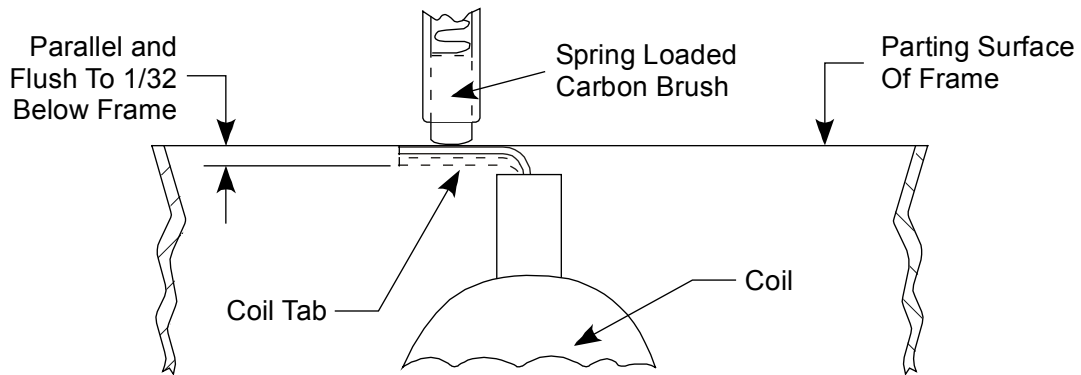
Coil Tab Positioning
Figure 4

CAUTION: IF THE COIL TAB PROTRUDES ABOVE THE MAGNETO FRAME, IT CAN MAKE DIRECT CONTACT WITH THE DISTRIBUTOR GEAR AXLE AND CAUSE THE MAGNETO TO MALFUNCTION.

- Prior to installing distributor block, make sure coil tab is parallel to and flush with frame mating surface to within 1/32 inch. See Figure 4.
