Service Bulletin

SUBJECT: Inspection of magneto driver P/N K5265 and clarification of torque requirements.

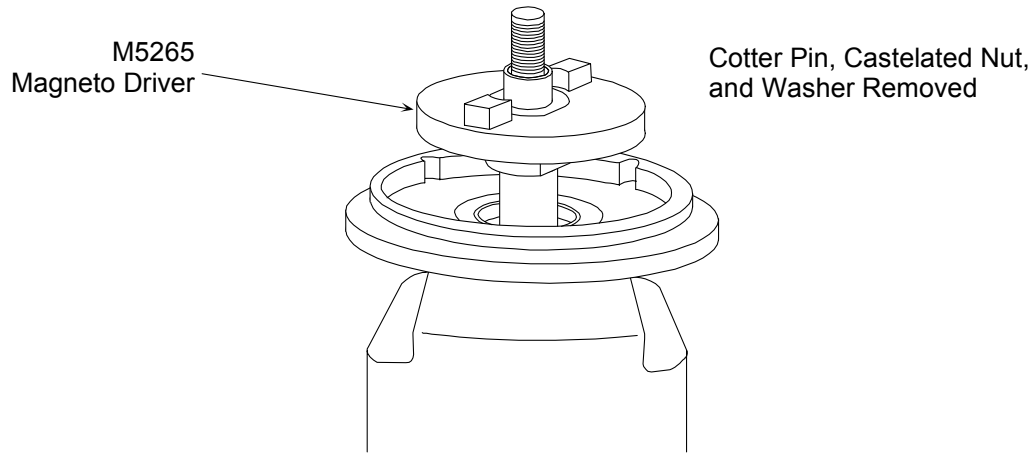
Figure One

- DETAILED INSTRUCTIONS: 1. Remove cotter pin, castellated nut, washer, and M5265 magneto driver from magneto and hub (see Figure One). This driver may require the use of a puller for removal.

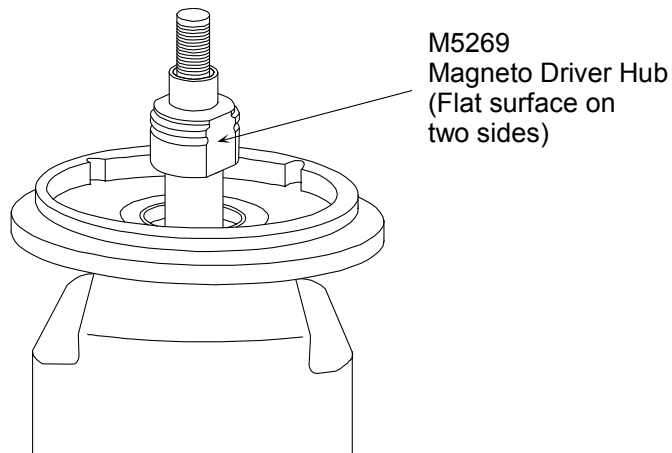
Figure Two

INFORMATION: Based on reports from the field of impulse coupling cracking, this service bulletin provides guidance on correct torque requirements.

2. Visually inspect the M5269 magneto driver hub for any signs of cracking on the flat surfaces. See Figure Two.
