SERVICE BULLETIN

S. B. NUMBER: S.B.MS17976-2-24-001

SUBJECT: Electrical Power - DC Generation - Transformer Rectifier Unit (TRU) AC Filter Capacitor Inspection

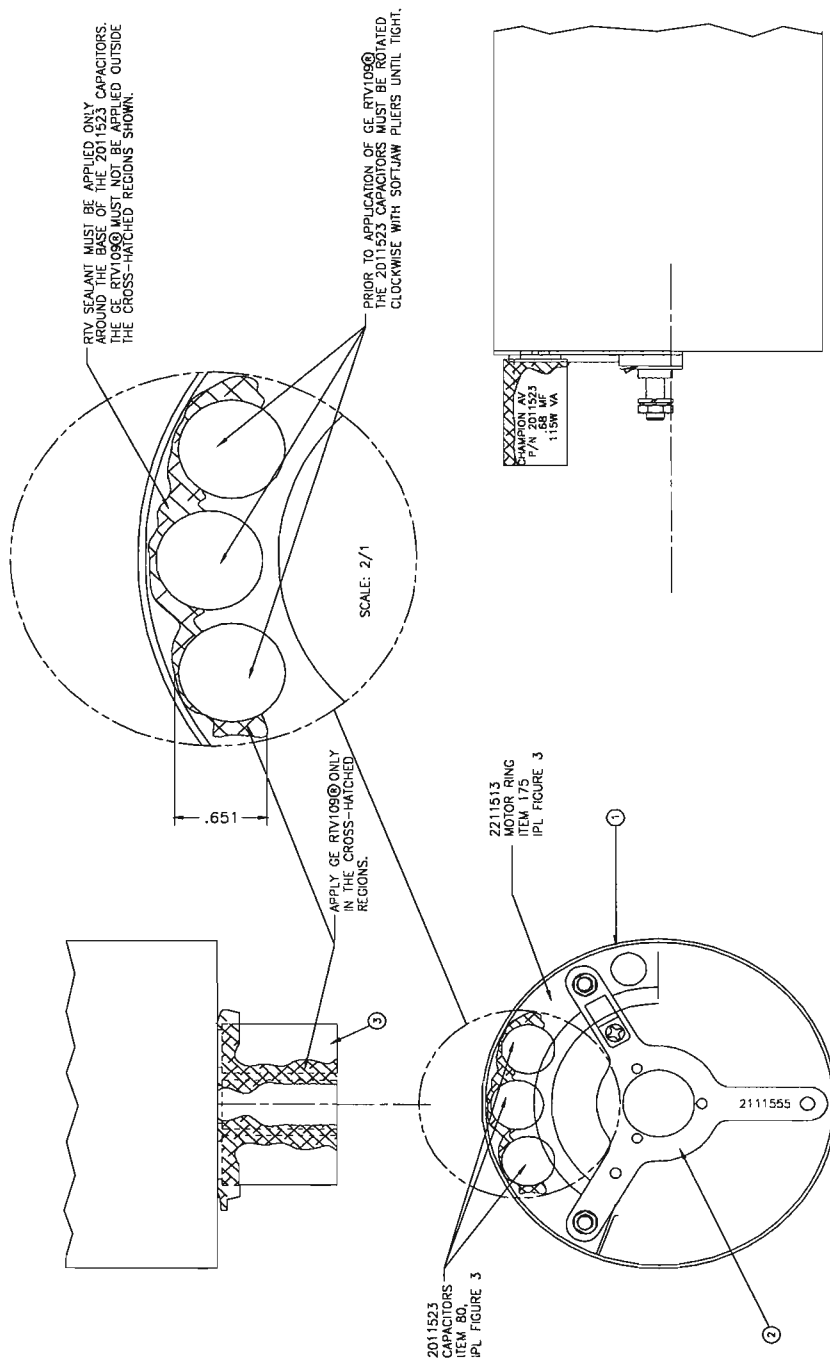
NOTE: Refer to attached illustration CH431.T.SB.01, Figure 1 when noted.

The MS17976-2 TRU's AC input filter capacitors are loosening under certain vibratory conditions.

- (1) Surface clean the area around the base of the capacitors and the motor ring with isopropyl alcohol using cotton swab or lint-free cloth.
- (2) Using GE RTV109 (Champion P/N: 306163), apply compound to crosshatched area as shown in CH431.T.SB.01, Figure 1.
- (3) Make sure no RTV compound has been applied to the seating portion of the motor ring assembly (175) where the converter end bell (5) is attached to the converter assembly.
- (4) Allow RTV compound to cure for one (1) hour (min) before the reassembly of the unit.
- (5) Position converter end bell (5) to converter assembly and replace self locking nuts (10).
- (6) Secure self-locking nuts (10).
