CHAMPION AEROSPACE, INC.
SERVICE LETTER

S.B. NUMBER: 28VS200Y4DH-24-04-001

SUBJECT: Electrical Power - DC Generation - Transformer Rectifier Unit (TRU) Fan Motor Upgrade

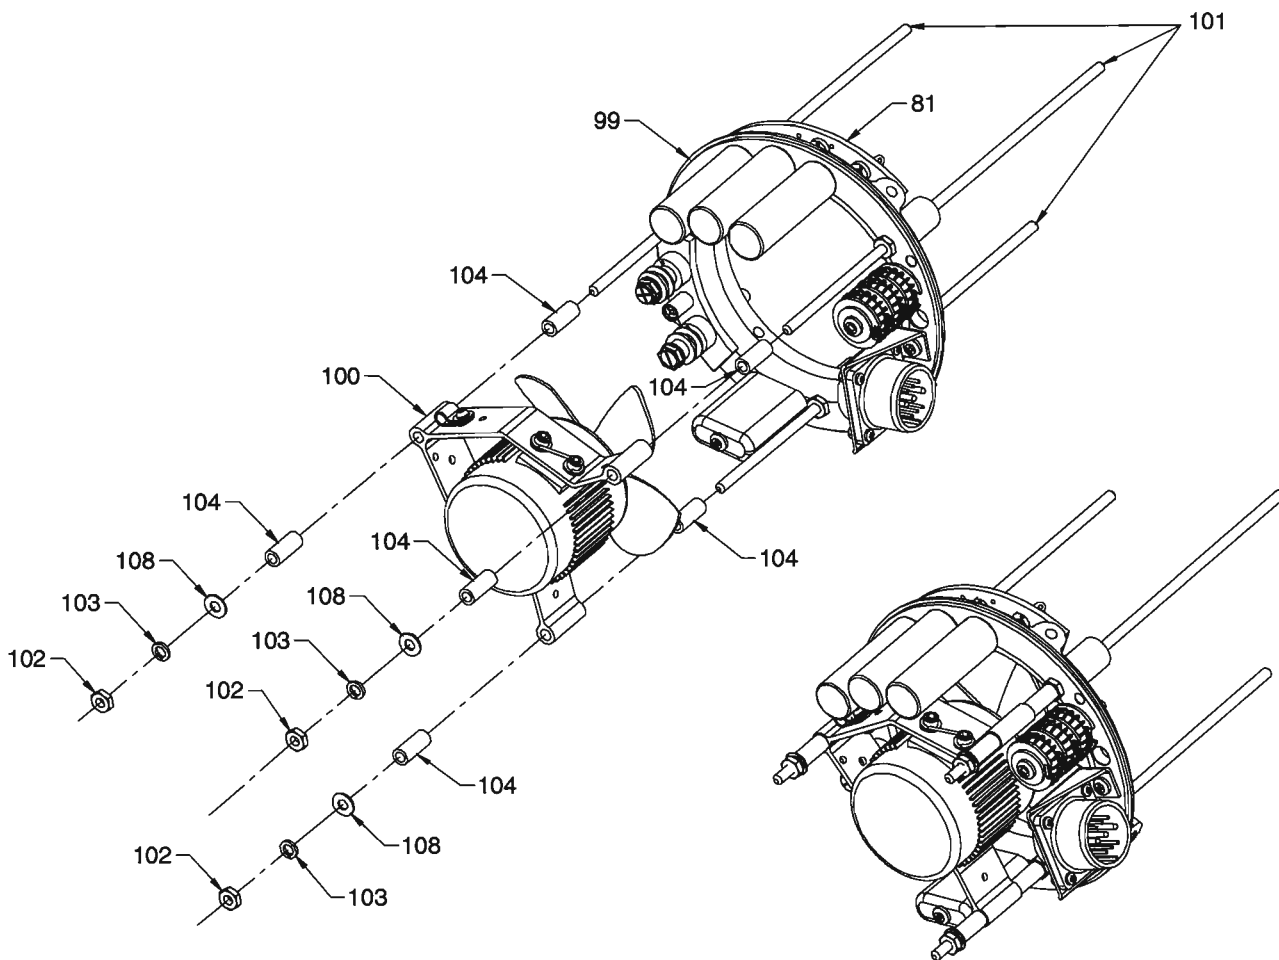
Figure 1. Original Fan Motor Assembly Removal

The transformer rectifier units (TRUs) existing fan motor assembly (P/N: 2561613) has been upgraded to a new fan motor assembly (P/N: 2031526) for improved reliability and increased life.

Champion has determined that the existing fan motor assembly (P/N: 2561613) life cycle is too short.

- (1) Remove mounting base (3), end bell (1) and case assembly (6) in accordance with IPL, Figure 1 of component maintenance manual 24-31-46.
- (2) Remove original fan motor assembly (100) wire lugs (112) from AC Terminal Board (81).
- (3) Remove three nuts (102), three lockwashers (103), three flat washers (108) and three spacers (104) from original fan motor assembly (100) as illustrated in Figure 1.
- (4) Remove original fan motor assembly (100) from threaded tie bolts (101).
- (5) Remove remaining three spacers (104).
