SERVICE LETTER

**SUBJECT: IGNITION - DISTRIBUTION - SERVICEABILITY LIMITS FOR IAE
V2500 ENGINES**

ATA SYSTEM: 74-21

SL No. CH31964-74-21-001

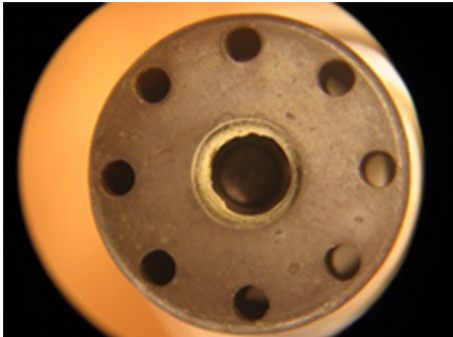
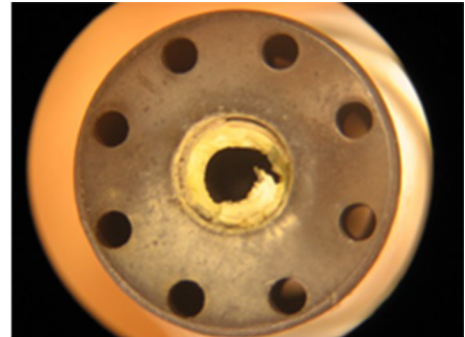
Figure 1

(1) The original ignition lead can potentially be a contributing factor and cause engine no starts. Tungsten oxidation buildup of the igniter tip ground electrode will have a yellowish appearance and may need to be removed in order to accomplish the measurement of the erosion wear limits of the tip opening (0.315 in. /8.001mm). Reference CMM 74-21-45; Paragraph 6, Inspection and Check, Figure 2.

Tungsten Oxidation Build-Up of Igniter Tip.

NOTE: The presence of oxide deposits on the firing end of ignition plugs with tungsten electrodes is a normal condition and typically will not affect the igniter's function. Care should be taken to not damage the ignition plug shell or tungsten electrode parent material when removing those deposits.

Champion recommends that V2500 operators who remove a CH31964 igniter for any reason and believed to be caused by tungsten oxidation of the igniter tip ground electrode, be inspected in accordance with CMM 74-21-45 and instructions provided in this service bulletin. The appearance of tungsten oxidation on the igniter tip ground electrode is normal for this design and typically does not affect igniter function. Champion also recommends that the ignition leads be examined for conditions shown in pictures above and be replaced immediately or at earliest opportunity.

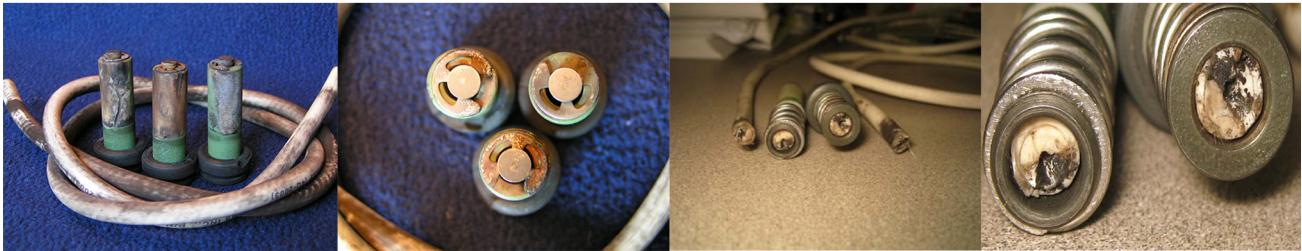
Original V2500 Ignition Lead Termination Design - (Non-Champion Parts)
Figure 2

- (1) The original ignition lead can potentially be a contributing factor and cause engine no starts and failed engine light-offs. High ignition lead-to-igniter connection temperatures have been a problem in the past as result of hot air leakage through the original non-Champion igniter into the terminal well area. The Champion igniter design incorporates a proprietary hot lock manufacturing process that eliminates internal hot air leakage into the terminal well area. If the leads exhibit heat and arcing damage as seen in photos below, the probability is increased that intermittent dielectric failure of the ignition lead will occur internally. This condition with the leads can be masked when a new igniter is installed during ignition system trouble shooting.
