TECHNICAL BULLETIN

SUBJECT: Ignition - Distribution - Inspection/Check Instructions for Champion Igniter CH34682

ATA SYSTEM: 74-20

T.B. NUMBER: T.B.CH34682-74-20-02-003

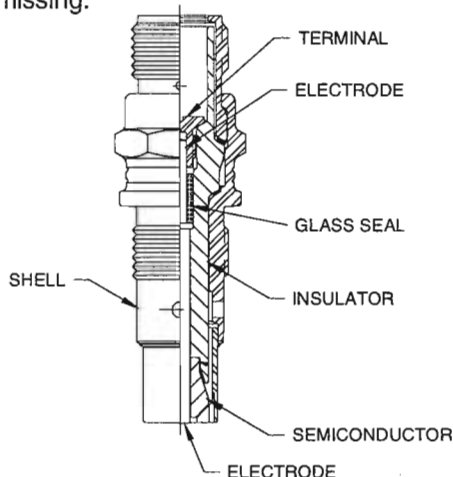
Figure 1. Igniter CH34682 Construction.

Champion Aerospace is providing this technical bulletin to assist in the servicing of igniter CH34682 (Figure 1). This information is specific to igniter CH34682 and includes detailed inspection and checks instructions to determine the operational condition of the igniter.

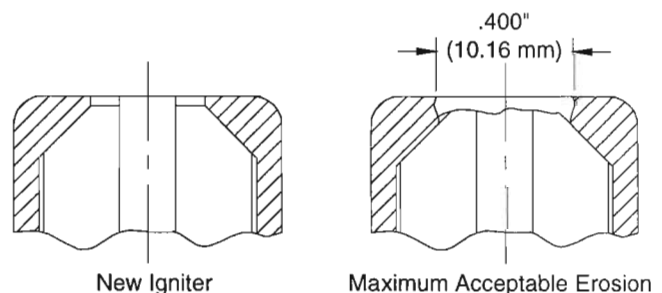
Figure 3. Igniter Wear Limits

- (2) Inspect firing tip for erosion to determine if gap is within serviceable limits (See Figure 3). Use calipers or gap gage to measure ground shell ID. If limits are exceeded, discard igniter. Limits are:

Ground Shell ID - .400" (10.16 mm)
