# Engineering Evaluation Report Report No. CH327.I.EER.005, Issue 3

One Hundred (100) competitor long life CFM56 igniter assemblies P/N 518888-1 / 1374M12P16. See **Table 1** for serial numbers.

Report Title: CFM56 Competitor Long Life Igniter Evaluation

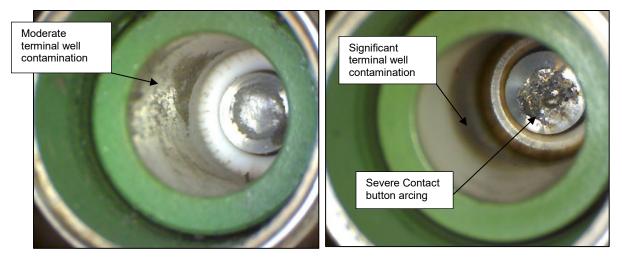
Figure 2: Terminal Well Contamination Example

Approximately 55% of the terminal wells inspected were clean, with the rest exhibiting some level of contamination. Photos below in **Figure 2** and in <u>Appendix B</u> show the varying levels of contaminates in the population of igniters examined

In addition, approximately 31% of the contact buttons show signs of arcing on the button while the remaining units appeared to be clean. An example of this arcing can be found in **Figure 2**. The photos in **Appendix B** show the as received condition of all one hundred (100) igniter terminal wells.

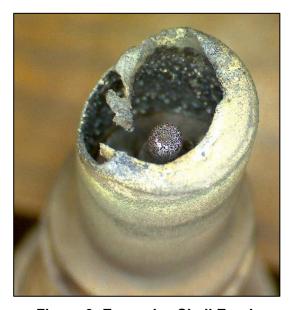
Figure 3: Excessive Shell Erosion

The firing ends of all igniters were visually examined, then measured for wear and abnormalities. A majority of the igniter tips appeared to have normal shell erosion to the I.D with seventeen (17) of the one hundred (100) units having shell I/D's measure over 0.02". However, a couple did exhibit excessive wear as seen in **Figure 3**. In addition to the excessive wear, there were a number of igniters that were missing material to the ground shell, similar to **Figure 4**, while the I.D was still within the normal wear expectation. Appendix C shows a group of photographs of all the igniter firing ends.

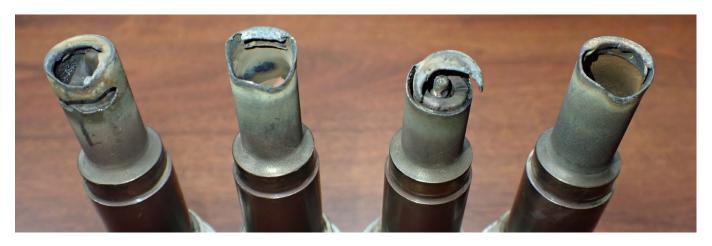
Figure 5: Igniters SN: LWY978, LYL040, LYA062, and LTY997. Total firing end deterioration with missing parts. See Figures 6-9 below.

- 4. At least four (4) igniters in this population exhibited complete erosion of the firing end tip with missing pieces presumably liberated into the combustor.

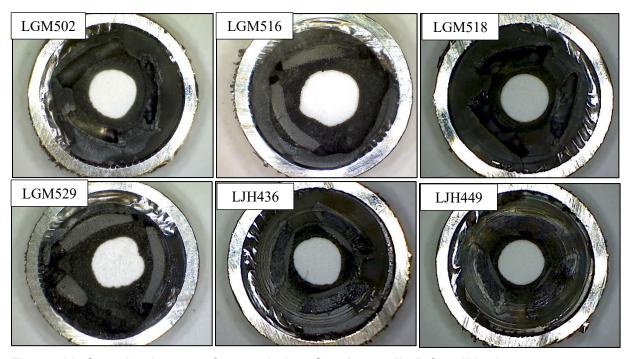
Figure 11: Sample pictures of ground pins. See Appendix D for all igniters.

After evaluating the one hundred (100) Competitor Long Life igniters returned, fifty-two (52) of the igniters appear to have all three ground pins remaining. However, the remaining forty-four (48) igniters appear to have portions of ground pins or entire ground pins missing with sixteen (16) of these units appearing to have all their ground electrode material missing. The pin numbers for each individual igniter are included in **Table 1** above. Pictures of the ground pins are shown below in **Figure 11** and **Appendix D**.

- 1. From this analysis, forty-eight (48) of the returned Competitor Long Life igniters exhibit conditions that indicate at least one entire ground pin missing.

- 2. Because of the cracking and evidence of missing ground pin material, partial or full ground pin liberation into the combustor is likely to have occurred with the Competitor Long Life igniters missing ground pins.

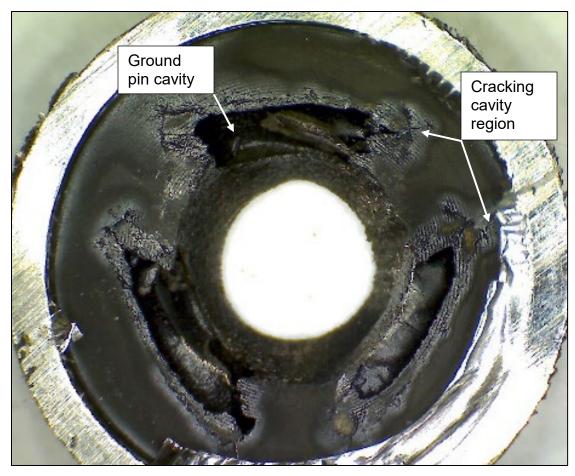
Figure 12: Igniter Tip Internal View

Upon further investigation of the removed shells, it was observed that some of the igniters also exhibited cracks in the cavity region housing the ground pin electrodes similar to **Figure 12**. This phenomenon has been witnessed before by Champion in previous competitive analysis, CH327.I.EER.004.

- 3. Based on observations after removing the igniter firing ends, see <a href="Appendix D">Appendix D</a> and <a href="Figure 12">Figure 12</a> above, the competitive part does not appear to have a rigid method of retaining the ground pins. This lack of retention could lead to ground pin movement (spinning) in application and eventual liberation from the igniter tip.
