Engineering Evaluation Report

Report No. CH327.I.EER.005, Issue 2

Ninety-Six (96) Competitor Long Life Igniter Assemblies

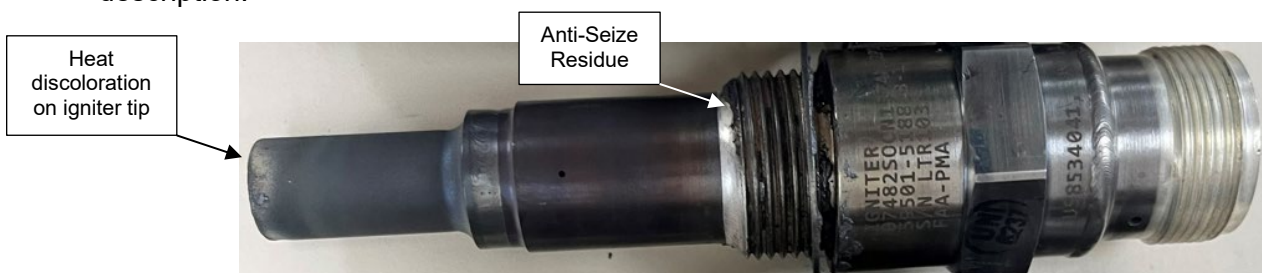
Figure 1: Typical Competitor Long Life Igniter Visual Examination

All ninety-six (96) igniters had the external appearance for a used igniter. There was normal heat discoloration to the igniter bodies below the installation threads as well as residue of anti-seize compound in the installation threads as can be seen in **Figure 1. Photograph 1 through Photograph 20** are of all the examined parts. Igniters are labeled from top to bottom in the photo description.

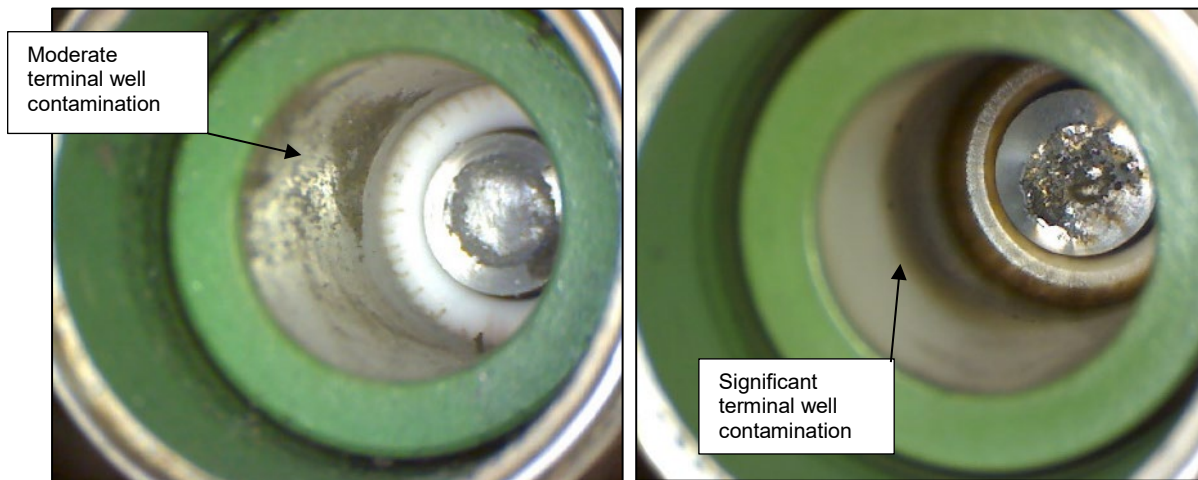
Figure 2: Terminal Well Contamination Example

Roughly 55% of the terminal wells inspected were clean, with the rest exhibiting some level of contamination. This could possibly be from the anti-seize compound noted in the installation threads. The photos in **Figure 4** show the varying levels of contaminates in the igniters.

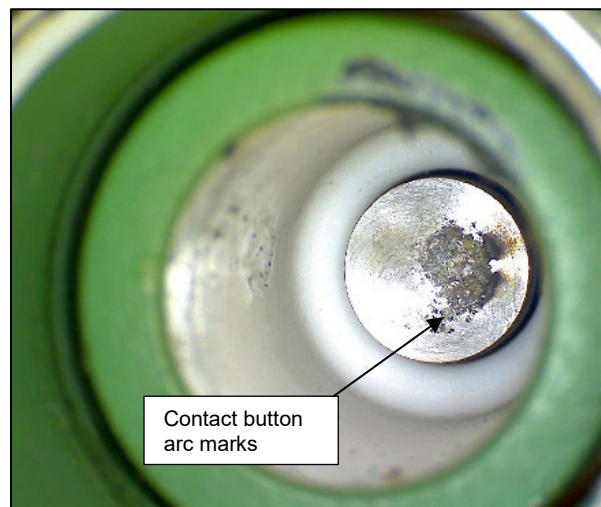
Figure 3: Contact Button Arcing Example

In addition, roughly 31% of the contact buttons show signs of arcing on the button while the remaining units appeared to be clean. An example of this arcing can be found below in **Figure 3**.

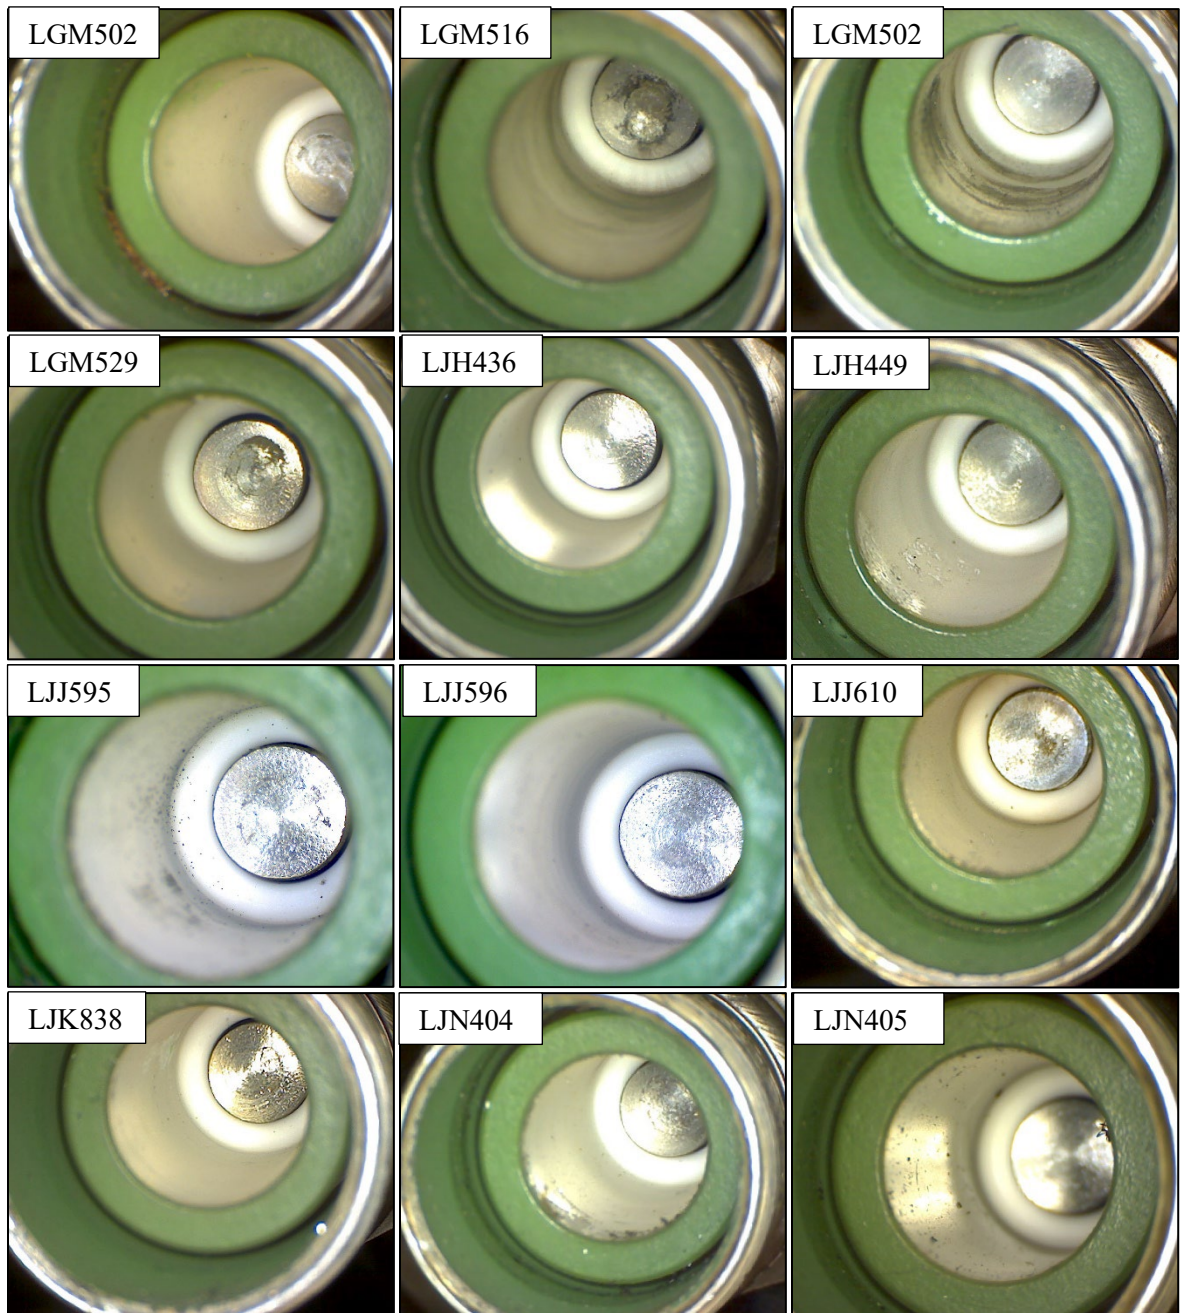
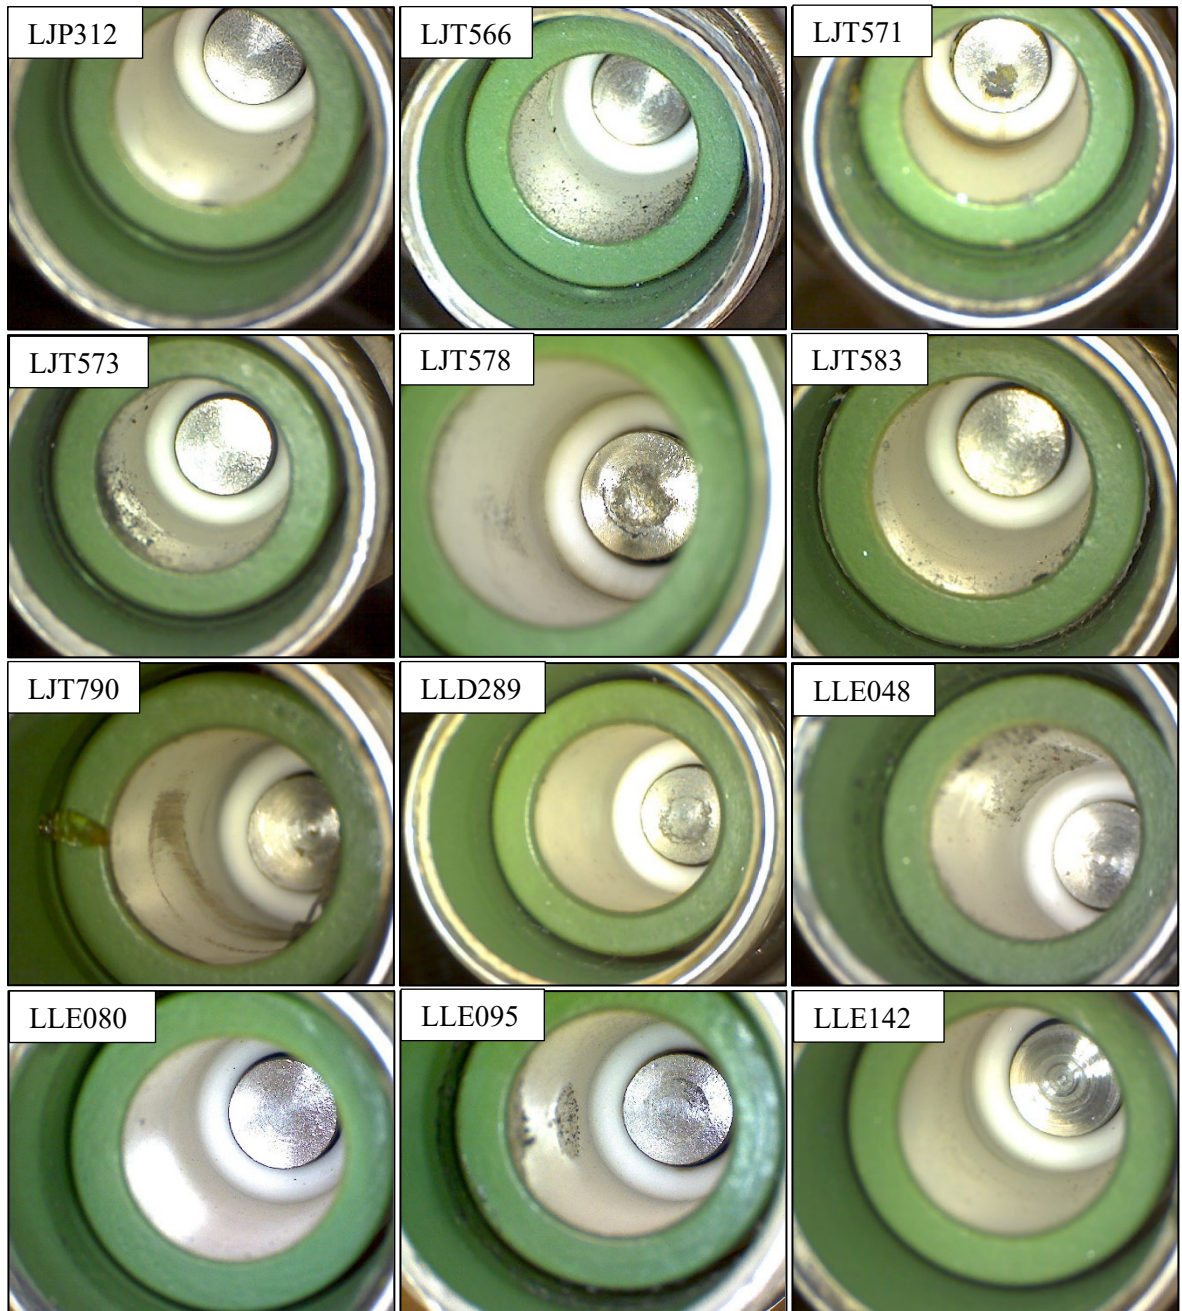
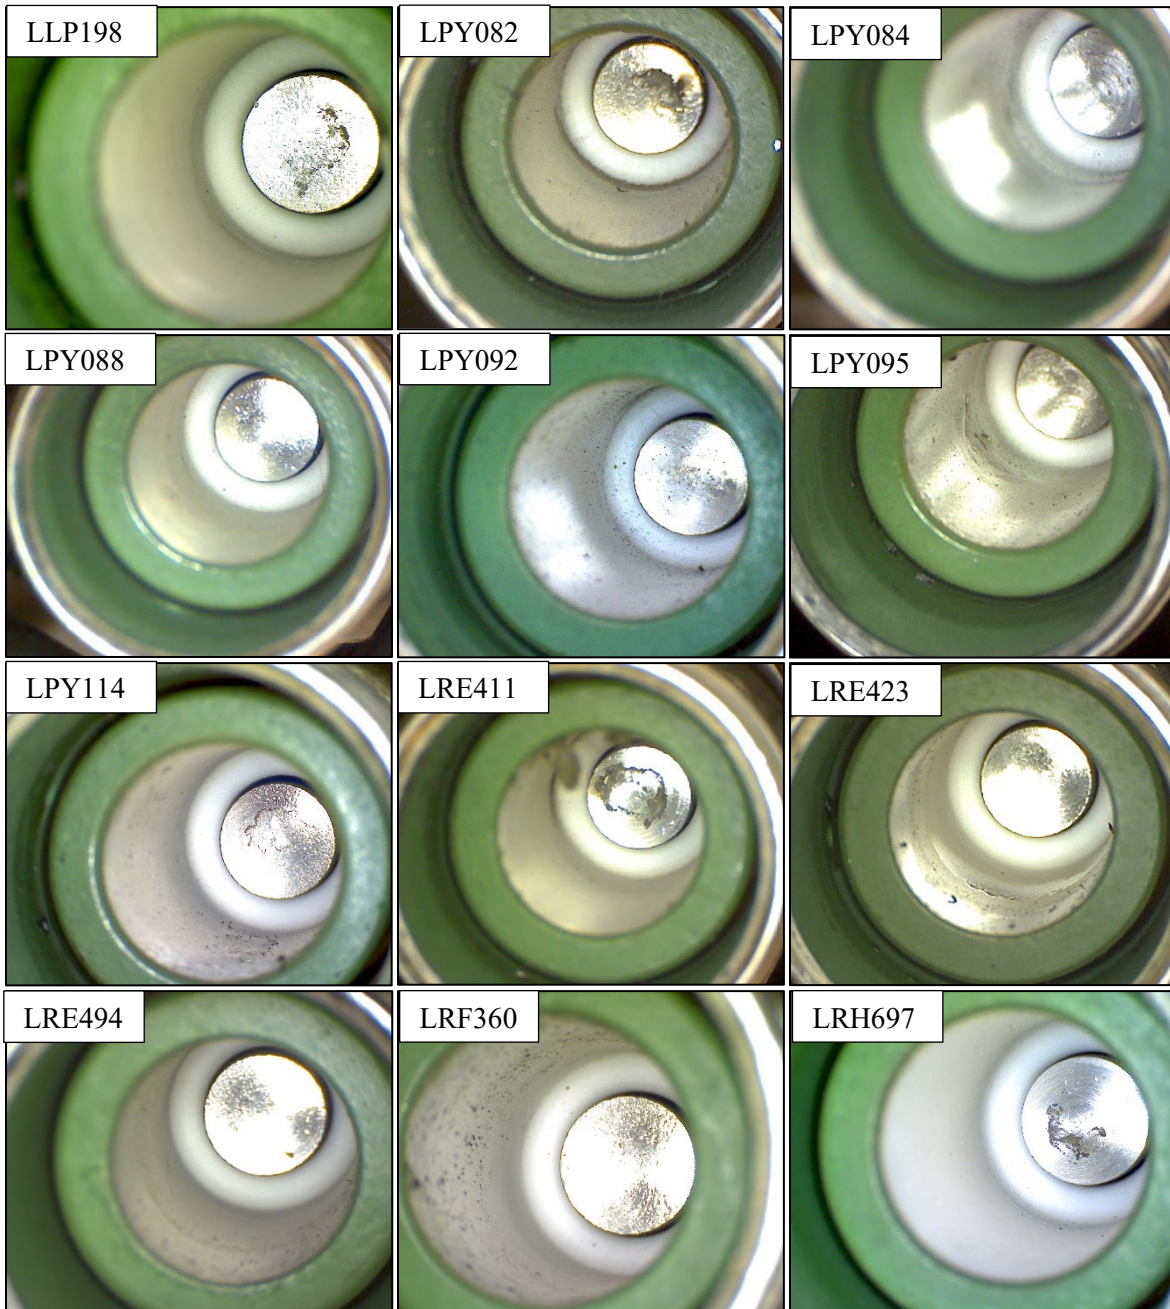
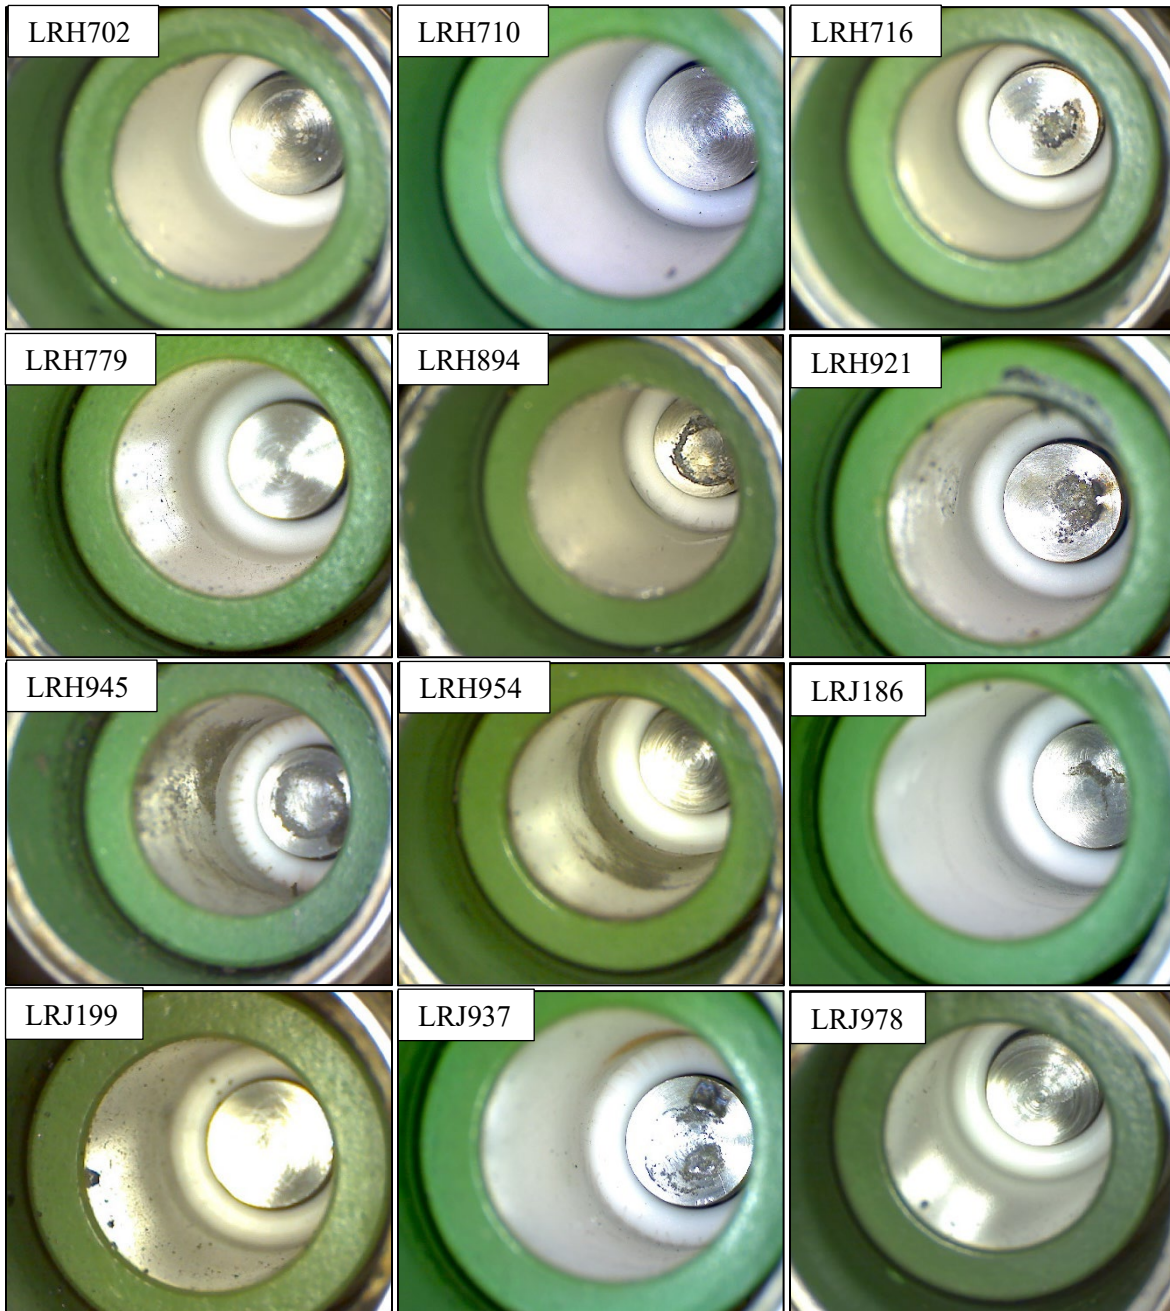
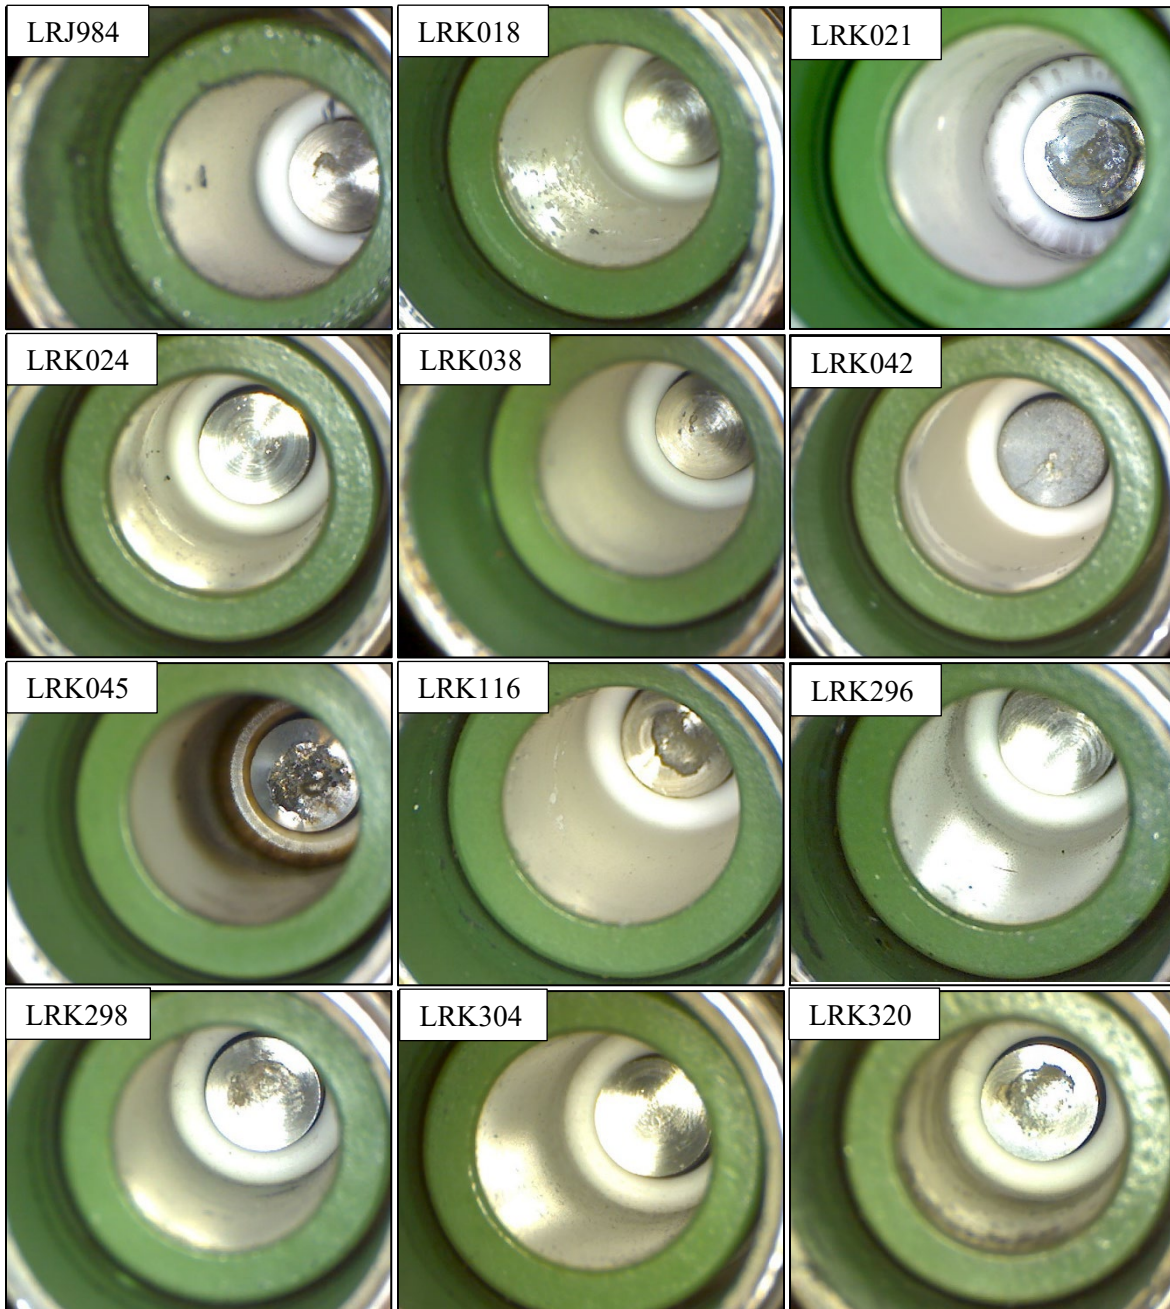
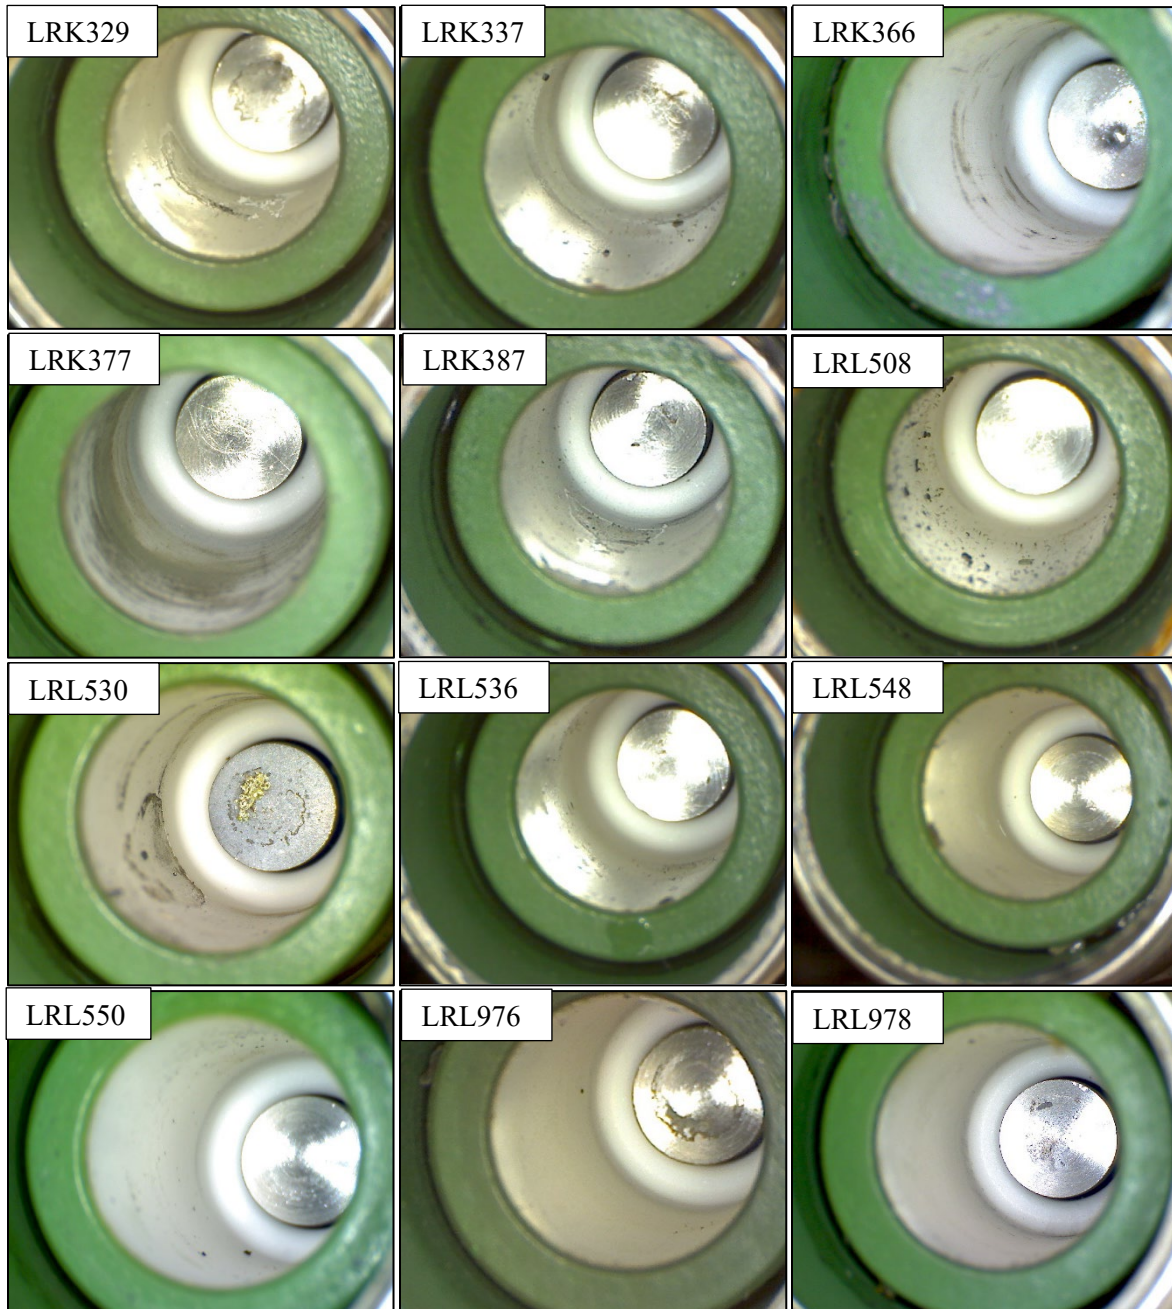
Figure 4: Competitor Long Life Igniter Terminal Well Contamination

The photos in **Figure 4** below show the as received condition of all ninety-six (96) igniter terminal wells.

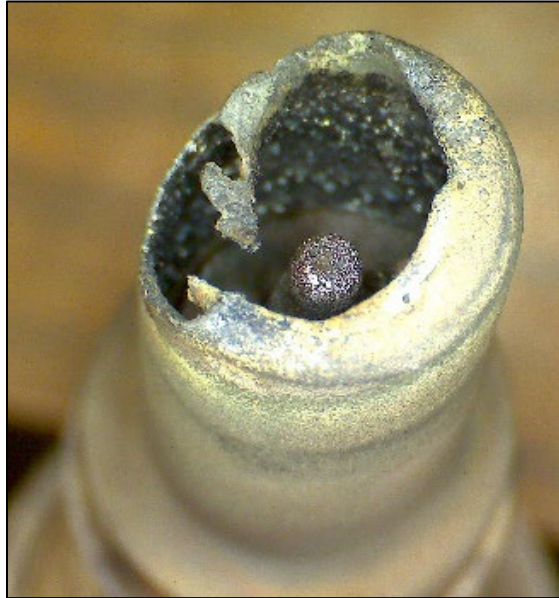
Figure 5: Excessive Shell Erosion

The firing ends of all igniters were visually examined, then measured for wear and abnormalities. A majority of the igniter tips appeared to have normal shell erosion to the I.D with thirteen (13) of the ninety-six (96) units having shell I.D's measure over 0.200". However, a couple did exhibit excessive wear as seen in **Figure 5**. In addition to the excessive wear, there were a small number of igniters that were missing material to the ground shell, similar to **Figure 6**, while the I.D was still within the normal wear expectation. **Figure 7** shows a group of photographs of all the igniter firing ends.

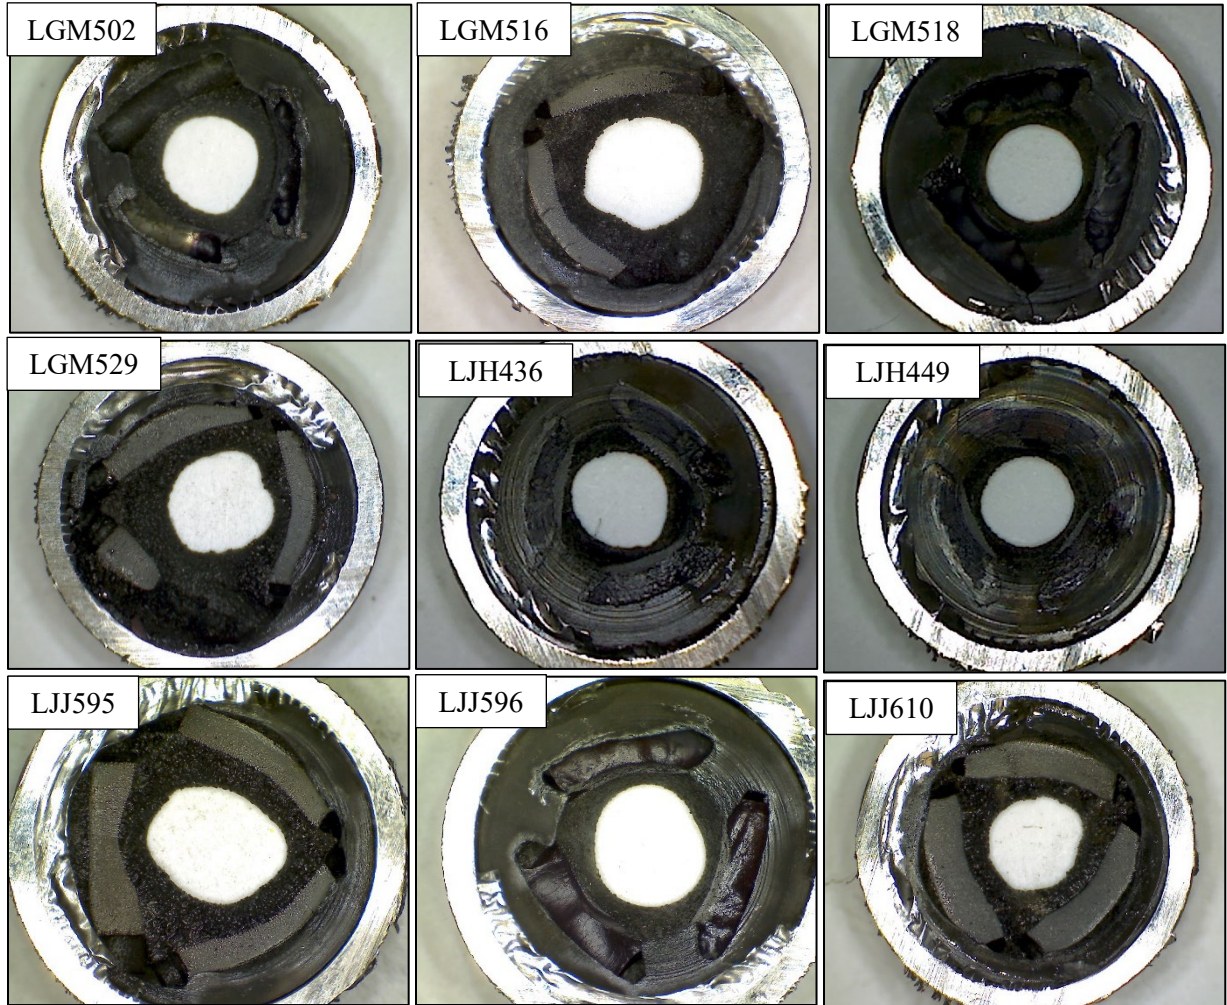
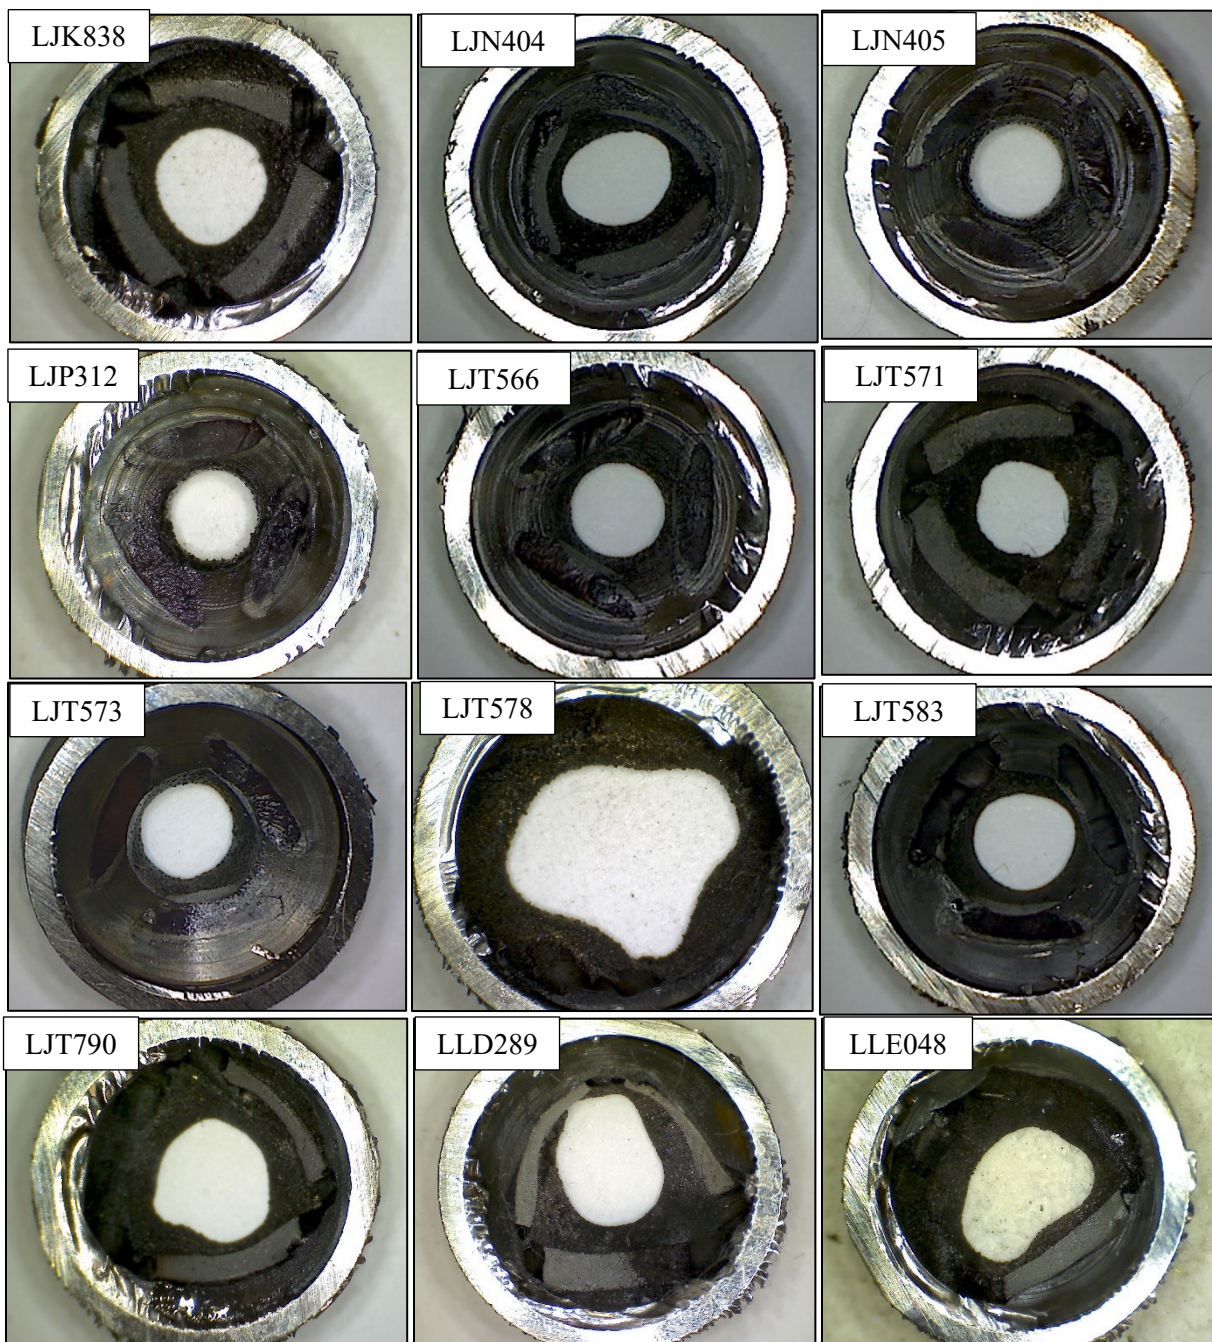
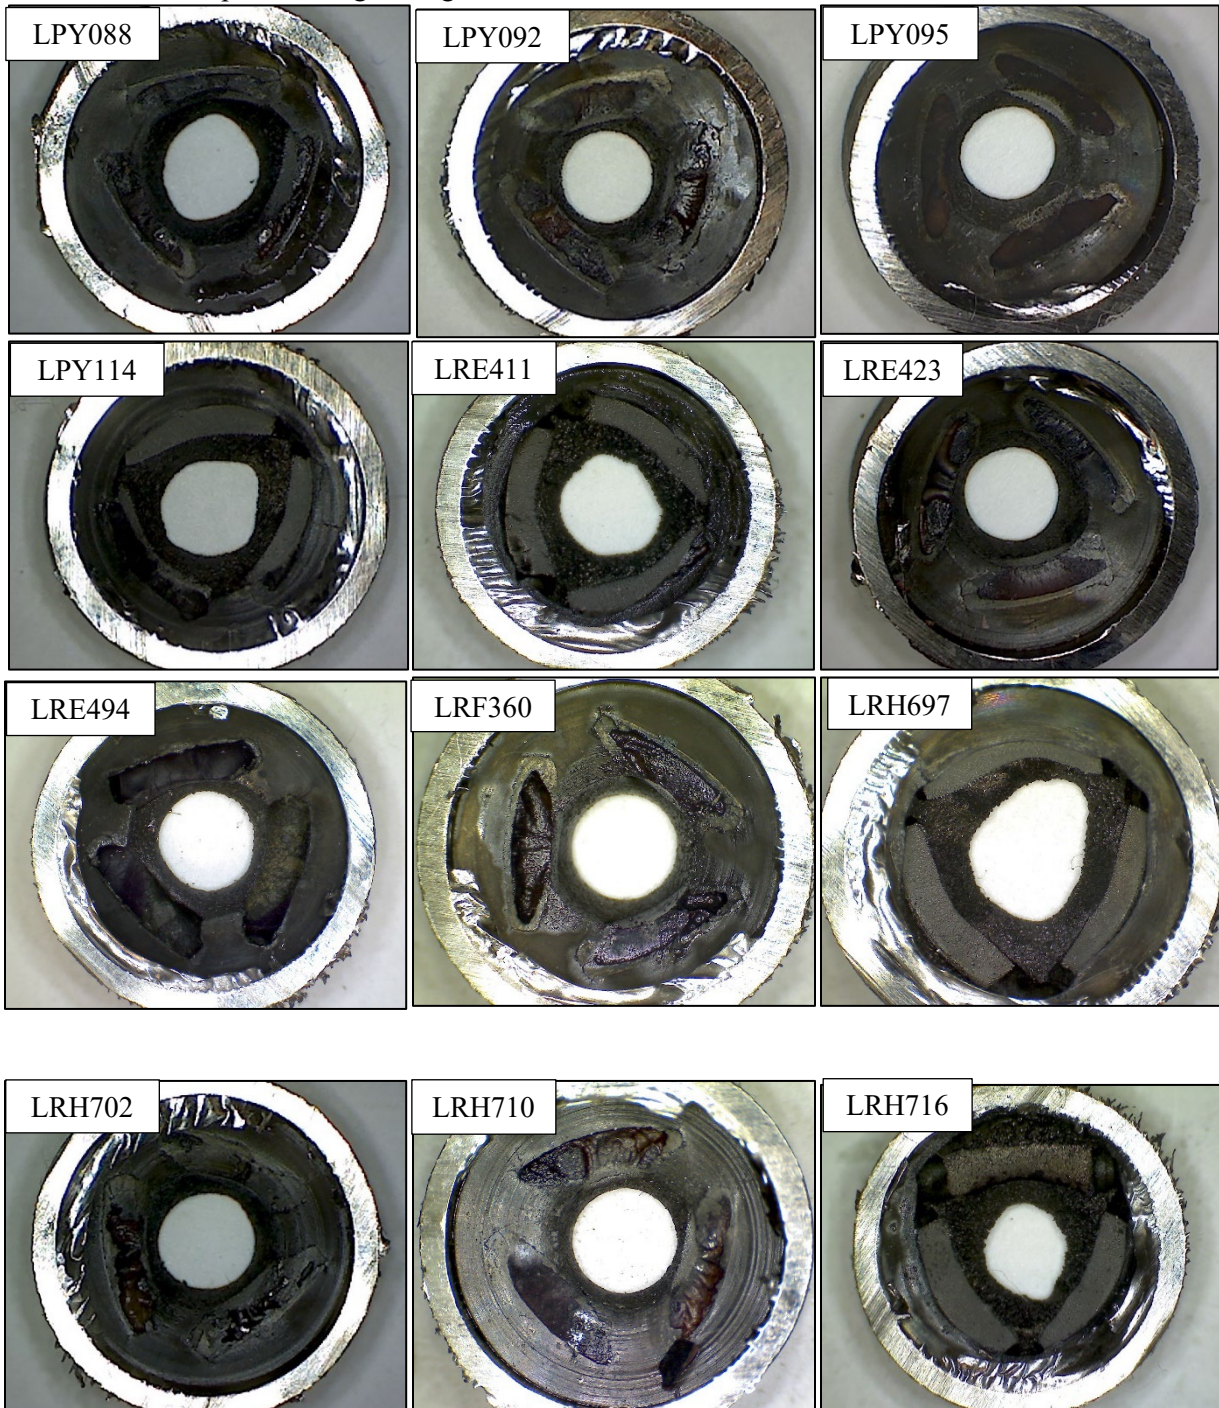
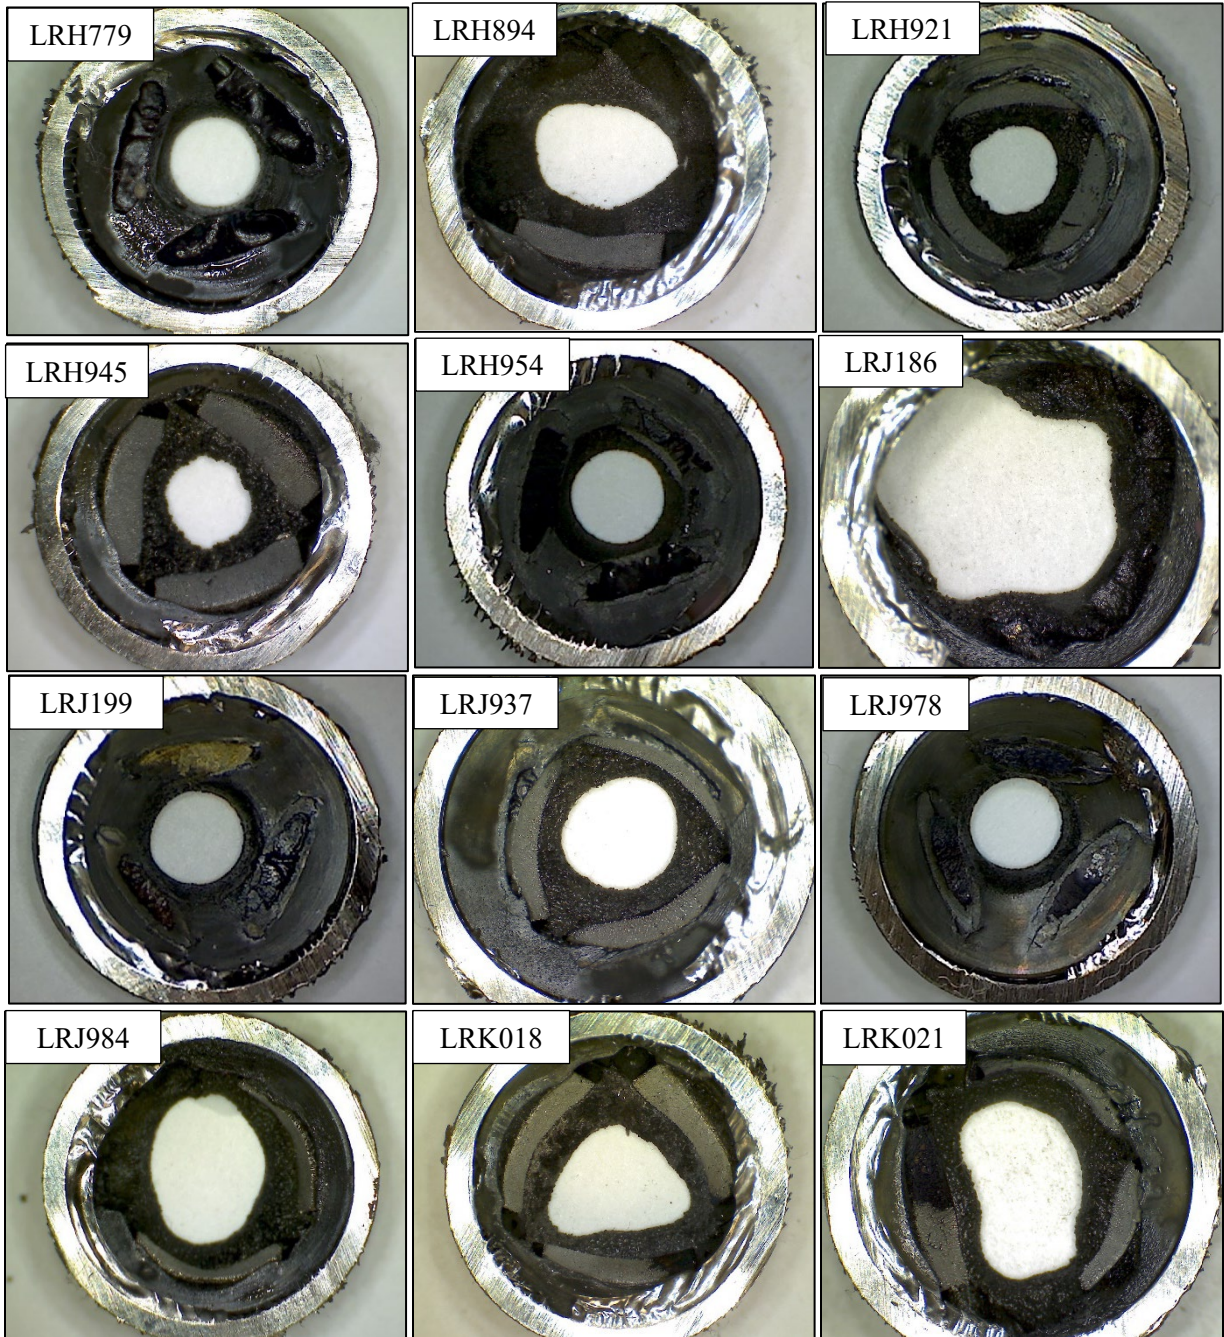
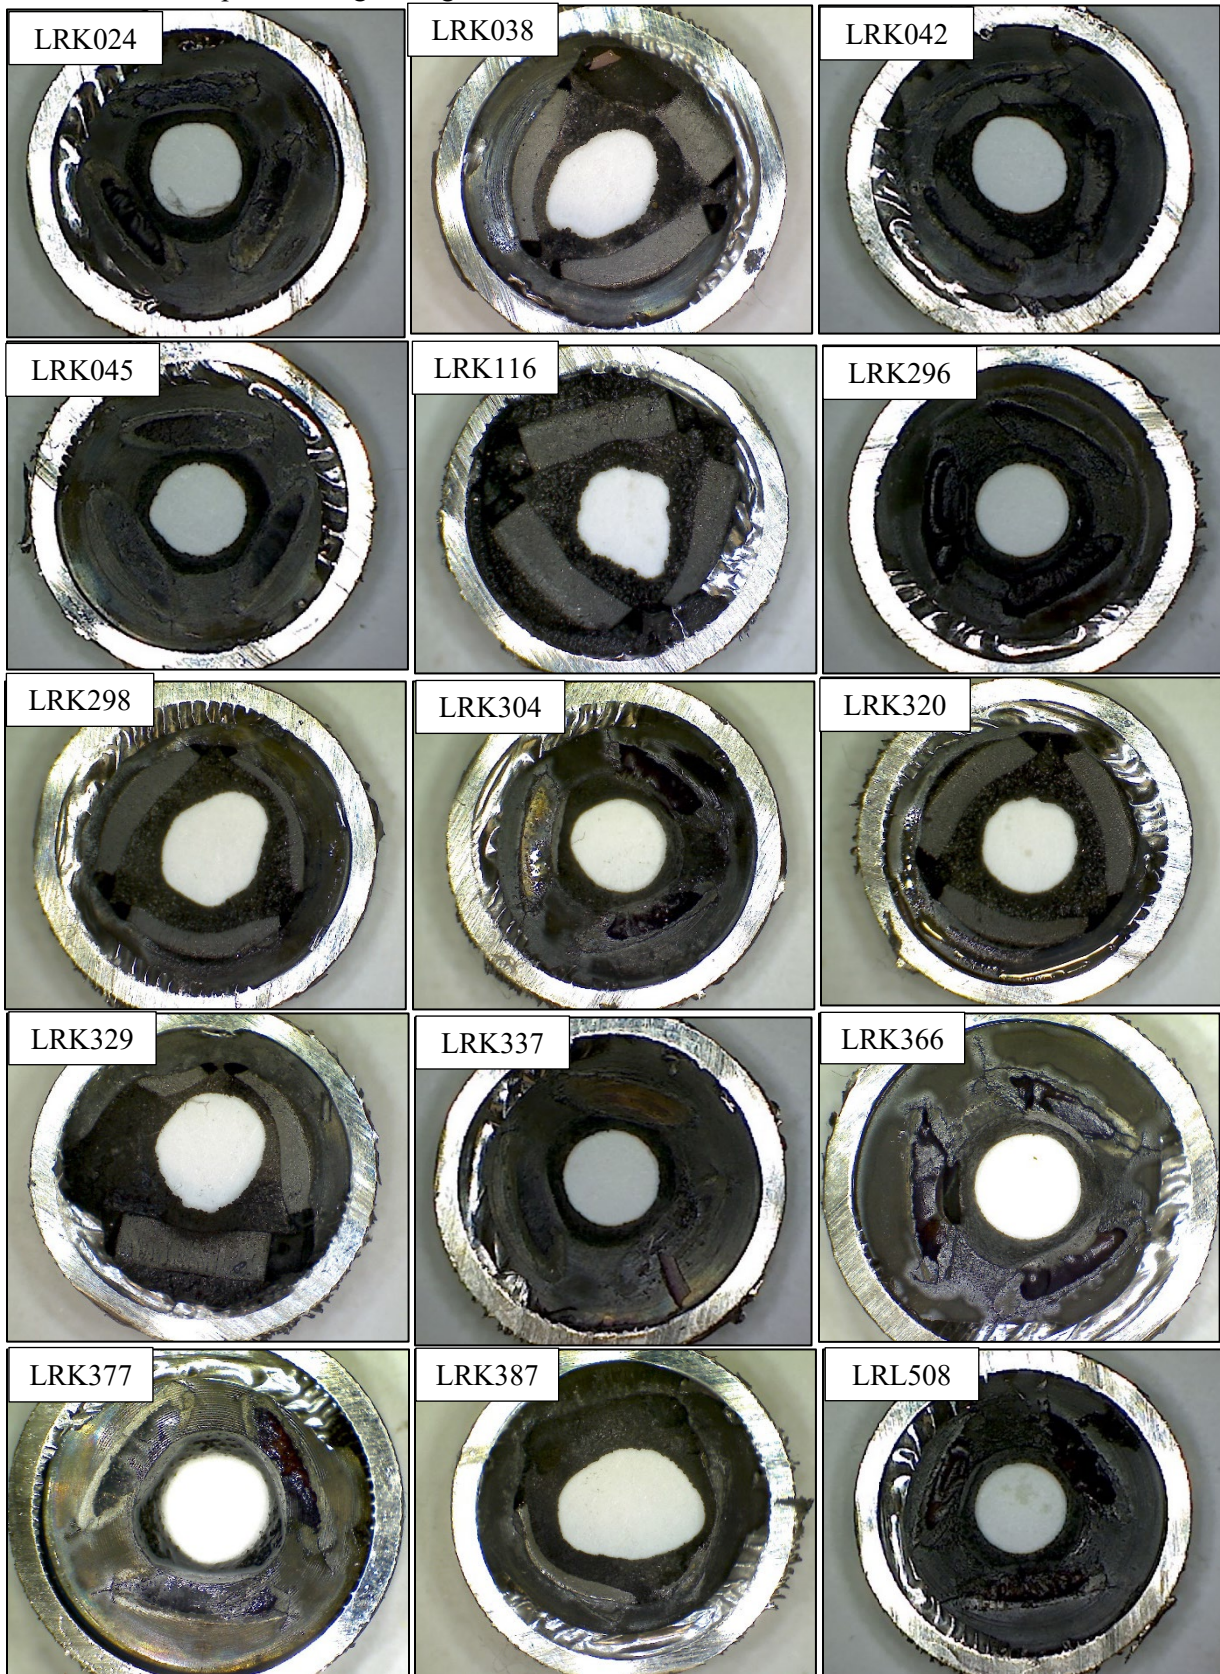
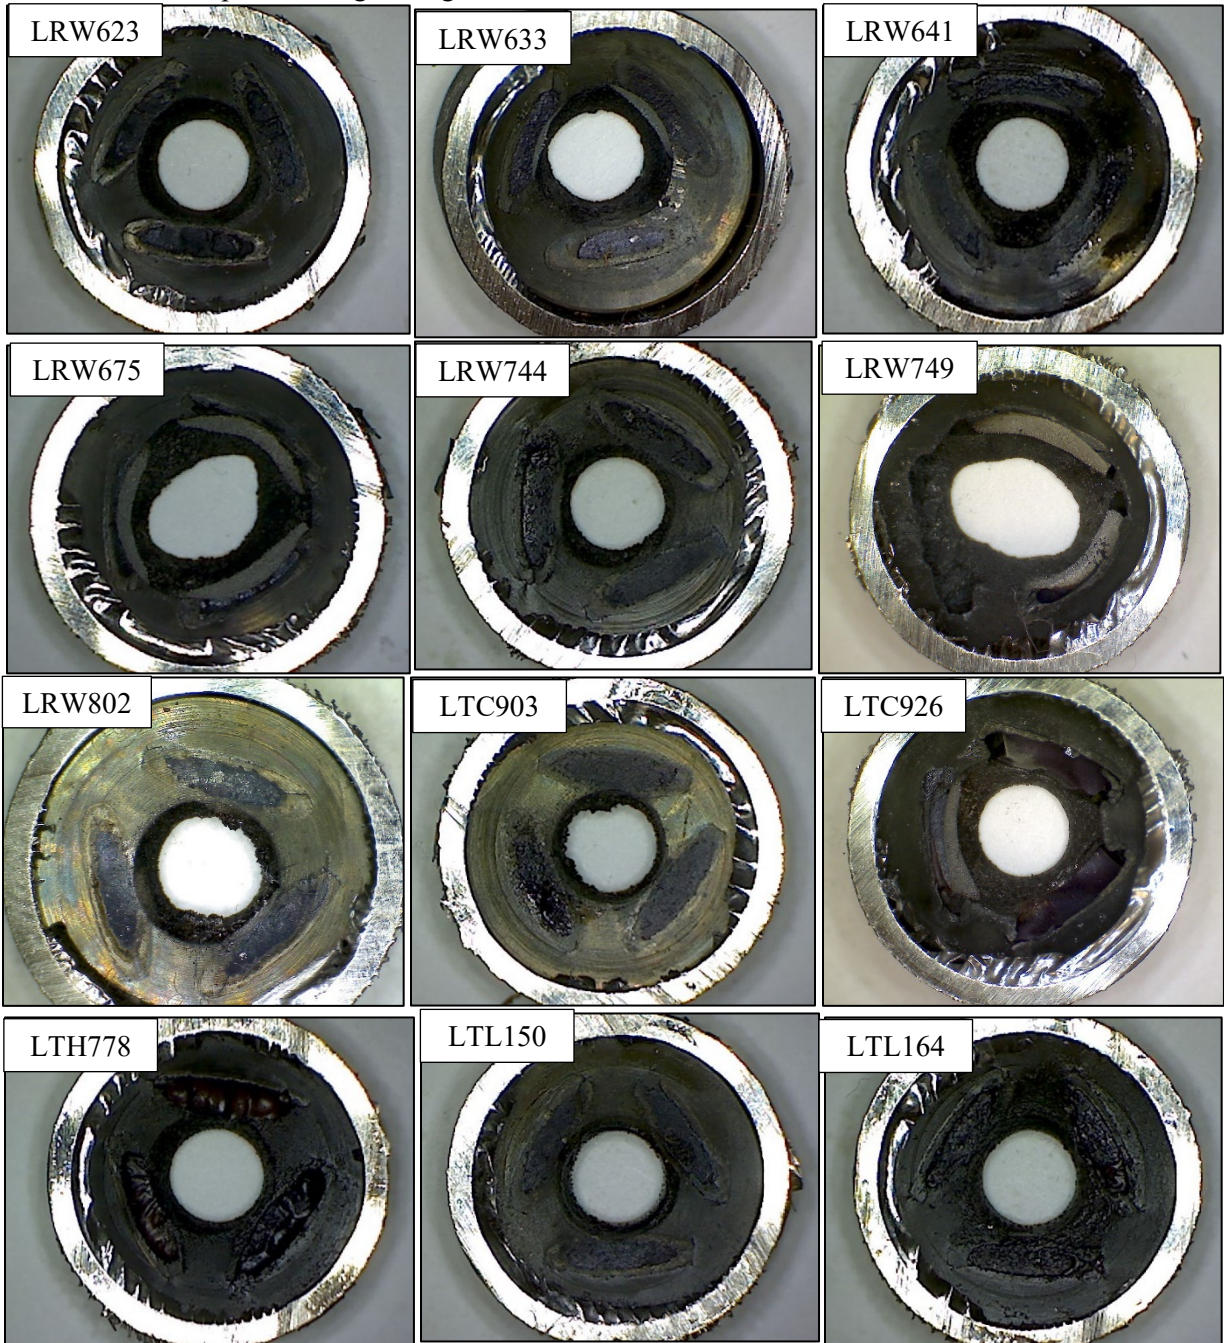
Figure 9: Competitor Long Life Igniter Pins

After evaluating the ninety-six (96) Competitor Long Life igniters returned, fifty-two (52) of the igniters appear to have all three ground pins remaining. However, the remaining forty-four (44) igniters appear to have portions of ground pins or entire ground pins missing with twelve (12) of these units appearing to have all their ground electrode material missing. The pin numbers for each individual igniter are included in **Table 2** above. Pictures of the ground pins are shown below in **Figure 9**.

1. From this analysis, it is seen that 39.6% of the returned Competitor Long Life igniters exhibit conditions that indicate at least one entire ground pin missing.
2. Because of the cracking and evidence of missing ground pin material, partial or full ground pin liberation into the combustor is likely to have occurred with the Competitor Long Life igniters missing ground pins.

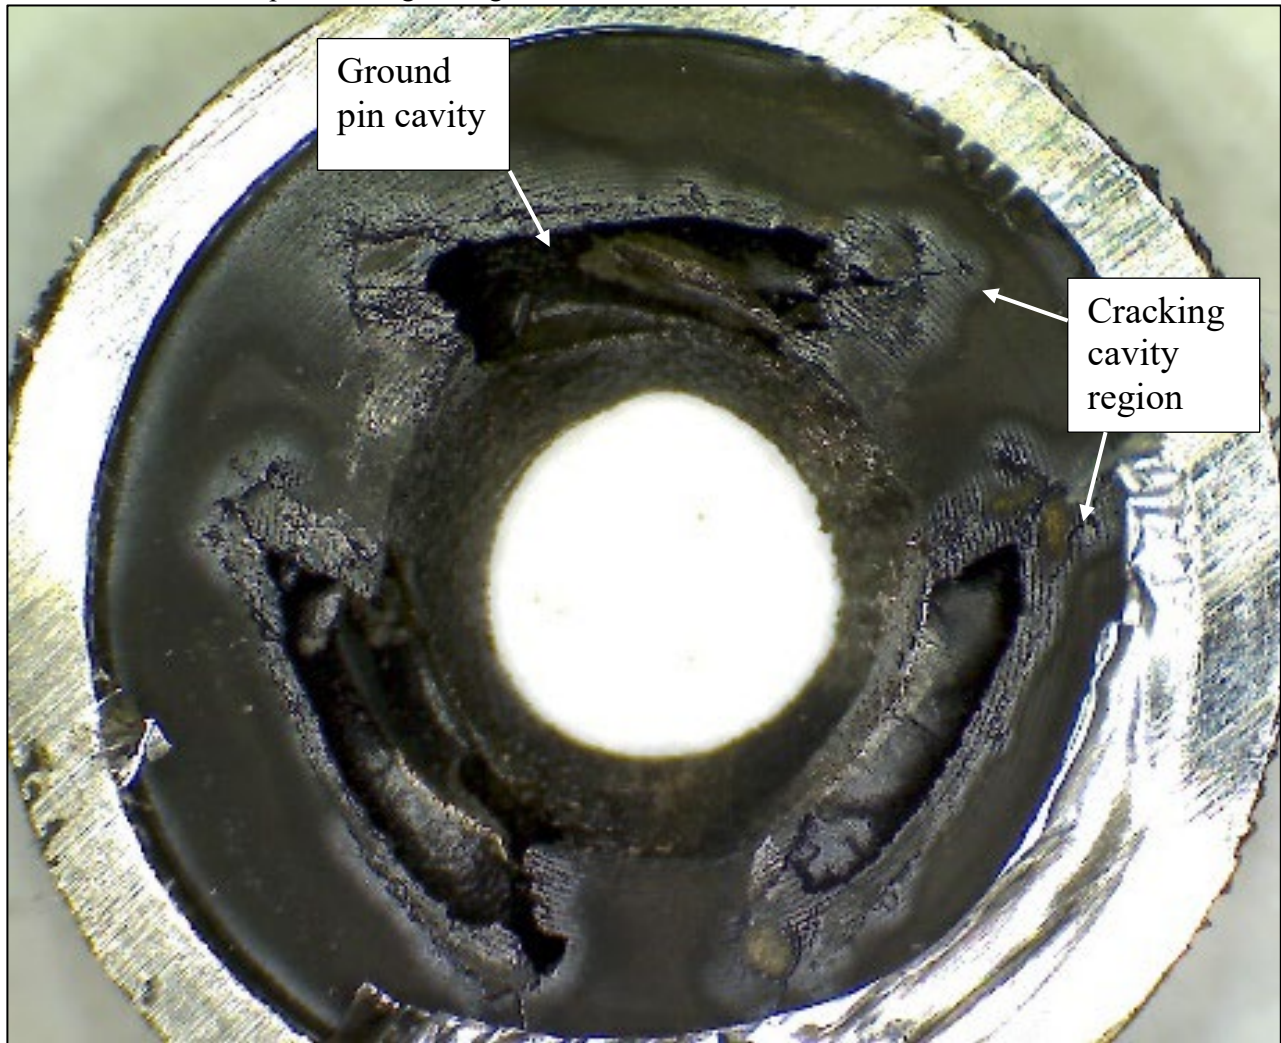
Figure 10: Igniter Tip Internal View

Upon further investigation of the removed shells, it was observed that some of the igniters also exhibited cracks in the cavity region housing the ground pin electrodes similar to **Figure 10**. This phenomenon has been witnessed before by Champion in previous competitive analysis, CH327.I.EER.004.
