TECHNICAL SPOTLIGHT

Subject: GE CF34 Family of Engines- Igniter Competitive Comparison

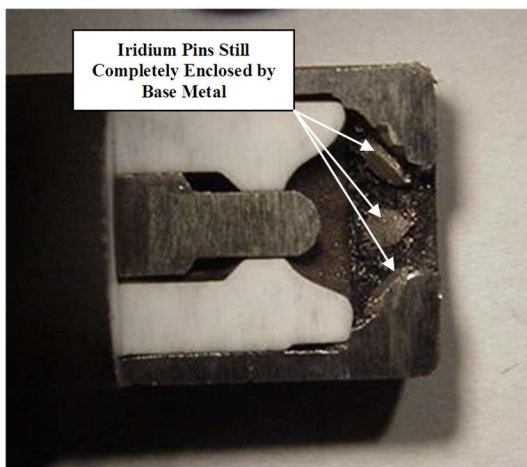
Figure 1: Champion Style Sectioned Tip

Figure 1 above demonstrates the Champion tip design provides consistent sparking to the 6 Iridium Pins embedded in the firing end shell and considerably lower insulator erosion. This leads to lower spark path length and ultimately ensures effective Wet Spark performance at this level of wear. It also ensures continued consumption of the highly erosion resistant Iridium Pins to maximize spark life, and

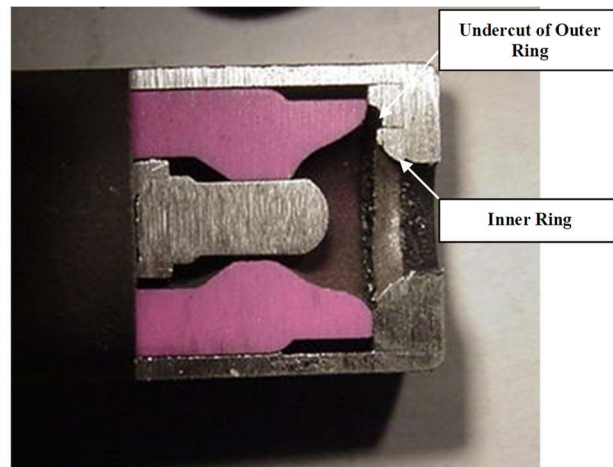
Figure 2: Unison Style Sectioned Tip

therefore, Igniter installed life. The Champion CF34-3, -8 and -10 igniters incorporate this design configuration as long life igniters. The Unison Igniter erosion of the insulator permits undercutting of the erosion resistant inner ring and consistently sparks to the outer ring, which is a less erosion resistant feature as shown in **Figure 2**. This limits life in the igniter and can even lead to tip liberation as shown in **Figure 3** and **4** below.

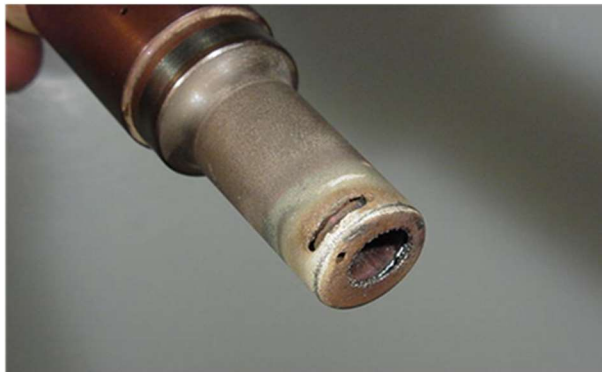
Figure 3: Unison Sidewall Erosion

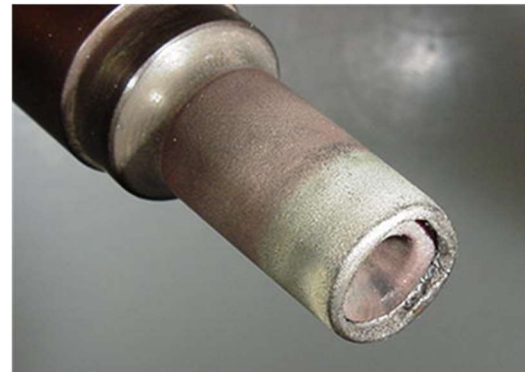
Figure 4: Unison Tip Loss from Sidewall Erosion

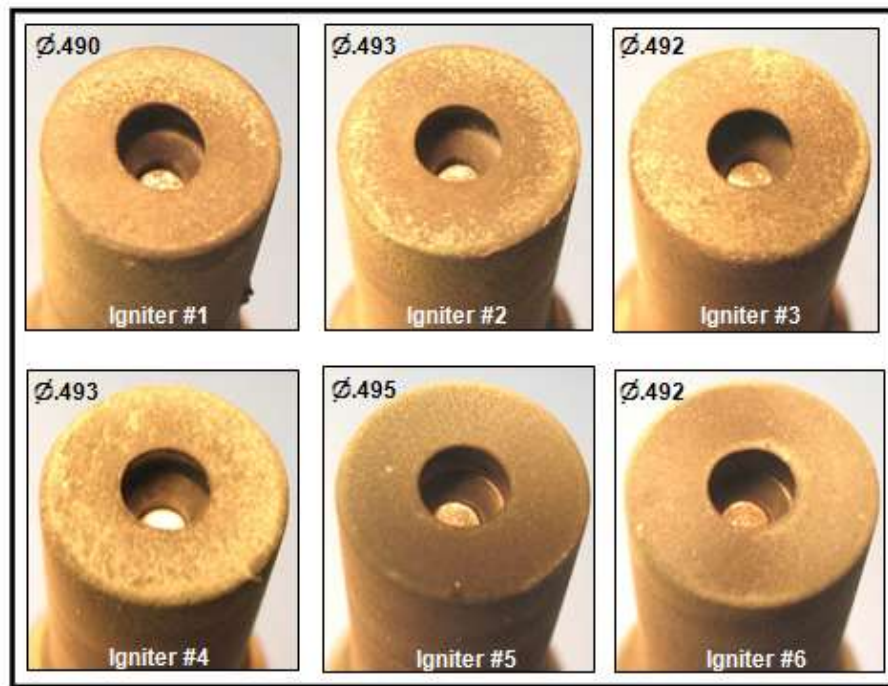
The resulting firing end conditions of the parts at the end of the performance effort are shown in **Figures 5 and 6**. All Unison igniters exceeded the maximum tip diameter of 0.500" allowance by GE Specification due to thermally induced tip swelling.

Figure 5. Champion Igniter Tips Exhibiting No Thermal Distress

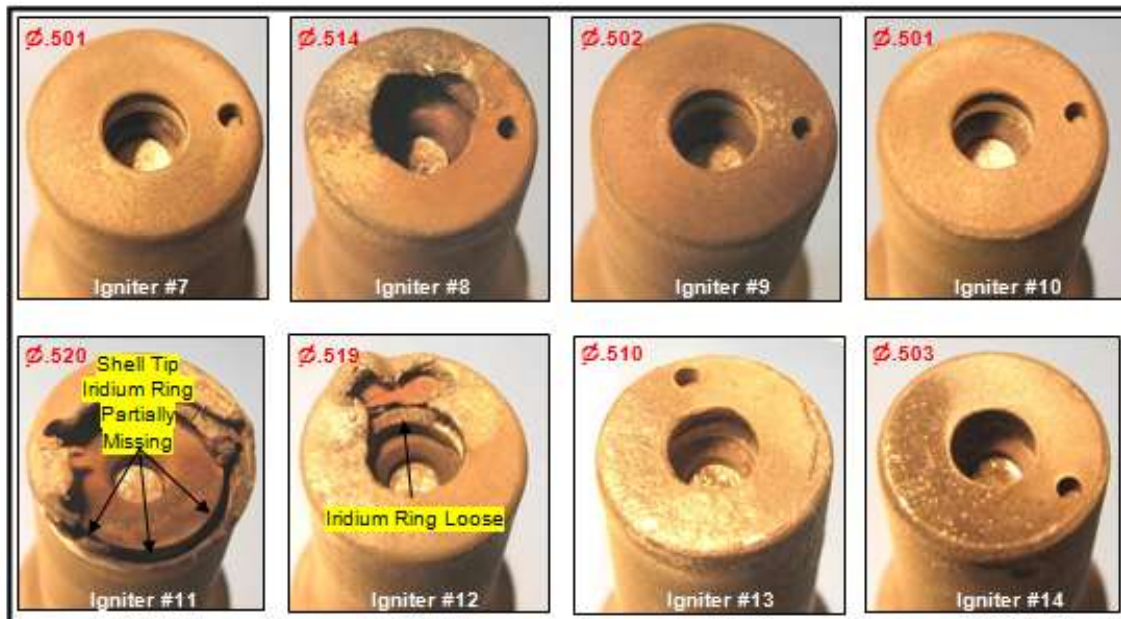
Figure 6. Unison Igniter Tips Exhibiting Severe Thermal Distress
