## TECHNICAL SPOTLIGHT

**Subject:** Igniter Competitive Evaluation (Champion CH31900-6, GE P/N 1374M13P11 and Unison 9072215-1, GE P/N 1374M12P10)

**Purpose:** To conduct a side-by-side “on engine” performance evaluation of CH31900-6 and 9072215-1 igniters installed in a Malaysian Airlines B737-400. The goal was to demonstrate Champion’s advanced firing end design will deliver longer life capability due to its desired electrical erosion characteristics.

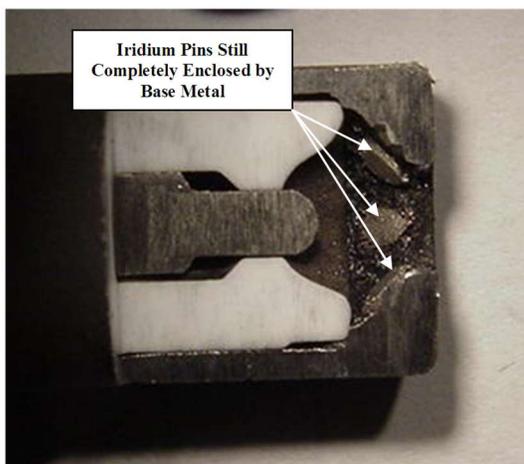
**Figure 1: Champion Sectioned Tip**

After 900 cycles the Champion CH31900-6 igniter erosion was well short of the 50% remaining life shell wall and center electrode wear limits established by the CMM, met new part gas leakage requirements at 500 psig and passed the 14kV Wet Spark Test (Fuel) required by the GE Igniter Specification. The Unison design only conformed to the gas leakage and center electrode recession requirement. Failure of the 14kV Wet Spark Test would prevent further use as the functional Service Limit was achieved. After functional test the igniter firing ends were sectioned to review the erosion patterns. See **Figures 1 and 2** below:

**Figure 1** demonstrates the Champion tip design exhibited consistent sparking to the 6 Iridium Pins embedded in the firing end shell and considerably lower insulator erosion. This leads to lower spark path length and ultimately ensures effective Wet Spark performance at this level of wear. It also ensures continued consumption of the highly erosion resistant Iridium Pins to maximize spark life, and therefore, Igniter installed life. The Unison Igniter erosion of the insulator permitted undercutting of their erosion resistant inner ring and consistent sparking to the outer ring, which is a less erosion resistant feature as shown in **Figure 2**. This limits life in the engine and can even lead to tip liberation as shown in **Figure 3** and **4** below.

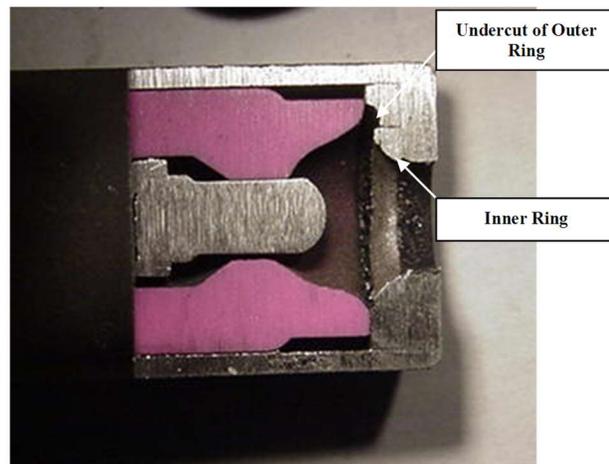
**Figure 2: Unison Sectioned Tip**

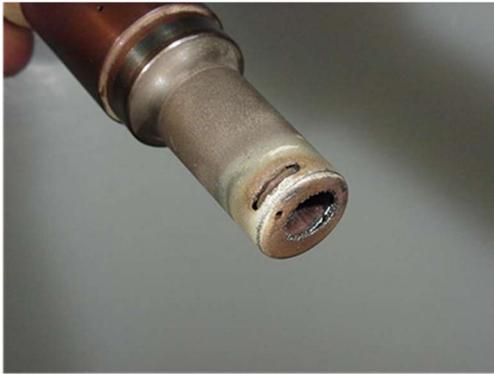
**Figure 3: Unison Side Wall Erosion**

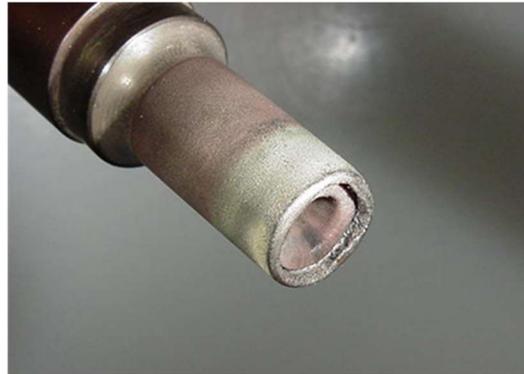
**Figure 4: Unison Tip Loss from Sidewall Erosion**

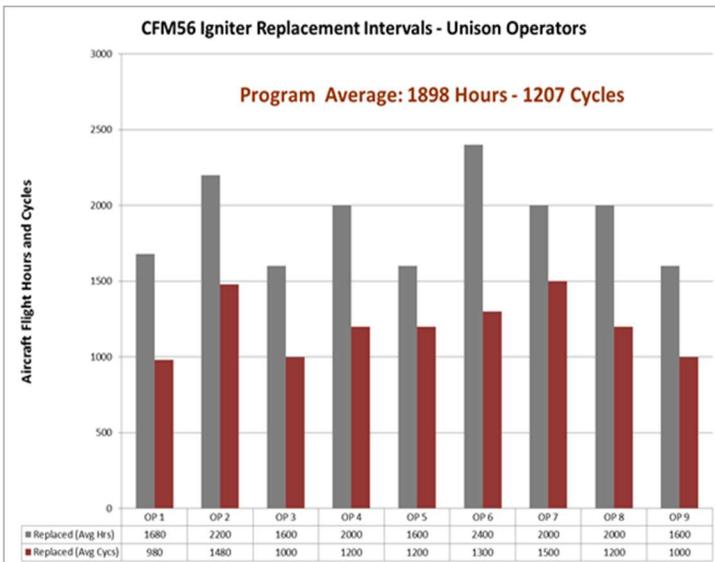
**Figure 5: Unison Operator Data**

Recent CFM56 operator field surveys of igniter replacement intervals fully support the on engine evaluation data and conclusions made above. See **Figures 5** and **6** for comparison data.

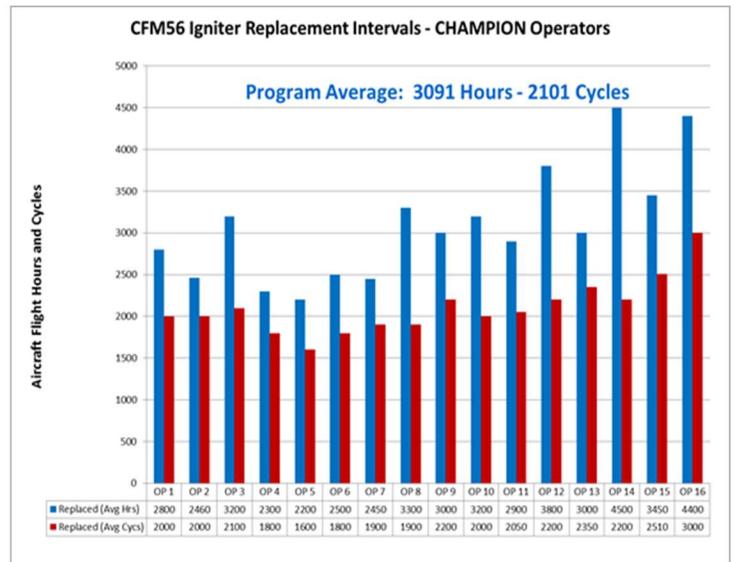
**Figure 6: Champion Operator Data**
