# SLICK SB1-88B

## Service Bulletin

**SUBJECT:** Periodic Inspection of Slick Models 6320, 6324, 6360, 6361, 6363, and 6365 Pressurized Magnetos

**MODELS AFFECTED:** These magnetos, when installed on Piper Dakota PA-28, Seneca PA-34, Saratoga PA-32, Cherokee 6 PA-32, Seminole PA-44, Navajo PA-31, and Malibu PA-46 aircraft.

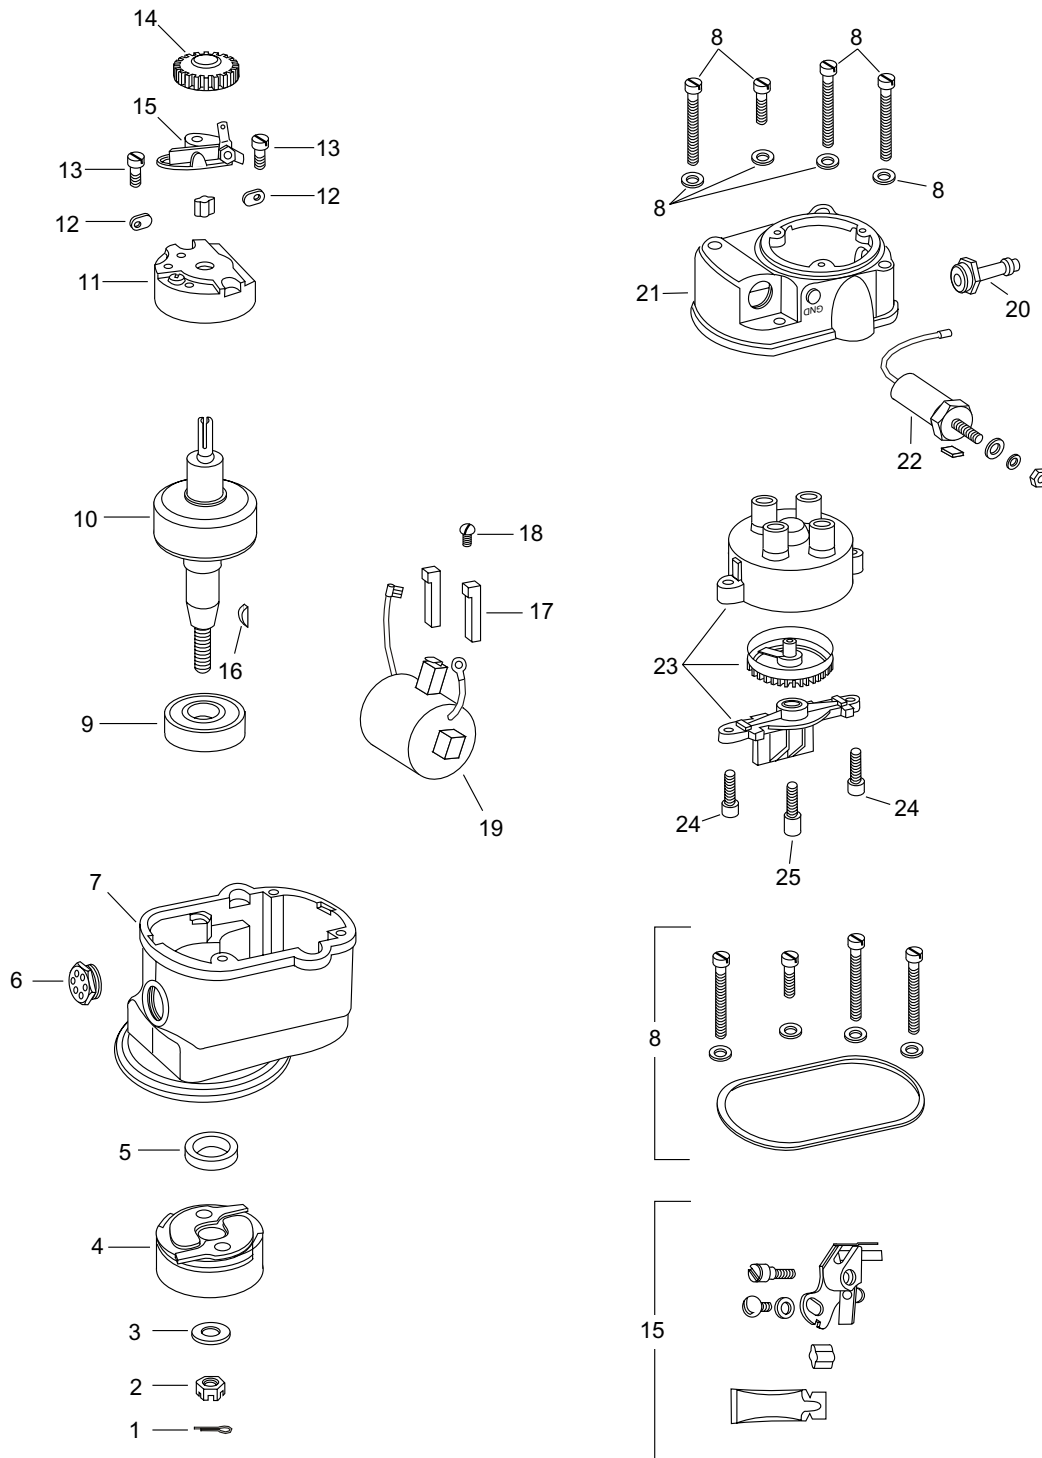
Exploded View

- (1) Check for rust and corrosion on screws (8, 13, 18, 24), bearing cap hold down clamps (12), rotor shaft (10), breaker point assembly (15), frame and coil laminations (19), etc. See Figure 1. Rust and corrosion are signs of contamination and require component cleaning or replacement (reference paragraphs 3.B and C of this bulletin and Slick Maintenance and Overhaul Manual L-1037).
