# Engineering Evaluation Report Report No. CH327.I.EER.005, Issue 3

One Hundred (100) competitor long life CFM56 igniter assemblies P/N 518888-1 / 1374M12P16. See **Table 1** for serial numbers.

Report Title: CFM56 Competitor Long Life Igniter Evaluation

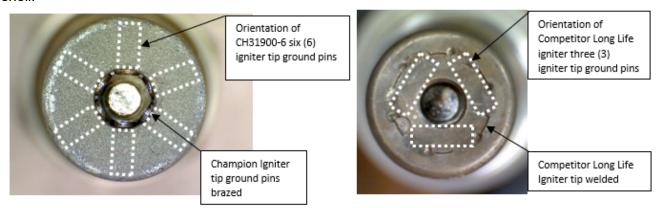
Figure 10: Champion and Competitor Long Life Igniter Geometry

In order to better review the ground pin wear, the firing tip end of each igniter was removed. **Figure 10** below shows the geometry of the Champion and Competitor Long Life igniter firing end tip designs for reference throughout this report. The Champion igniter design utilizes ground pins installed perpendicular to the center electrode equally spaced around the ground shell diameter, which are brazed into the firing end shell. In contrast, the Competitor Long Life igniter design features ground pins installed in a triangular pattern inside a metallic insert that in turn is welded into the firing end shell.

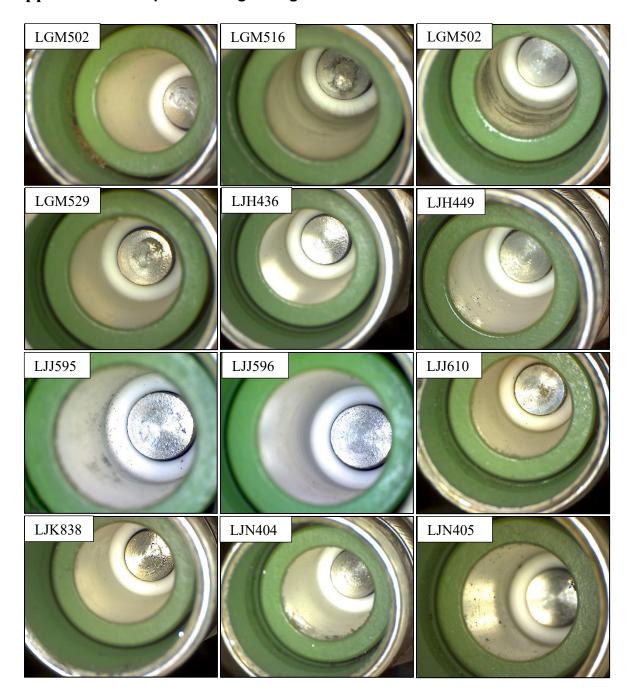
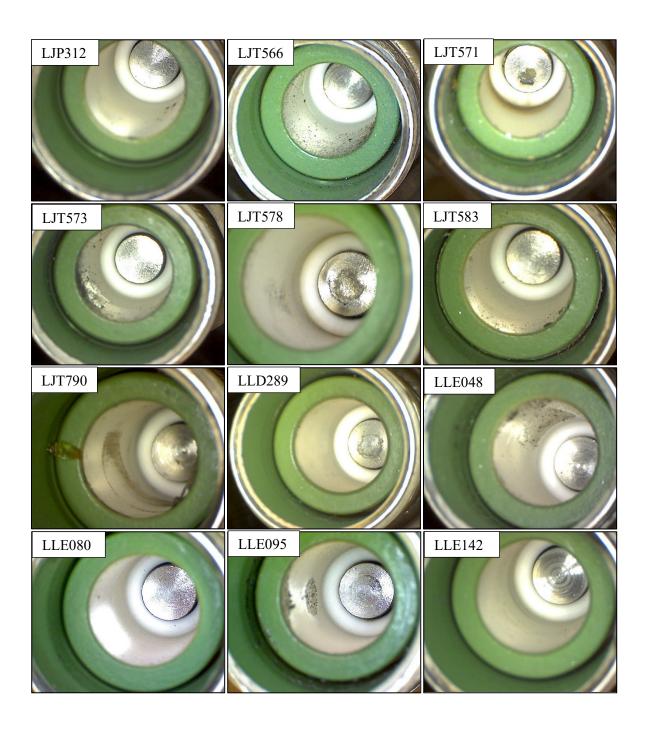
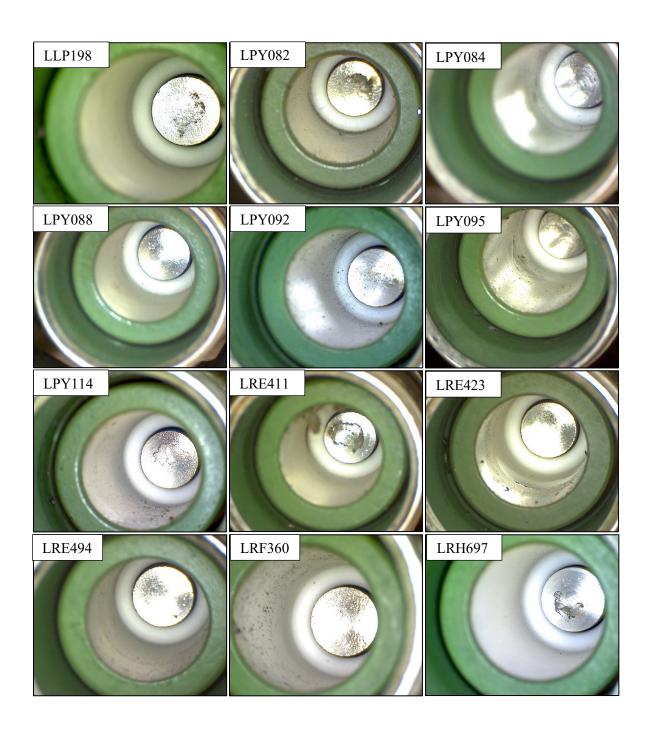
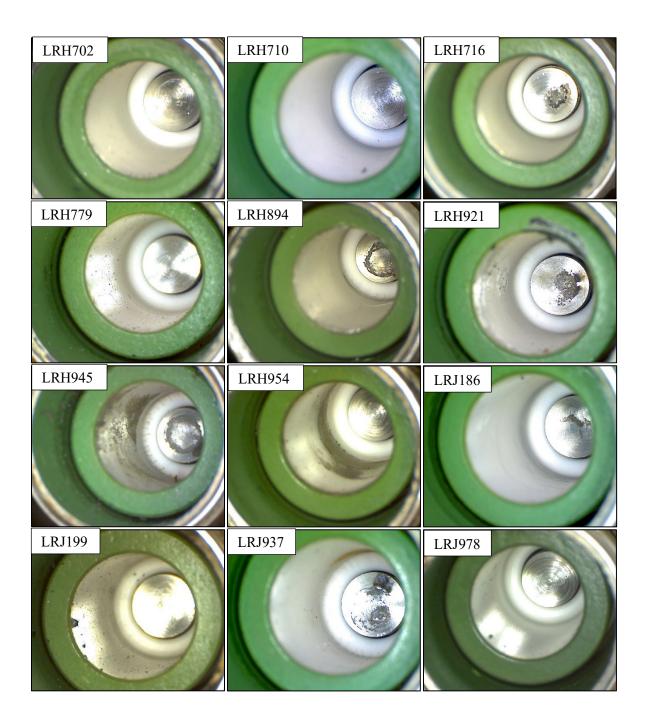
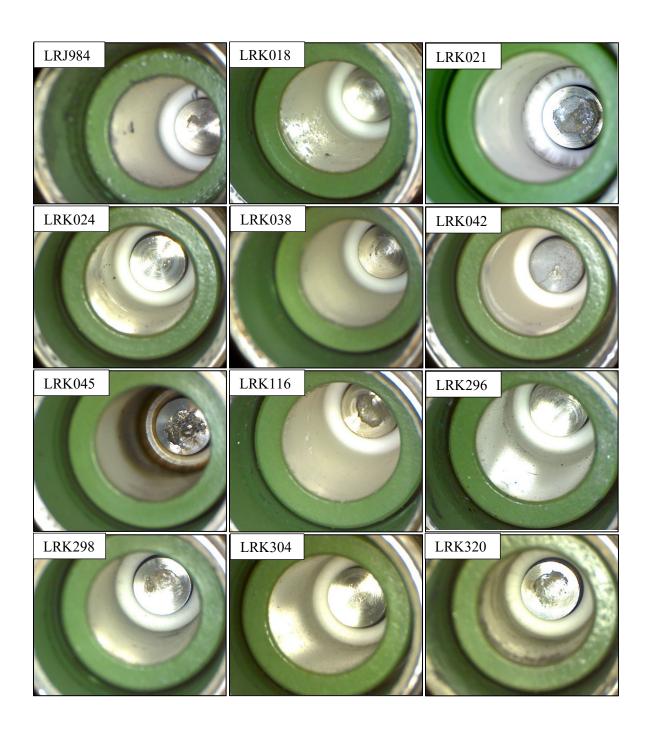
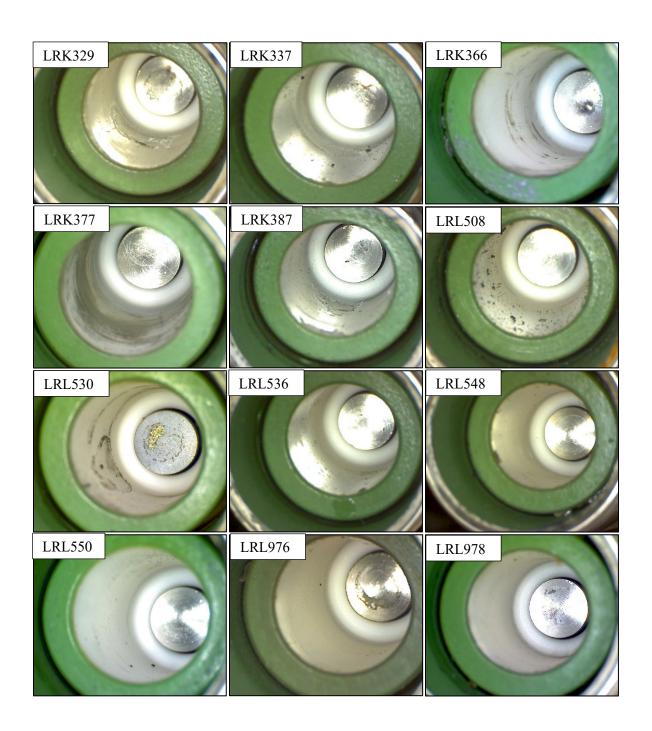
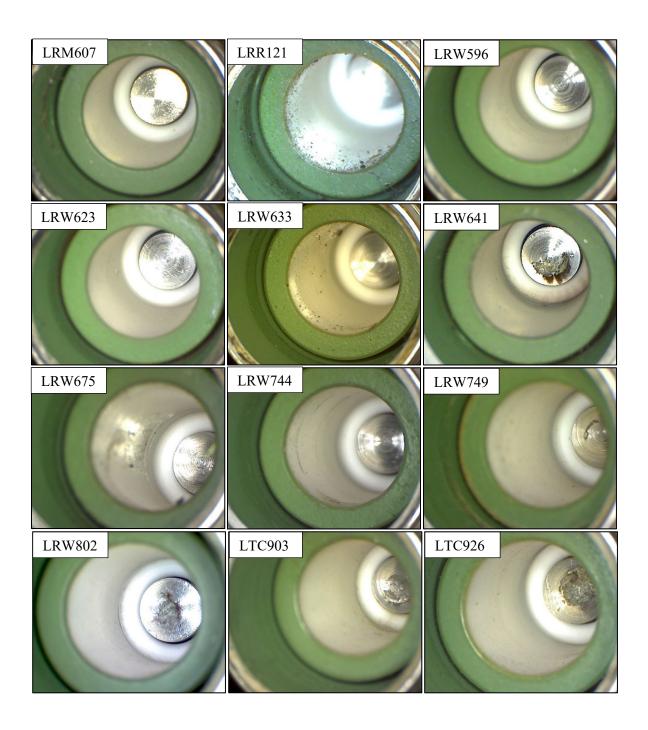
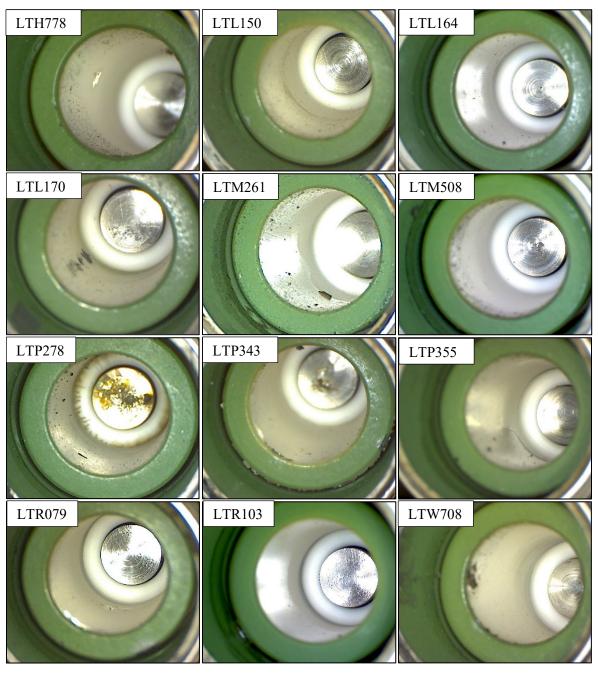
Appendix B: Competitor Long Life Igniter Terminal Well Contamination

Approximately 55% of the terminal wells inspected were clean, with the rest exhibiting some level of contamination. Photos below in **Figure 2** and in <u>Appendix B</u> show the varying levels of contaminates in the population of igniters examined

In addition, approximately 31% of the contact buttons show signs of arcing on the button while the remaining units appeared to be clean. An example of this arcing can be found in **Figure 2**. The photos in **Appendix B** show the as received condition of all one hundred (100) igniter terminal wells.

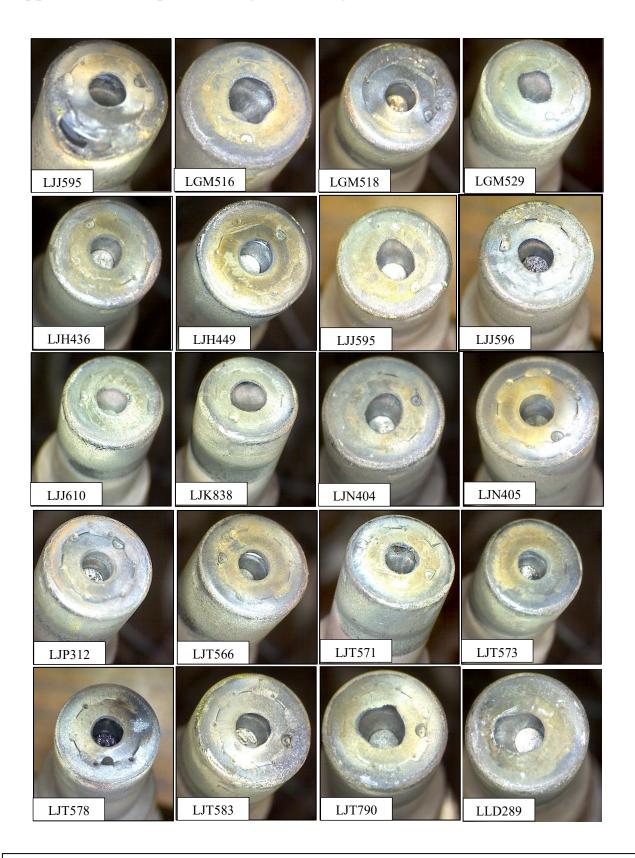
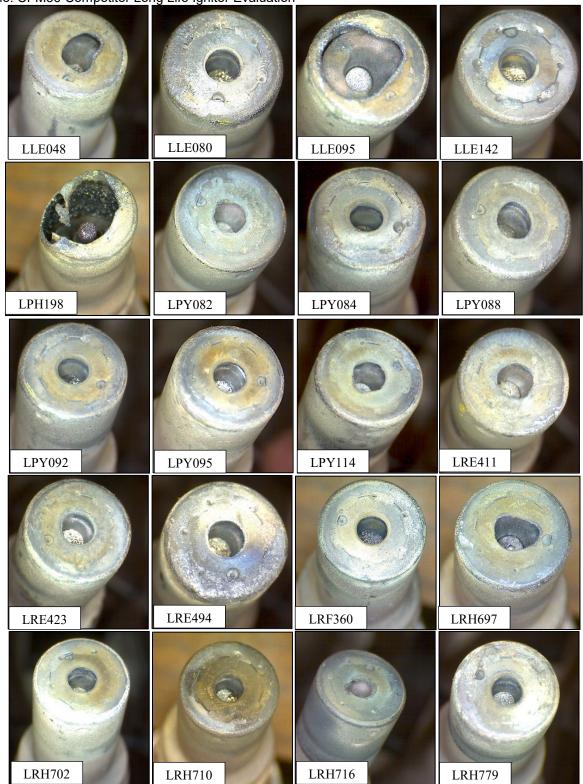
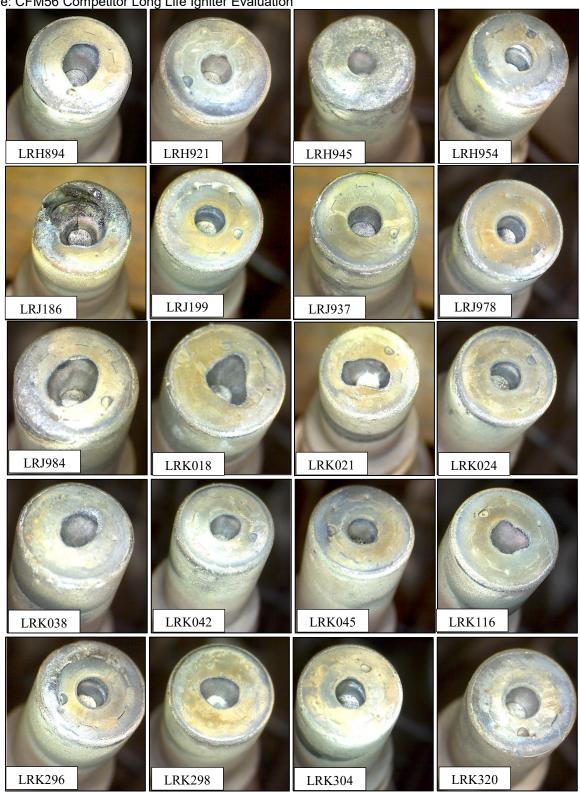
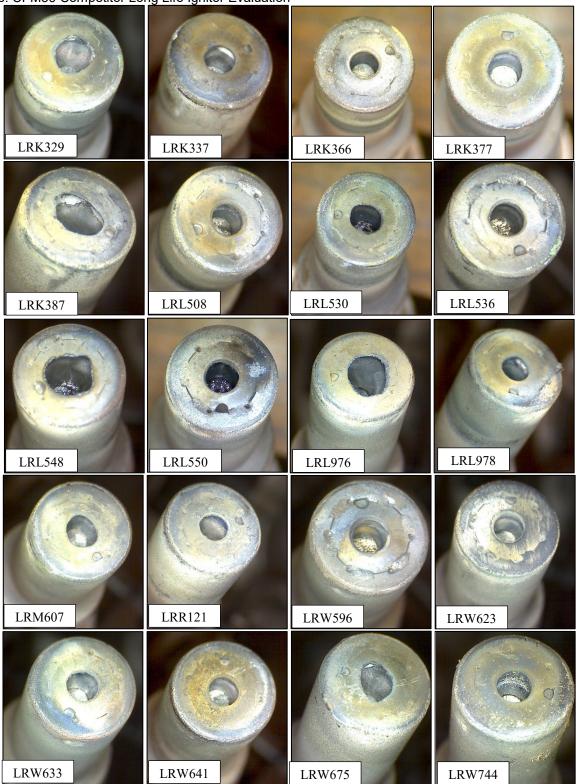
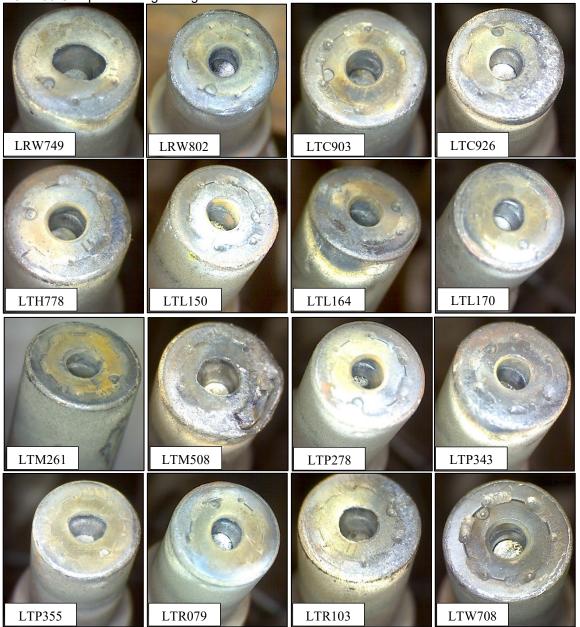
# **Appendix C: Competitor Long Life Firing Ends**

The firing ends of all igniters were visually examined, then measured for wear and abnormalities. A majority of the igniter tips appeared to have normal shell erosion to the I.D with seventeen (17) of the one hundred (100) units having shell I/D's measure over 0.02". However, a couple did exhibit excessive wear as seen in **Figure 3**. In addition to the excessive wear, there were a number of igniters that were missing material to the ground shell, similar to **Figure 4**, while the I.D was still within the normal wear expectation. Appendix C shows a group of photographs of all the igniter firing ends.

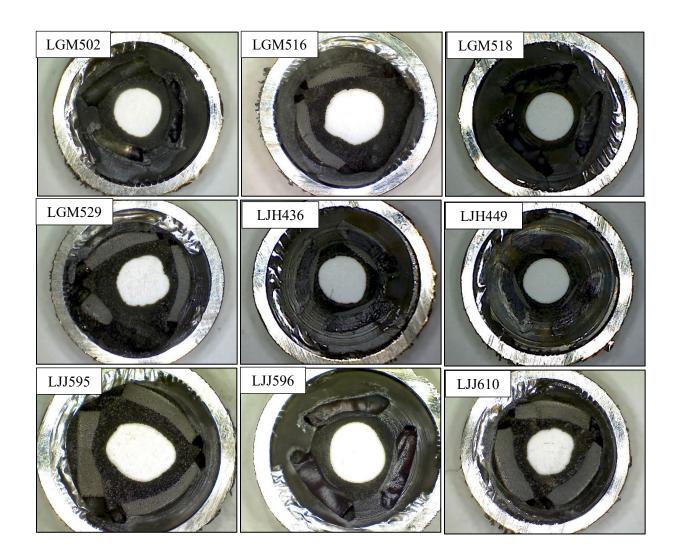
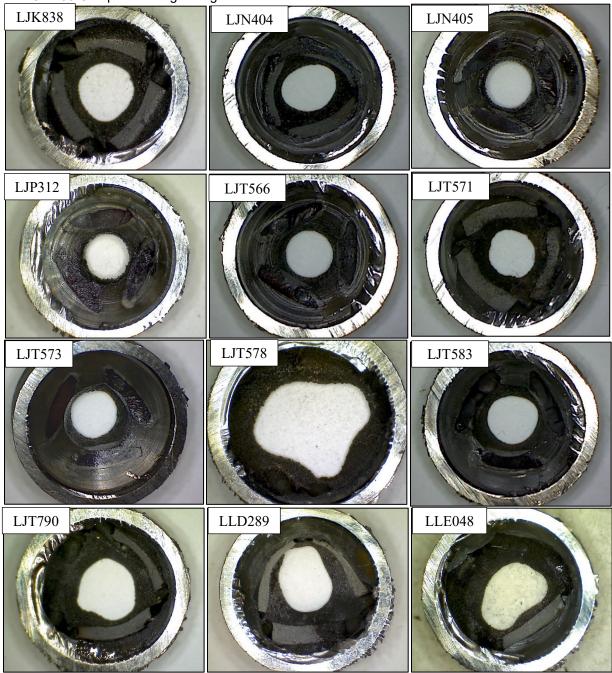
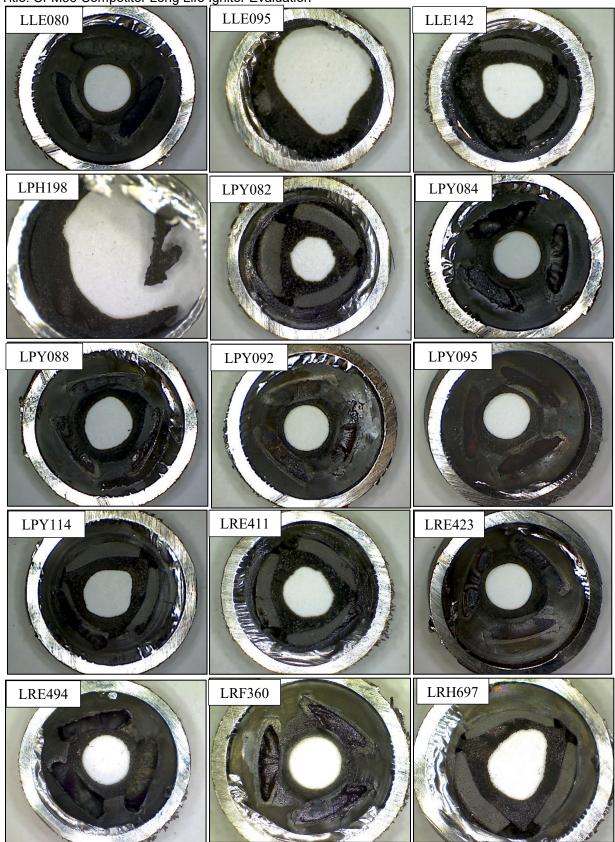
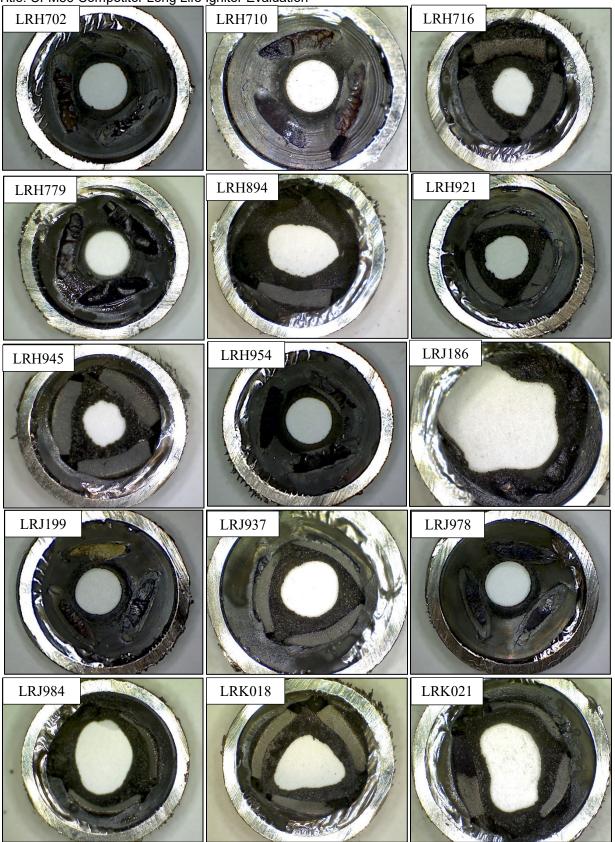
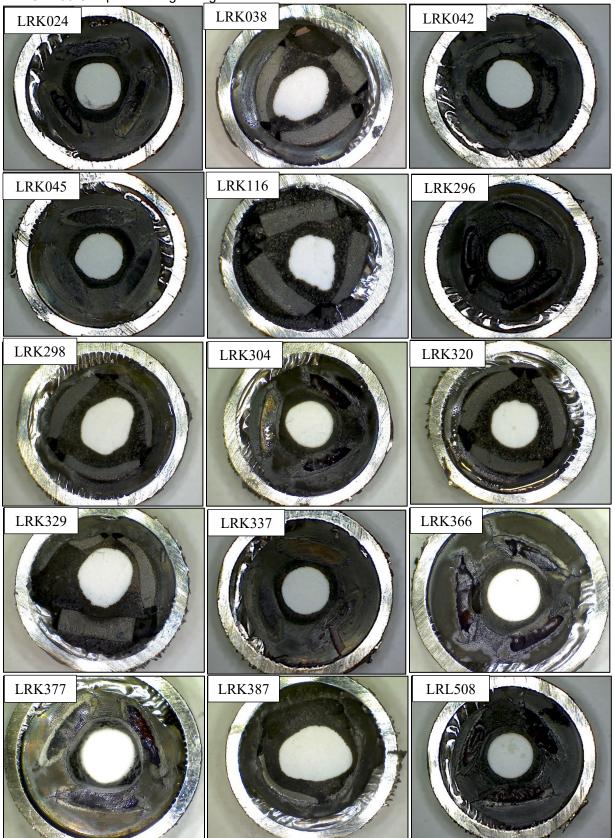
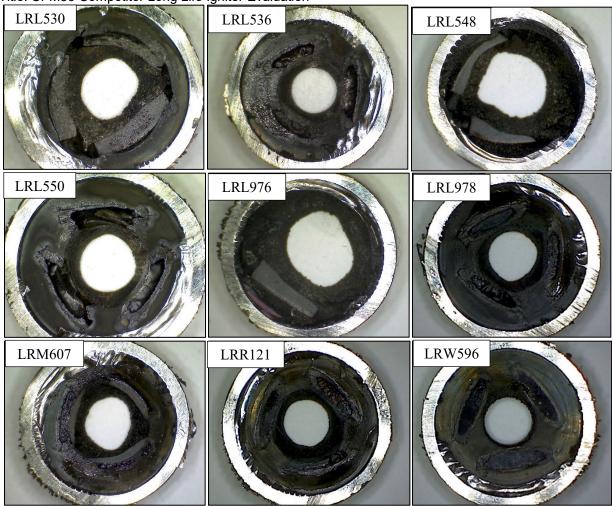
# **Appendix D: Competitor Long Life Igniter Pins**

After evaluating the one hundred (100) Competitor Long Life igniters returned, fifty-two (52) of the igniters appear to have all three ground pins remaining. However, the remaining forty-four (48) igniters appear to have portions of ground pins or entire ground pins missing with sixteen (16) of these units appearing to have all their ground electrode material missing. The pin numbers for each individual igniter are included in **Table 1** above. Pictures of the ground pins are shown below in **Figure 11** and **Appendix D**.

- 1. From this analysis, forty-eight (48) of the returned Competitor Long Life igniters exhibit conditions that indicate at least one entire ground pin missing.

- 2. Because of the cracking and evidence of missing ground pin material, partial or full ground pin liberation into the combustor is likely to have occurred with the Competitor Long Life igniters missing ground pins.

- 3. Based on observations after removing the igniter firing ends, see <a href="Appendix D">Appendix D</a> and <a href="Figure 12">Figure 12</a> above, the competitive part does not appear to have a rigid method of retaining the ground pins. This lack of retention could lead to ground pin movement (spinning) in application and eventual liberation from the igniter tip.
