Engineering Evaluation Report

Report No. CH327.I.EER.005, Issue 2

Ninety-Six (96) Competitor Long Life Igniter Assemblies

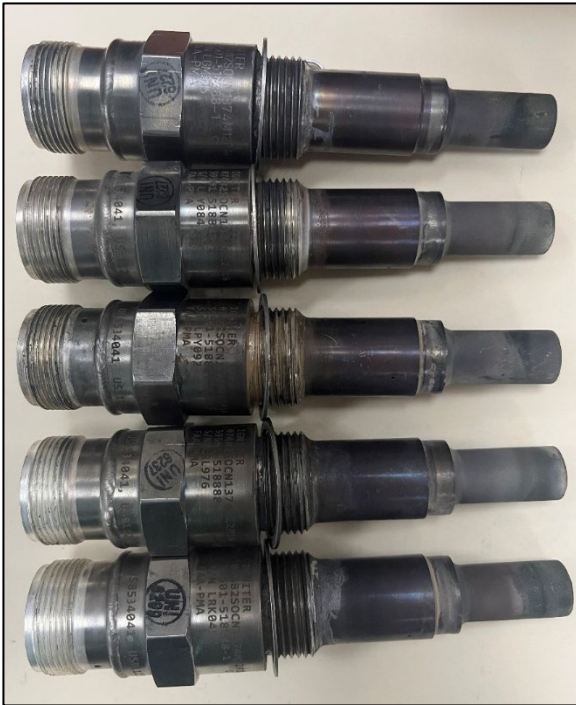
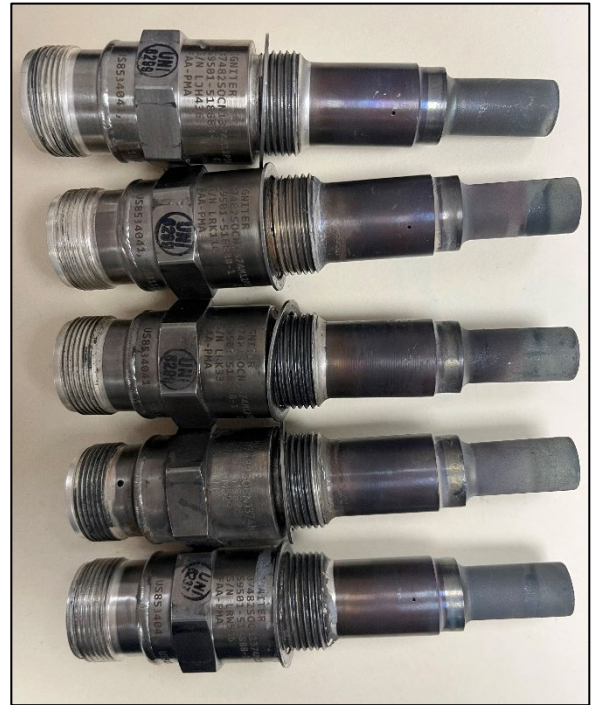
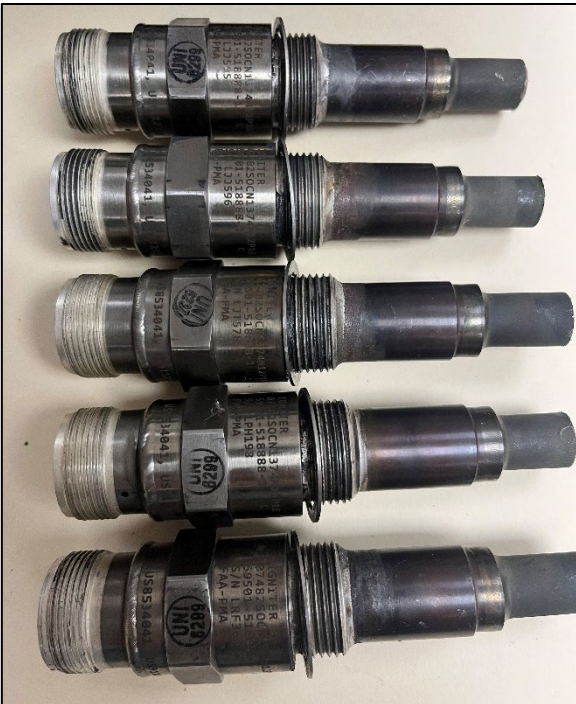
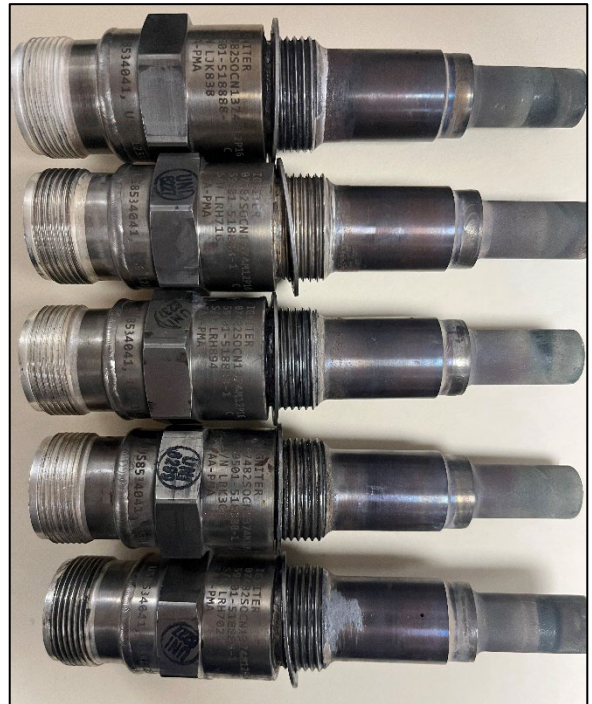
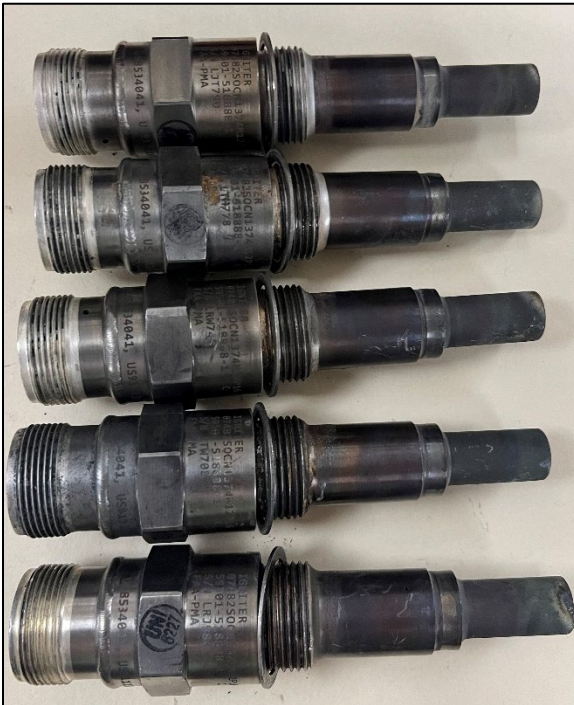
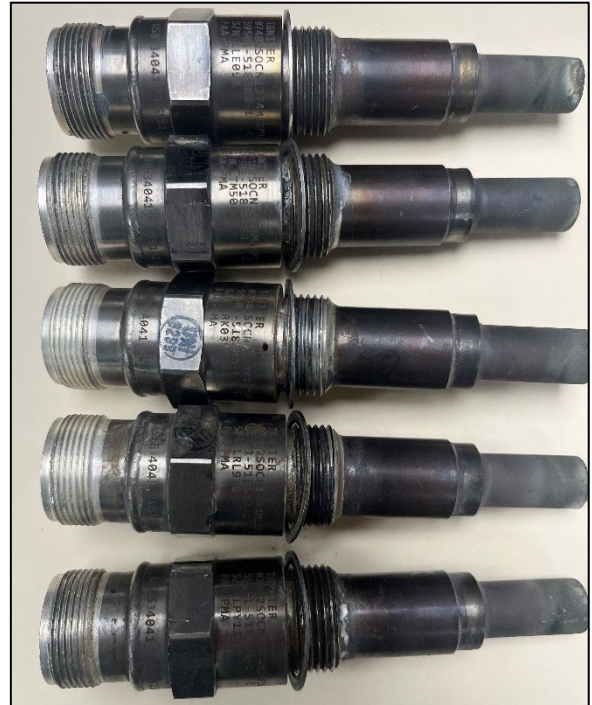
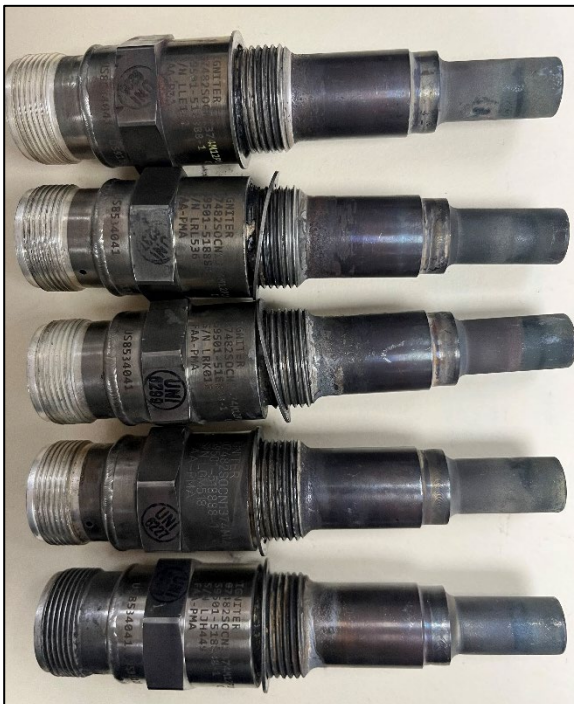
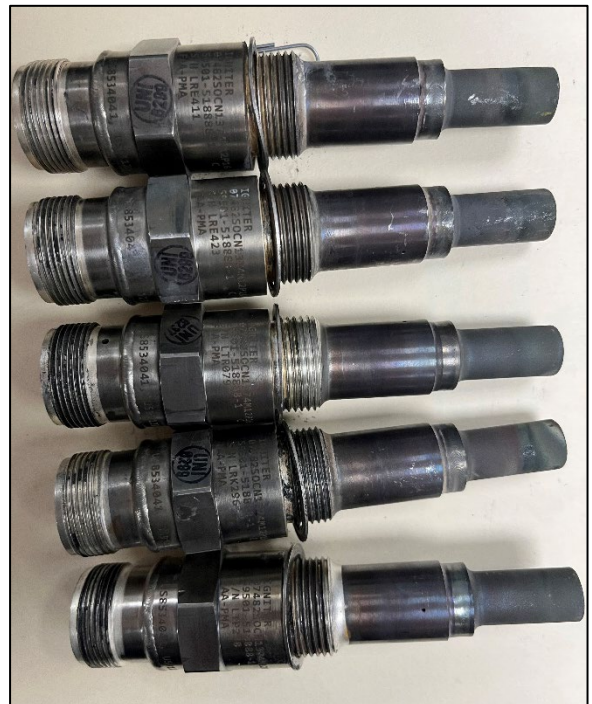
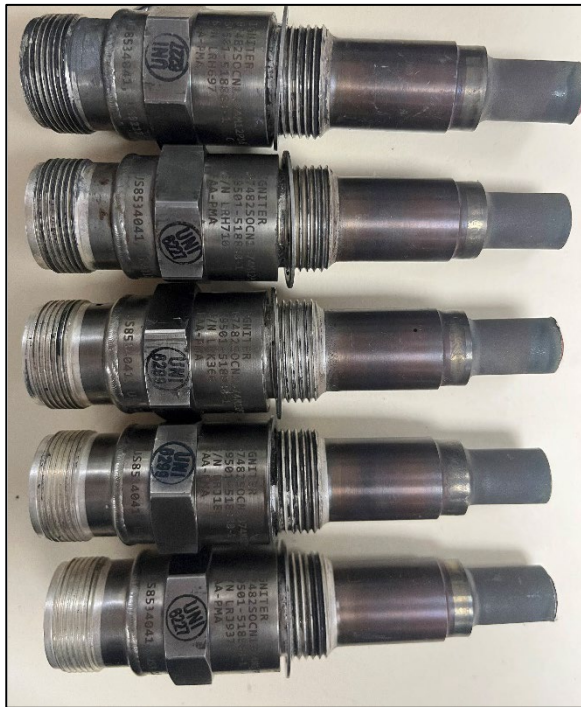
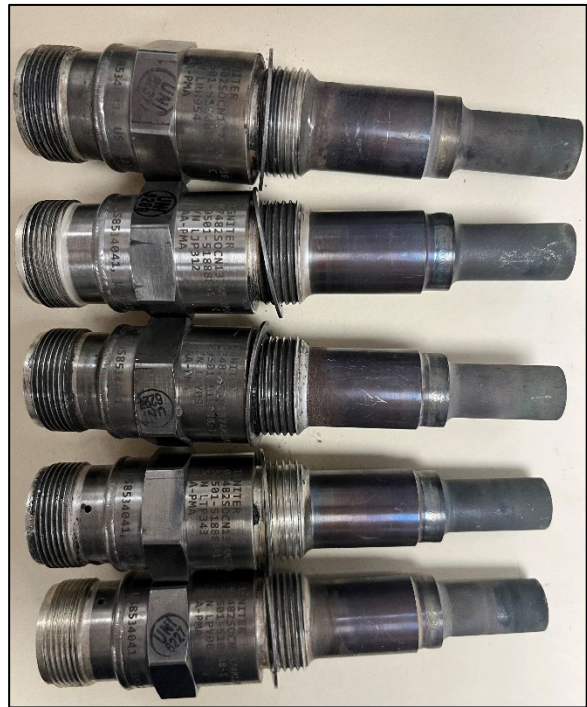
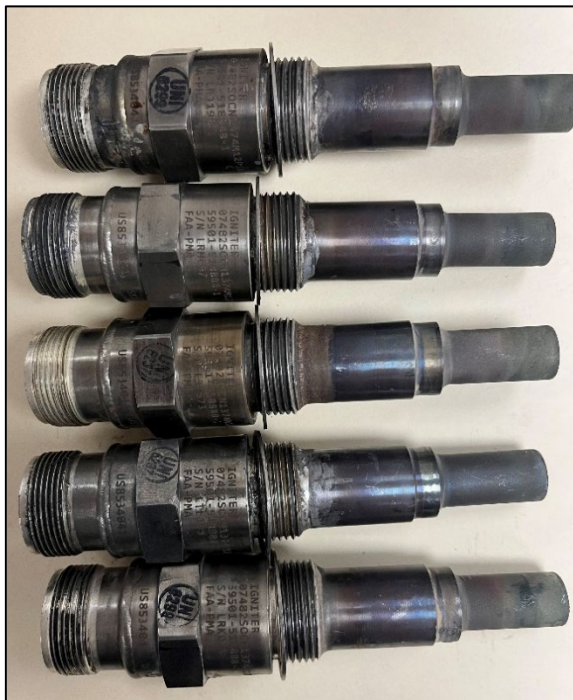
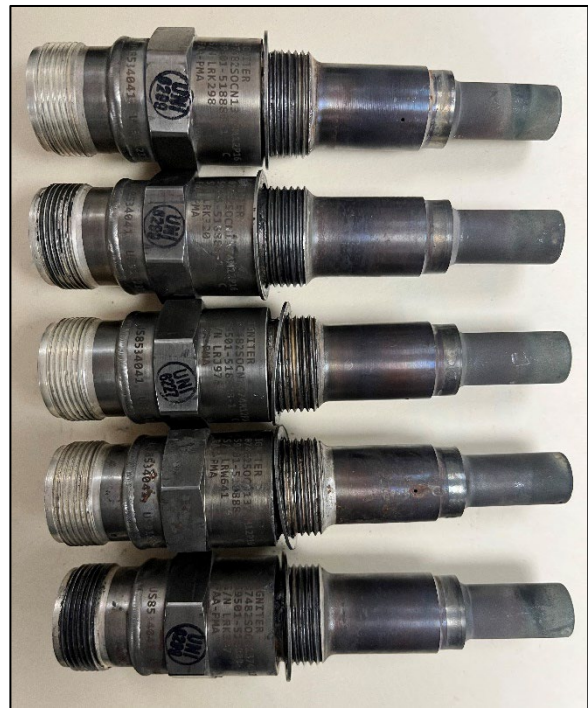
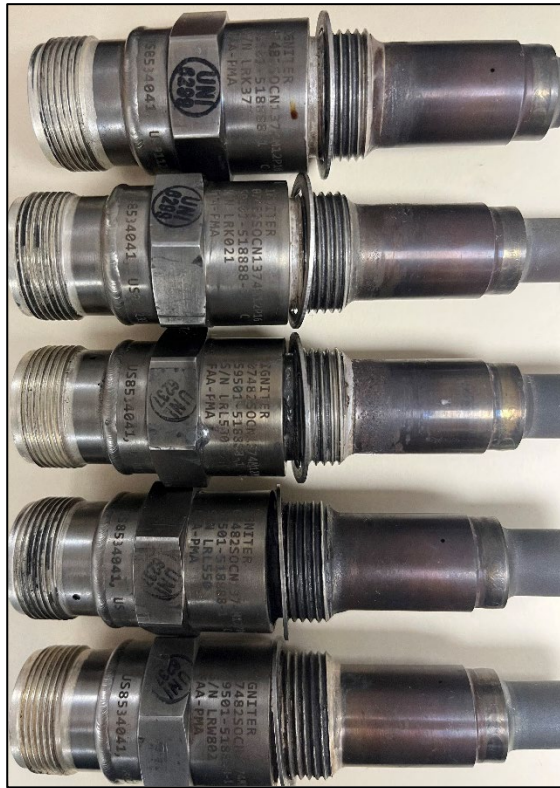
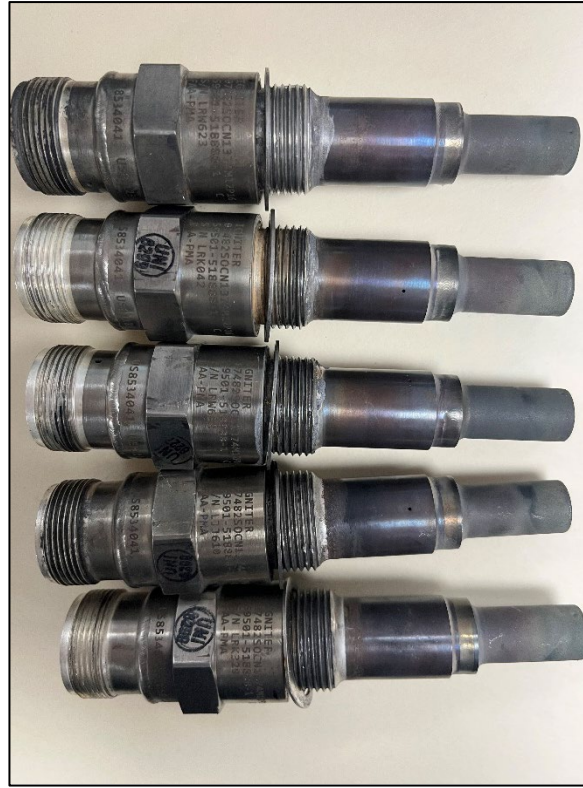
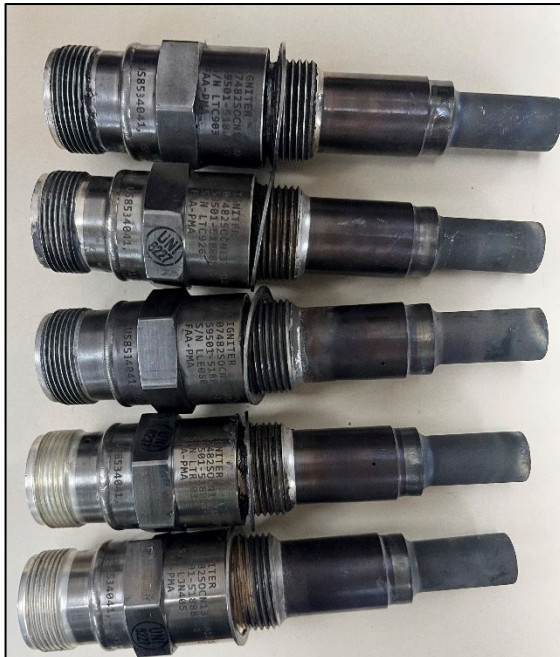
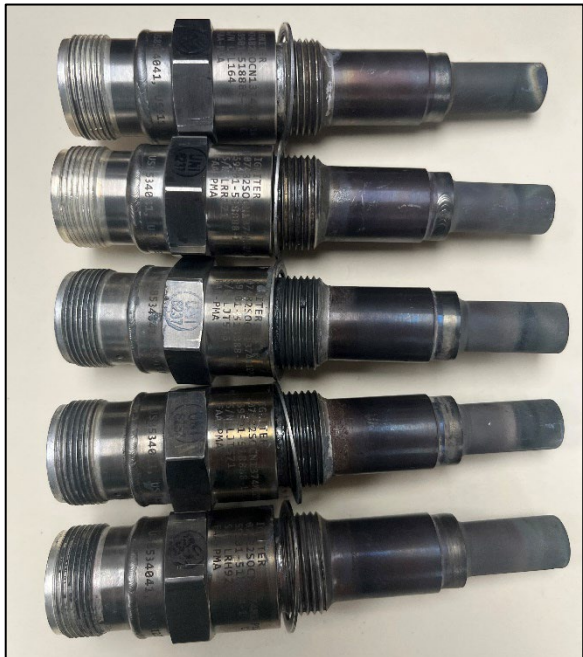
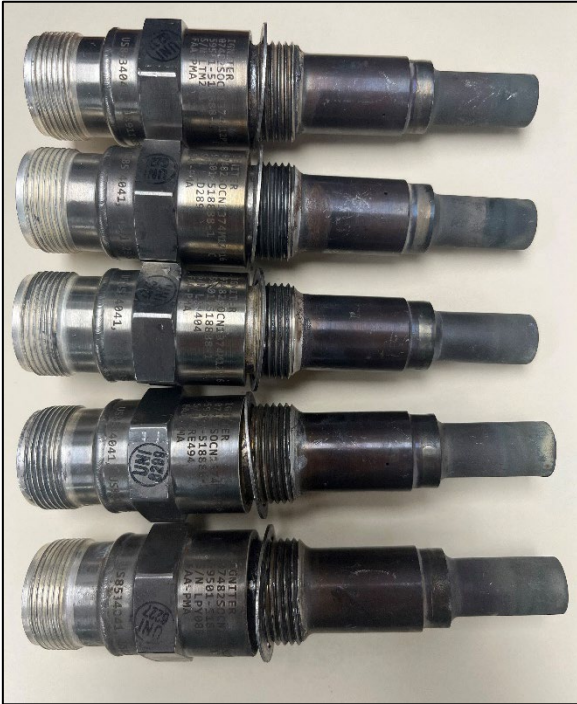
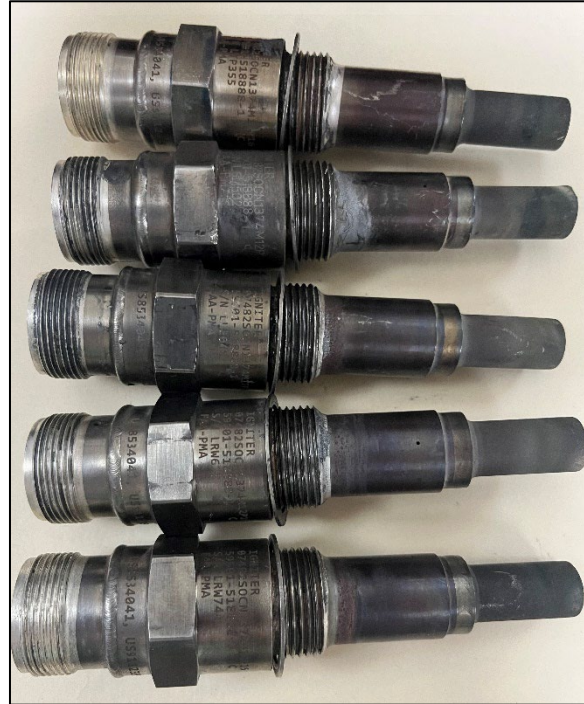
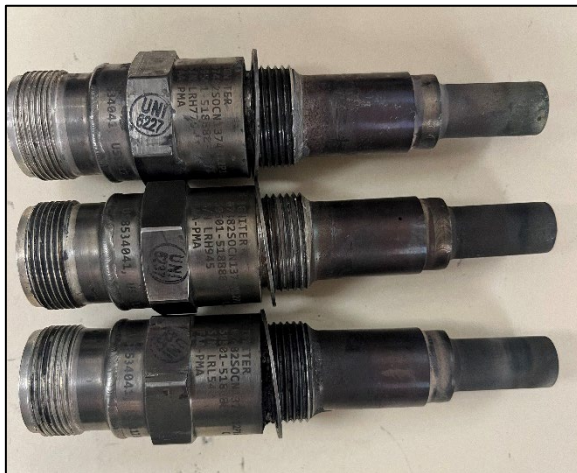
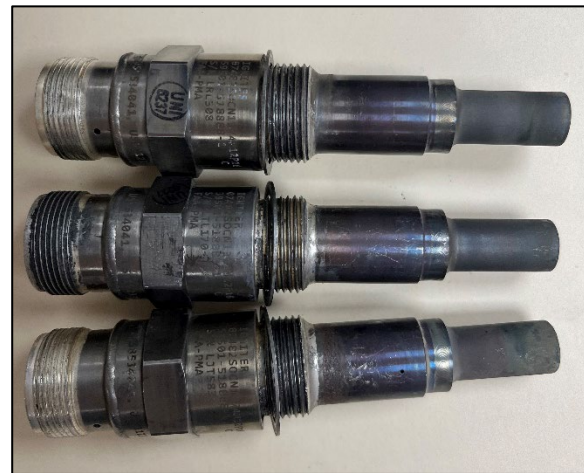
All ninety-six (96) igniters had the external appearance for a used igniter. There was normal heat discoloration to the igniter bodies below the installation threads as well as residue of anti-seize compound in the installation threads as can be seen in **Figure 1. Photograph 1 through Photograph 20** are of all the examined parts. Igniters are labeled from top to bottom in the photo description.

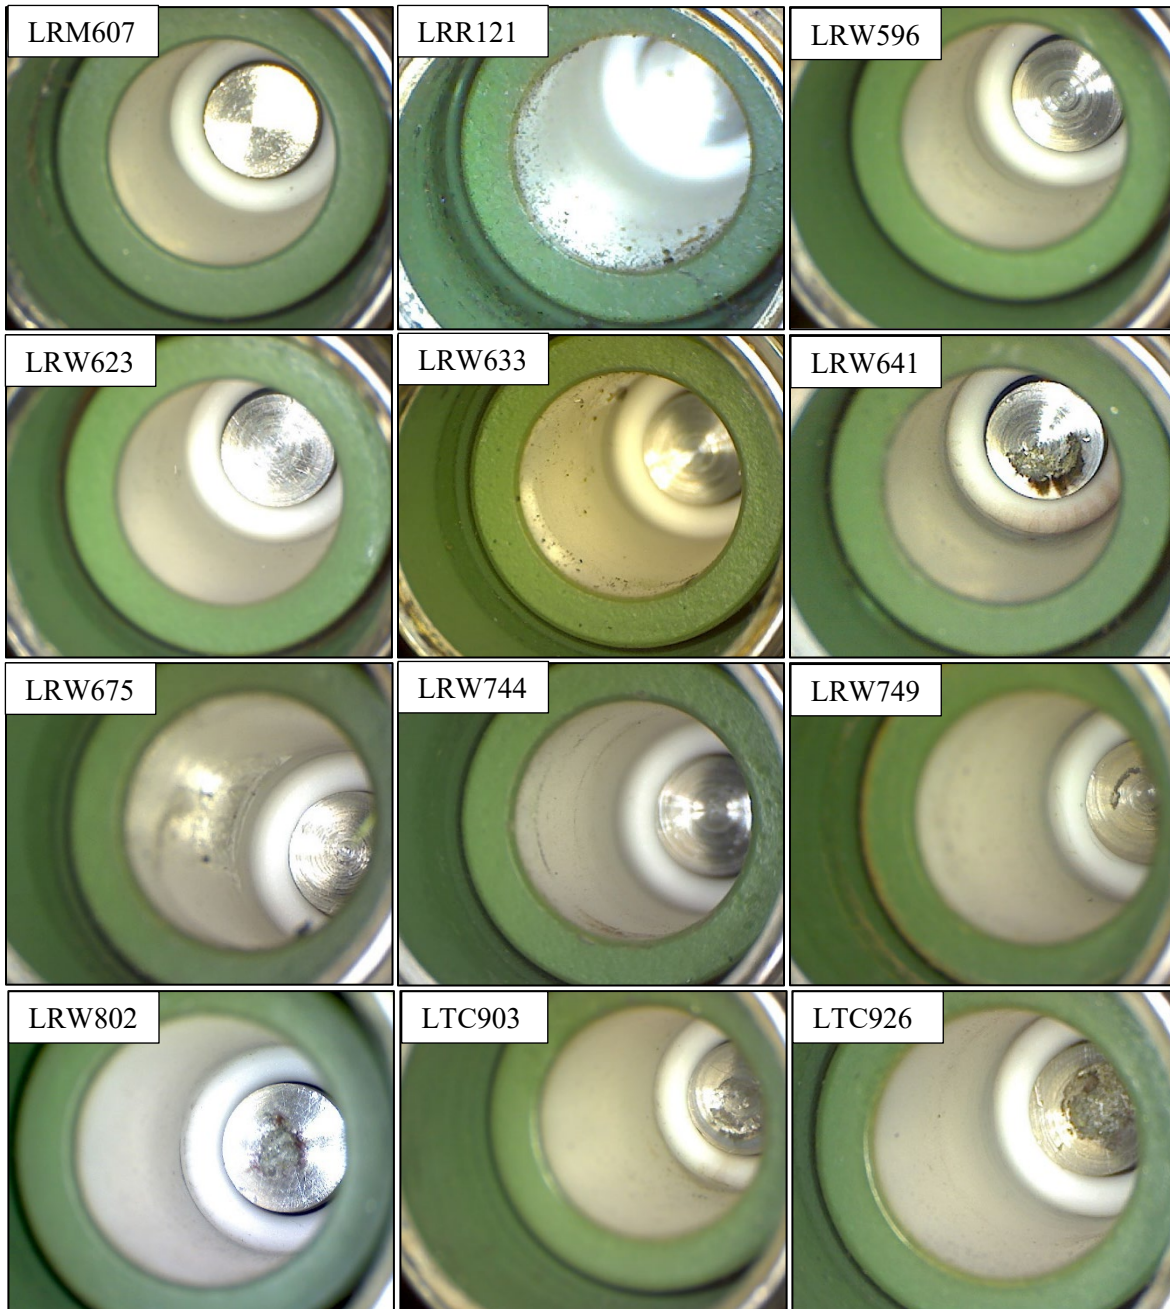
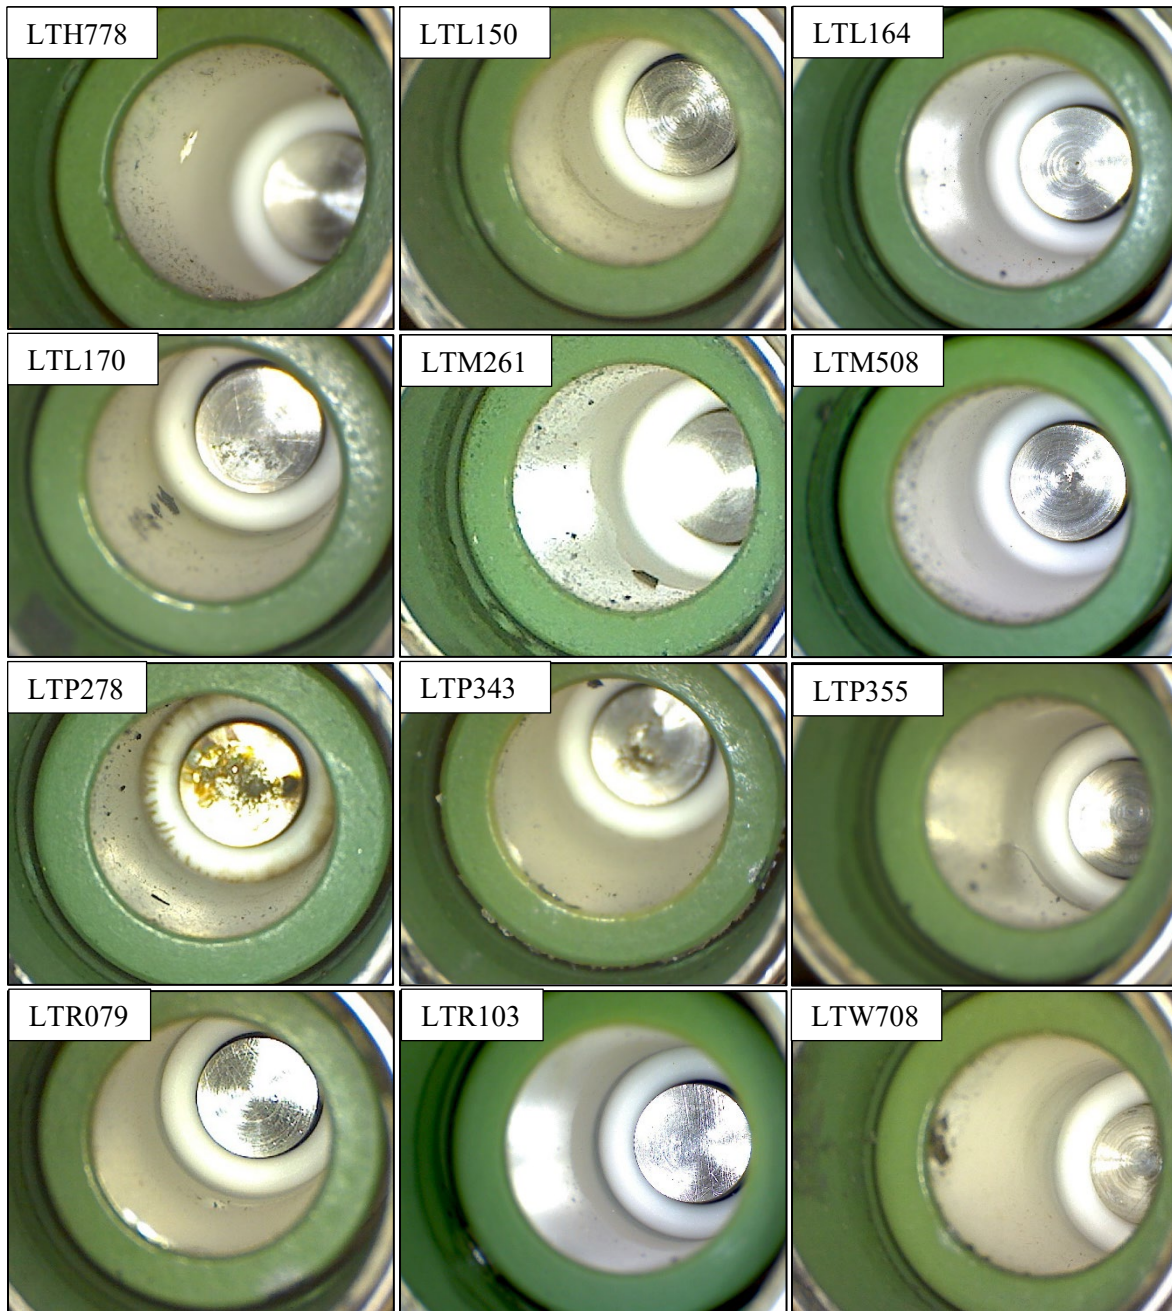
Figure 4: Competitor Long Life Igniter Terminal Well Contamination

Roughly 55% of the terminal wells inspected were clean, with the rest exhibiting some level of contamination. This could possibly be from the anti-seize compound noted in the installation threads. The photos in **Figure 4** show the varying levels of contaminates in the igniters.

The photos in **Figure 4** below show the as received condition of all ninety-six (96) igniter terminal wells.

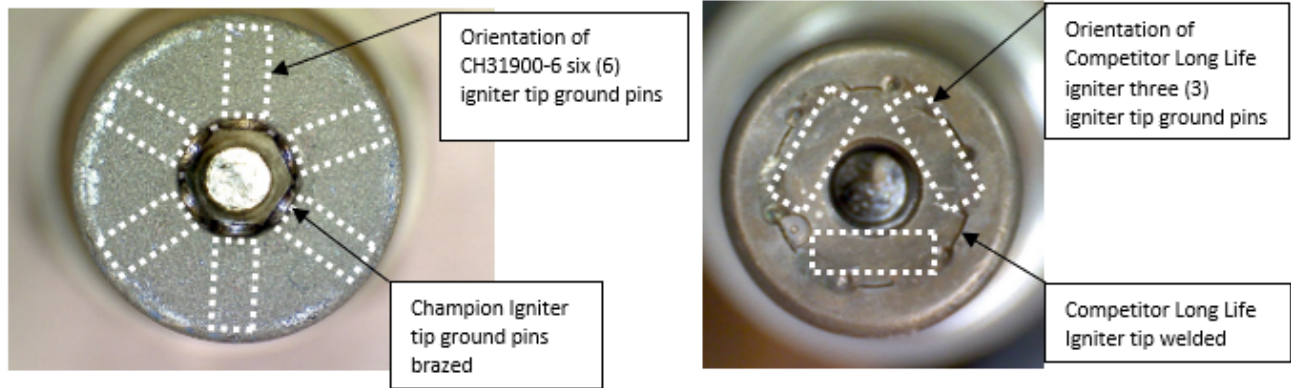
Figure 8: Champion and Competitor Long Life Igniter Geometry

In order to better review the ground pin wear, the firing tip end of each igniter was removed. **Figure 8** below shows the geometry of the Champion and Competitor Long Life igniter firing end tip designs for reference throughout this report. The Champion igniter design utilizes ground pins installed perpendicular to the center electrode equally spaced around the ground shell diameter, which are brazed into the firing end shell. In contrast, the Competitor Long Life igniter design features ground pins installed in a triangular pattern inside a metallic insert that in turn is welded into the firing end shell.

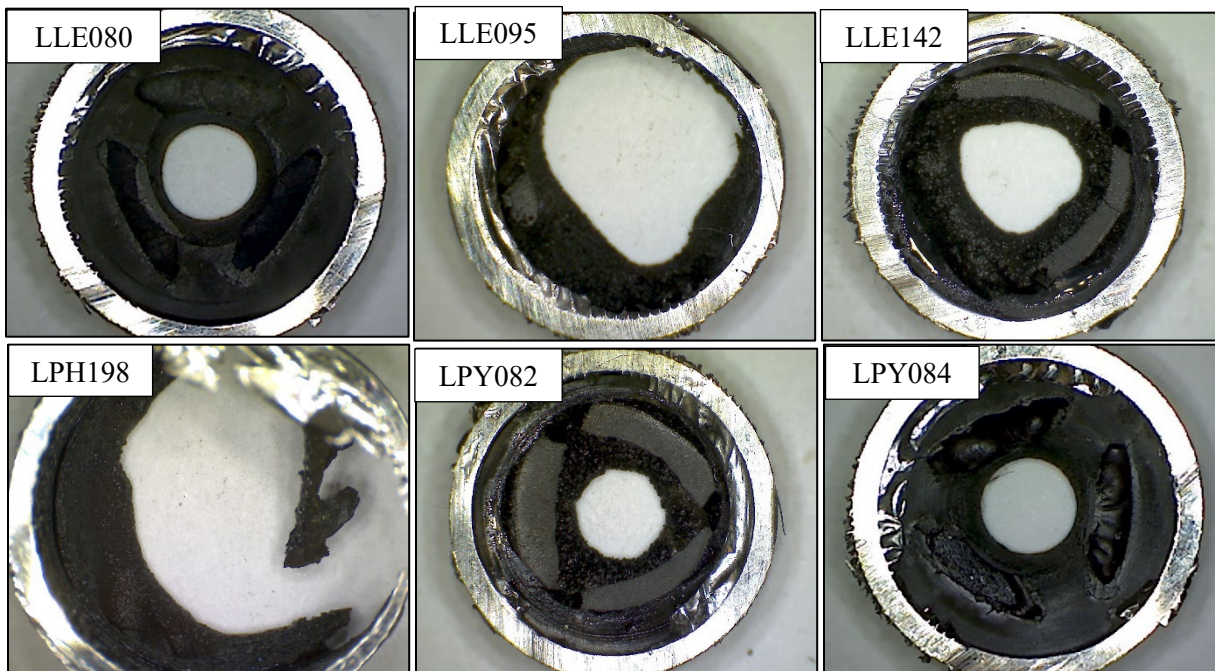
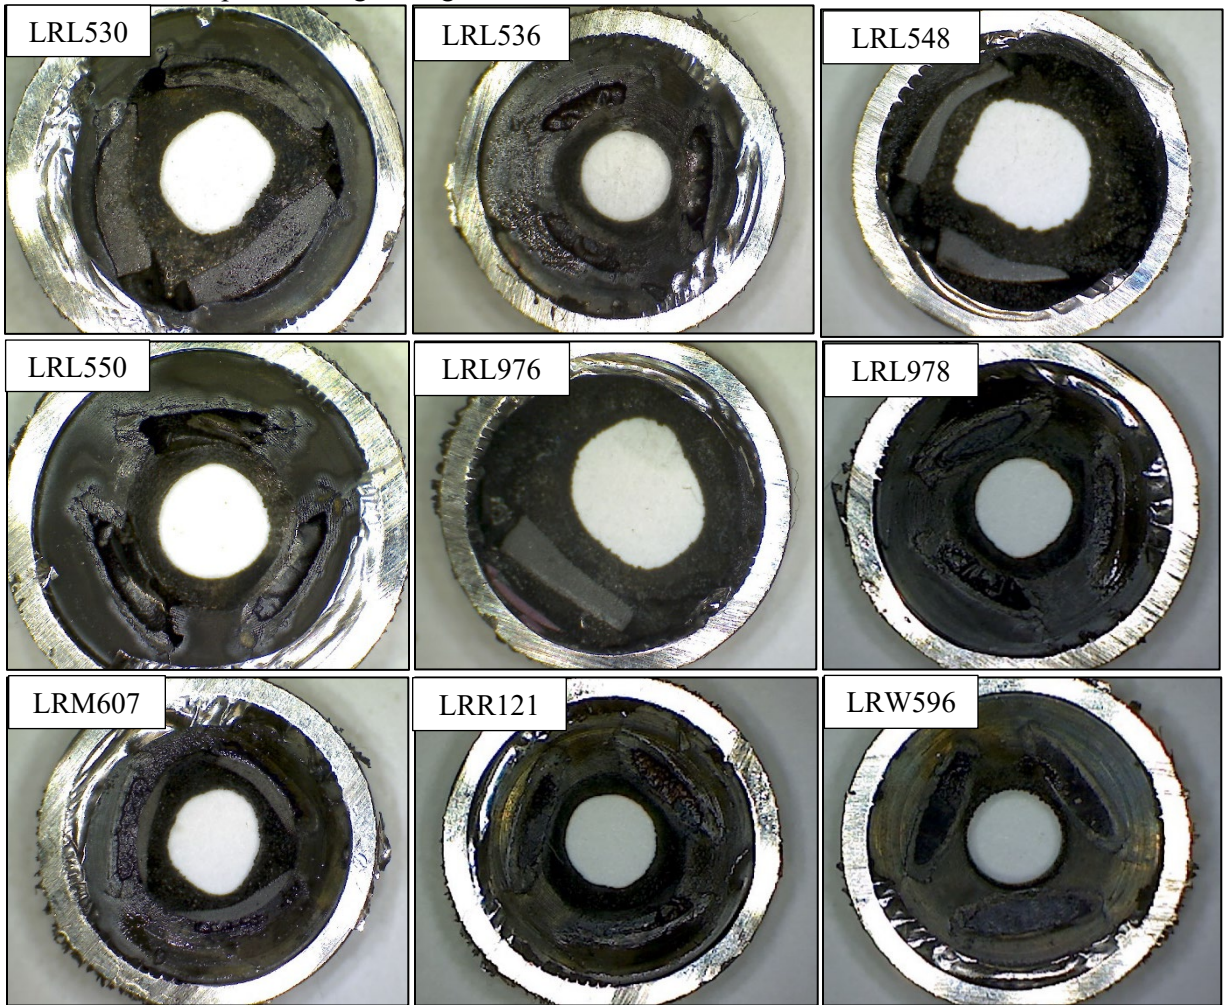
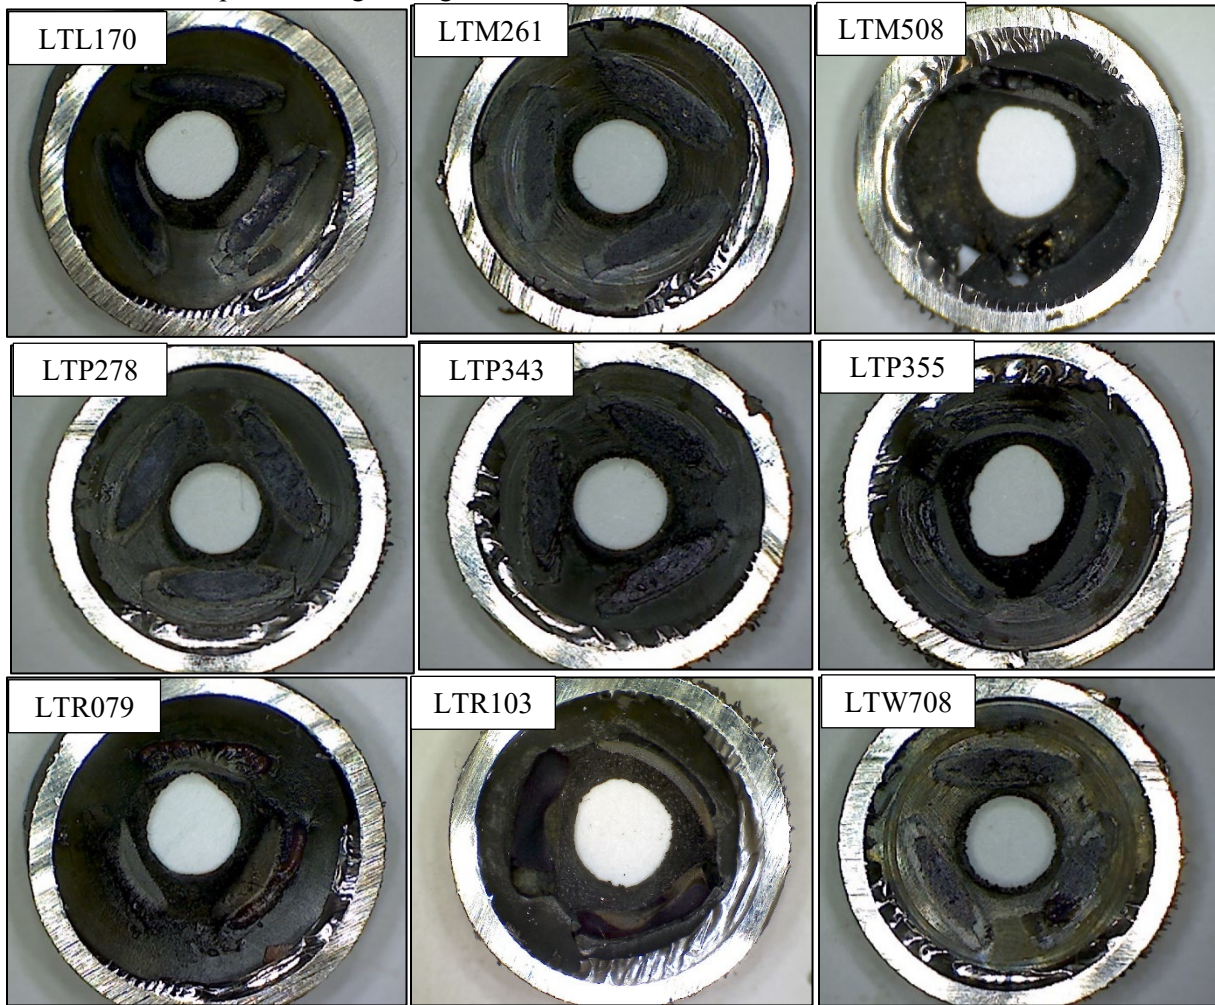
Figure 9: Competitor Long Life Igniter Pins

After evaluating the ninety-six (96) Competitor Long Life igniters returned, fifty-two (52) of the igniters appear to have all three ground pins remaining. However, the remaining forty-four (44) igniters appear to have portions of ground pins or entire ground pins missing with twelve (12) of these units appearing to have all their ground electrode material missing. The pin numbers for each individual igniter are included in **Table 2** above. Pictures of the ground pins are shown below in **Figure 9**.

1. From this analysis, it is seen that 39.6% of the returned Competitor Long Life igniters exhibit conditions that indicate at least one entire ground pin missing.
2. Because of the cracking and evidence of missing ground pin material, partial or full ground pin liberation into the combustor is likely to have occurred with the Competitor Long Life igniters missing ground pins.
